CULTURAL HERITAGE IMPACT ASSESSMENT

**PROPOSED MCGIBBON CONDOMINIUM PROJECT
69 MAIN STREET SOUTH, 71-77 MAIN STREET SOUTH, 79 MAIN STREET SOUTH, AND 94-96 MILL STREET,
FORMER ESQUESING TOWNSHIP, HALTON COUNTY
COMMUNITY OF GEORGETOWN, TOWN OF HALTON HILLS, ONTARIO**

ASI File: 15TS-266

February 2016

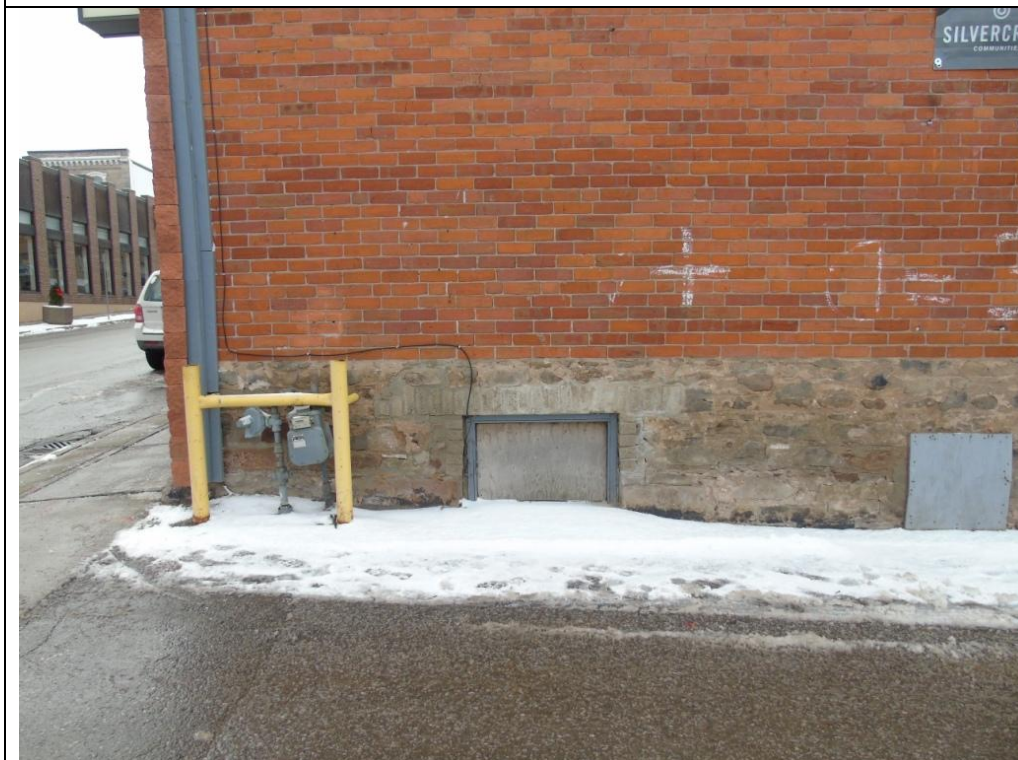
The east elevation is far more utilitarian in design than the south elevation, and lacks the decorative brickwork and fenestration of the south fronting on Mill Street. The east elevation clearly displays the coursed fieldstone foundation, with three windows leading to the basement. At the time of assessment, all three of these windows were boarded up. The main floor lacks any windows, but features two louvered vents. The second floor features a narrow, centrally located one-over-one sash window encased in a thick concrete frame, with a red brick segmental arch and concrete sill. A single, centrally-located internal red brick chimney is present on the east elevation. Extensive repairs to the brickwork on the east elevation are

Plate 22: Detail of the brickwork and foundation on the east elevation of the structure at 94-96 Mill Street, looking west.

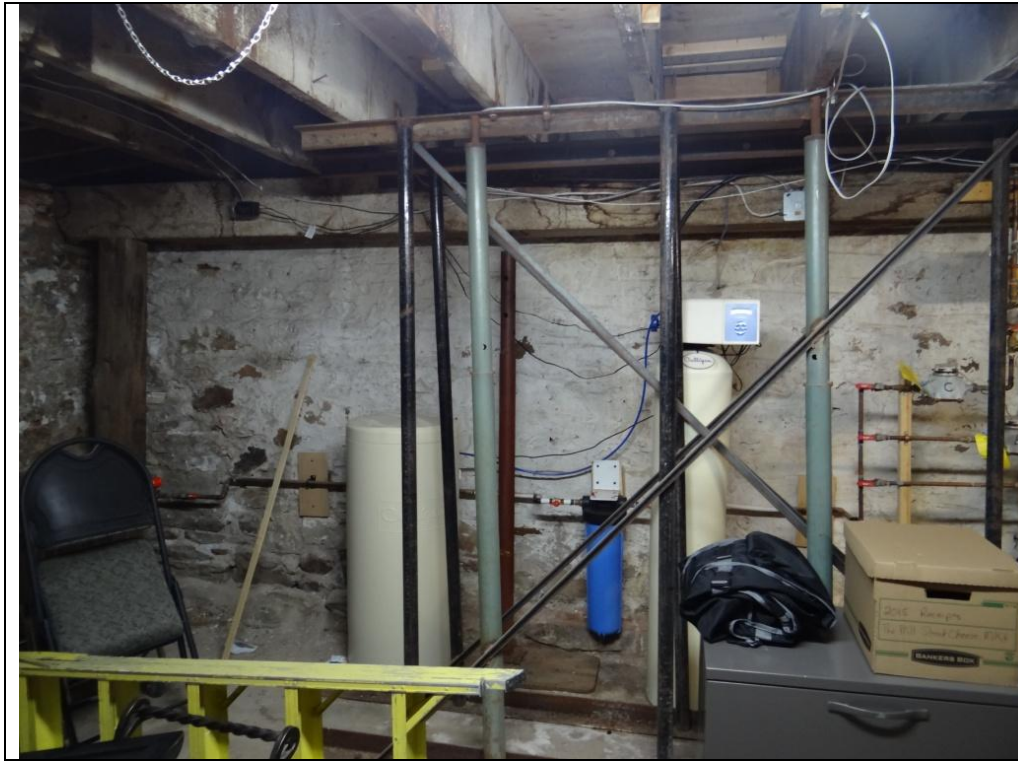
Plate 31: Detail of modern structural steel posts added to reinforce the main floor joists in the basement at 94-96 Mill Street.

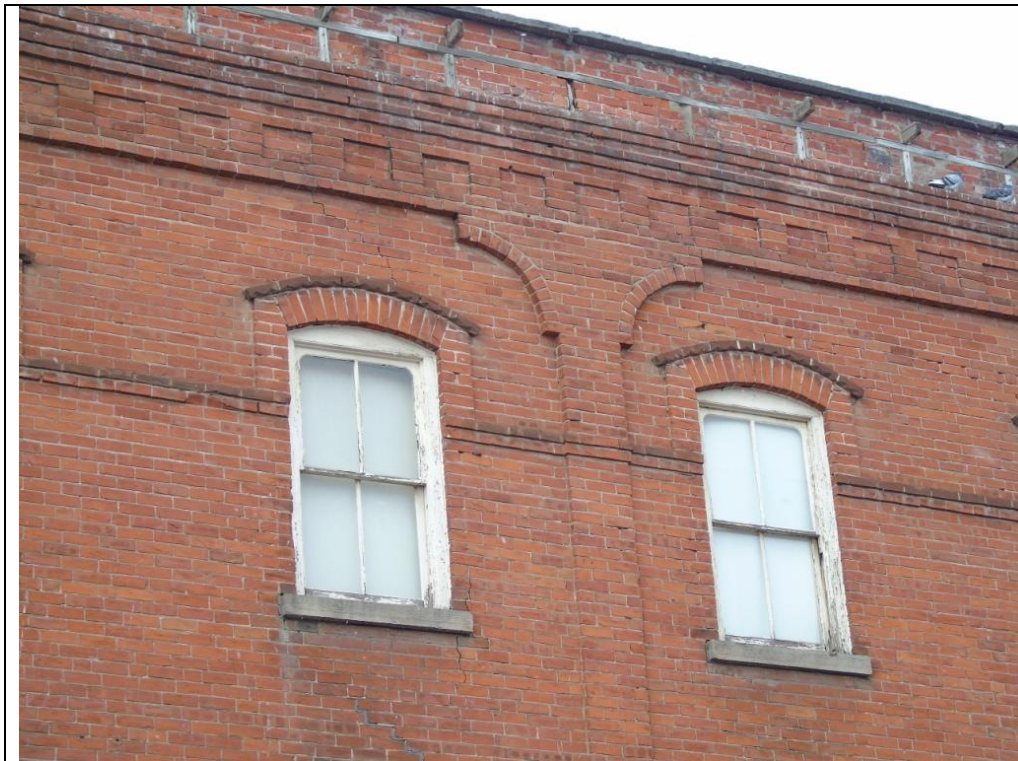
The second and third floors of the south elevation feature nine symmetrically-located two-over-two sash windows with red brick segmental arches and concrete sills. There is one exception to this, with one double-hung one-over-one sash window located slightly further to the west than the general pattern on the western end of the third floor. A portion of a fire escape ladder is present over this window and staining on the brick beneath it suggests the ladder once continued down to ground level. Repairs were begun but not completed on the overhanging roof on the south elevation, where the brackets and frieze present on the west elevation were removed and never replaced (Plate 49).

Plate 49: South elevation of 79 Main Street South, showing decorative brickwork, sash windows with segmental arches, and repairs to the roofline, looking northeast.

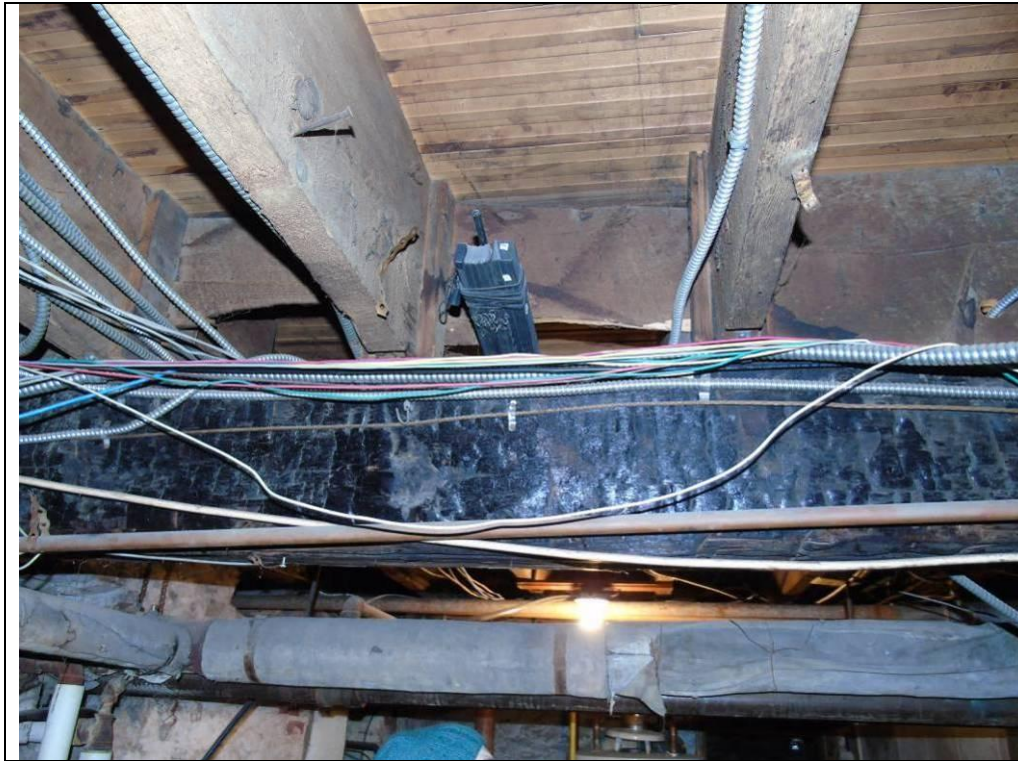
The basement of the structure at 79 Main Street South is attached to the basement of 71-77 Main Street South, both of which serve as part of the McGibbon Hotel. The basement features a combination of original heritage elements with modern additions and repairs to facilitate the restaurant and bar. The basement primarily features original random coursed fieldstone foundations, dirt/gravel floors, flagstone floors, sawn ceiling beams and floor joists, and visible softwood floorboards. There are also modern elements visible, including modern dimensional lumber, drywall, and faux wood panelling in the areas used most frequently for the restaurant including food preparation, storage, and refrigeration. The original heavy steel door is still present on the boiler room in the basement, retained from the original coal-fired boiler. Large flagstones were noted in one section of basement and may date to the original 1850s hotel. The basement also retains original support beams and foundations from the hotel building that was destroyed by fire in the 1880s, one of which is heavily charred but still structurally sound (Plates 65-73).

Plate 73:
Basement of 79
Main Street
South, showing
charred hewn
wooden support
beam, damaged
by 1880s hotel
fire.

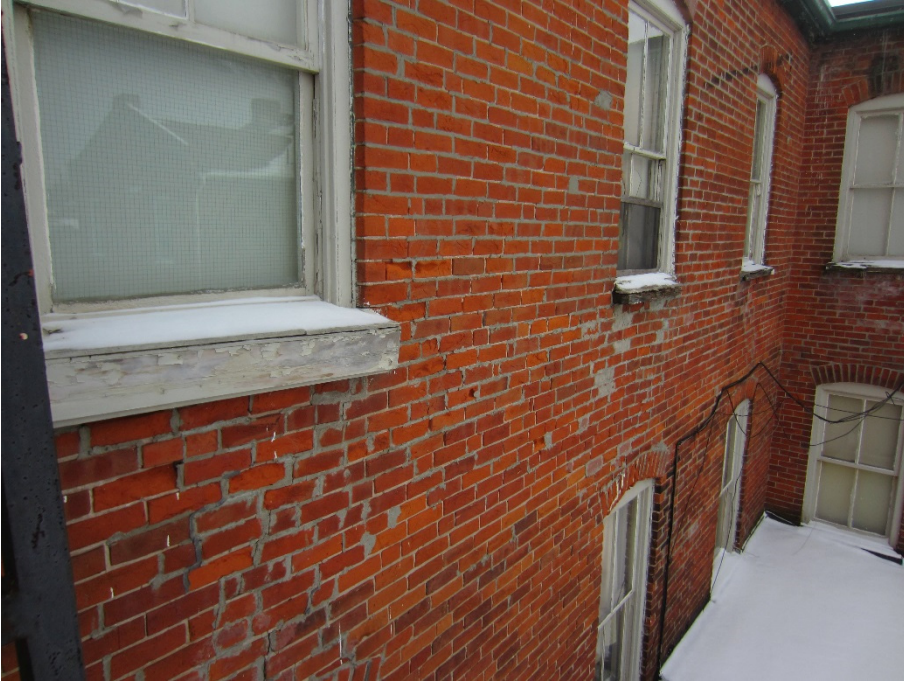
Photo #7: Visible cracks and repair on facade

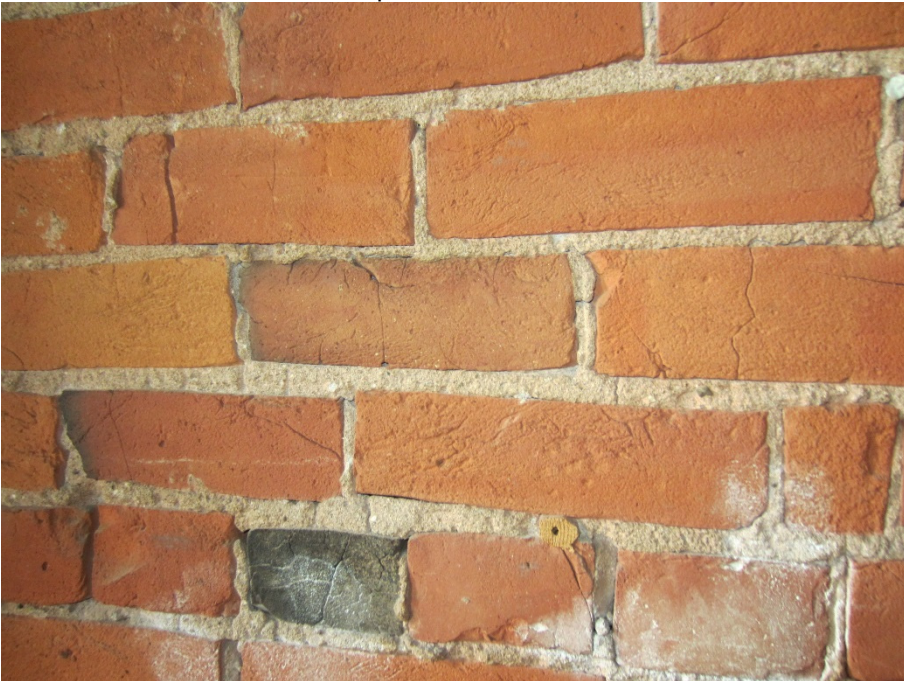
Photo #8: Visible cracks

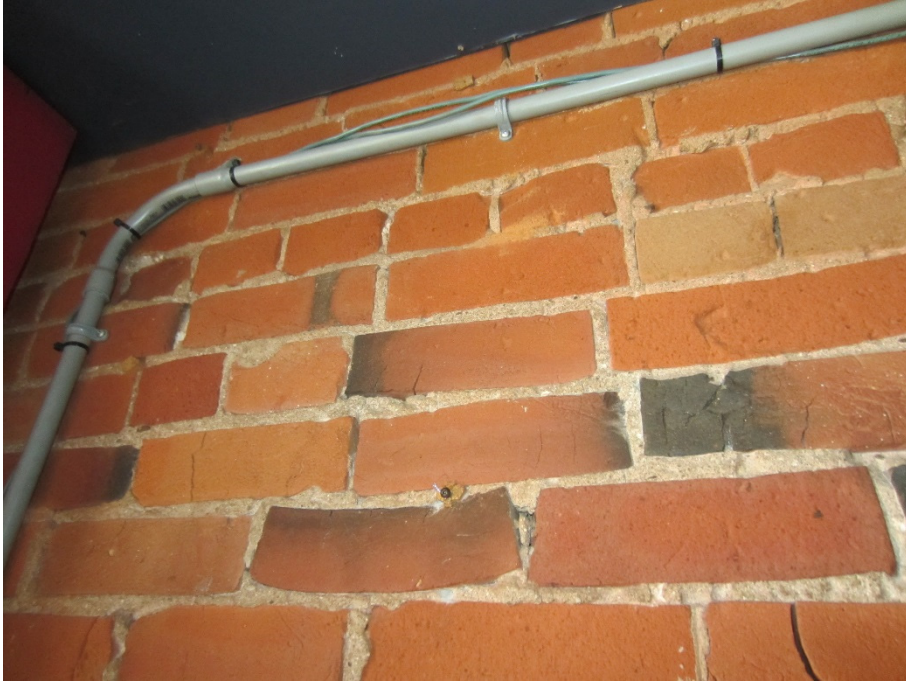
Photo #9: Visible cracks

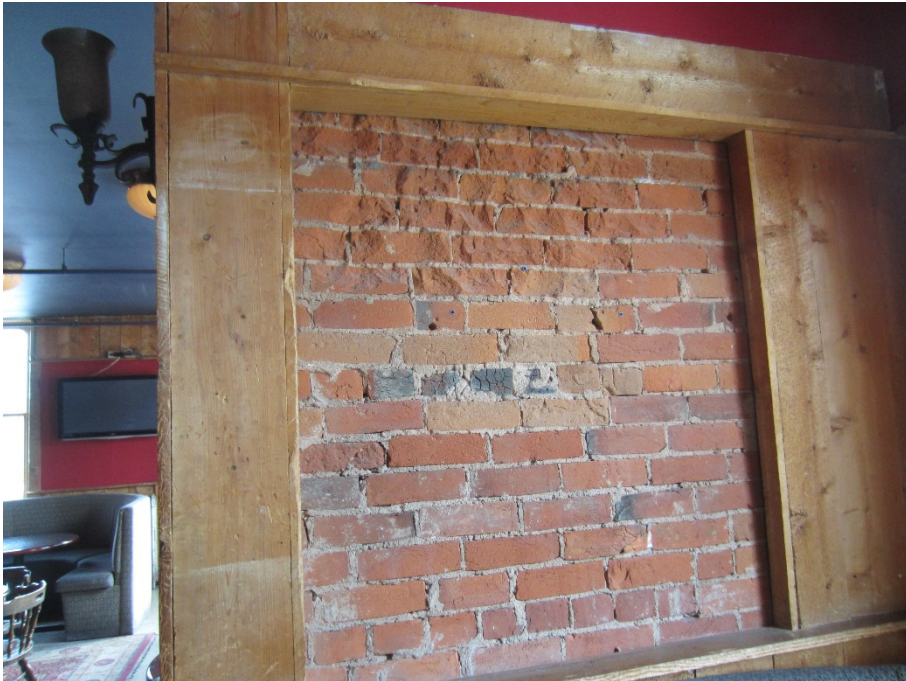
Photo #10: Visible cracks and spalling

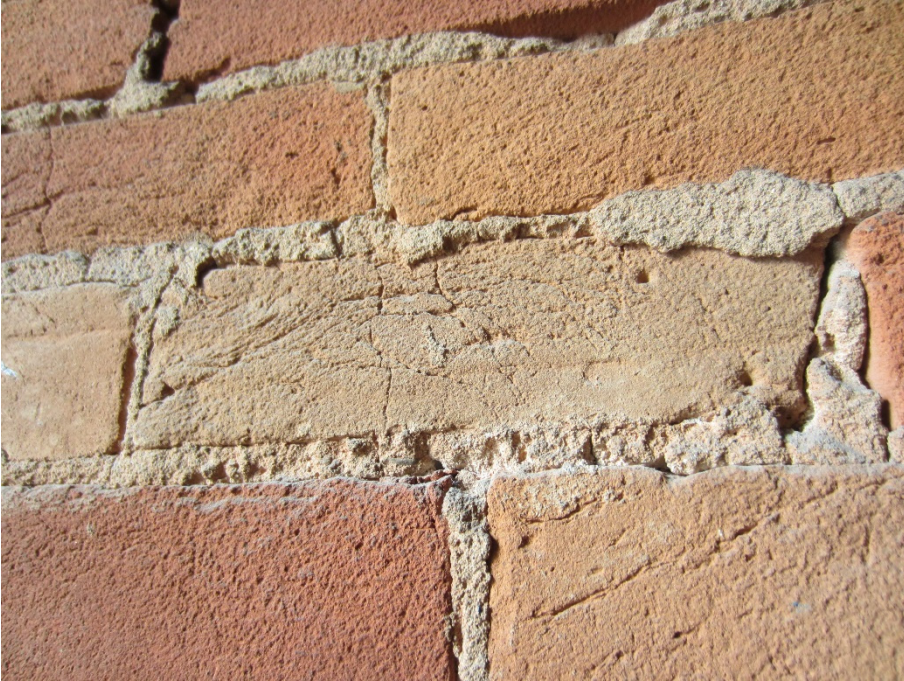
Photo #11: Visible cracks
