TREE ASSESSMENT REPORT

42 MILL STREET, GEORGETOWN HALTON HILLS, ON

NOVEMBER, 2016

RON KOUDYS
LANDSCAPE
ARCHITECTS inc.

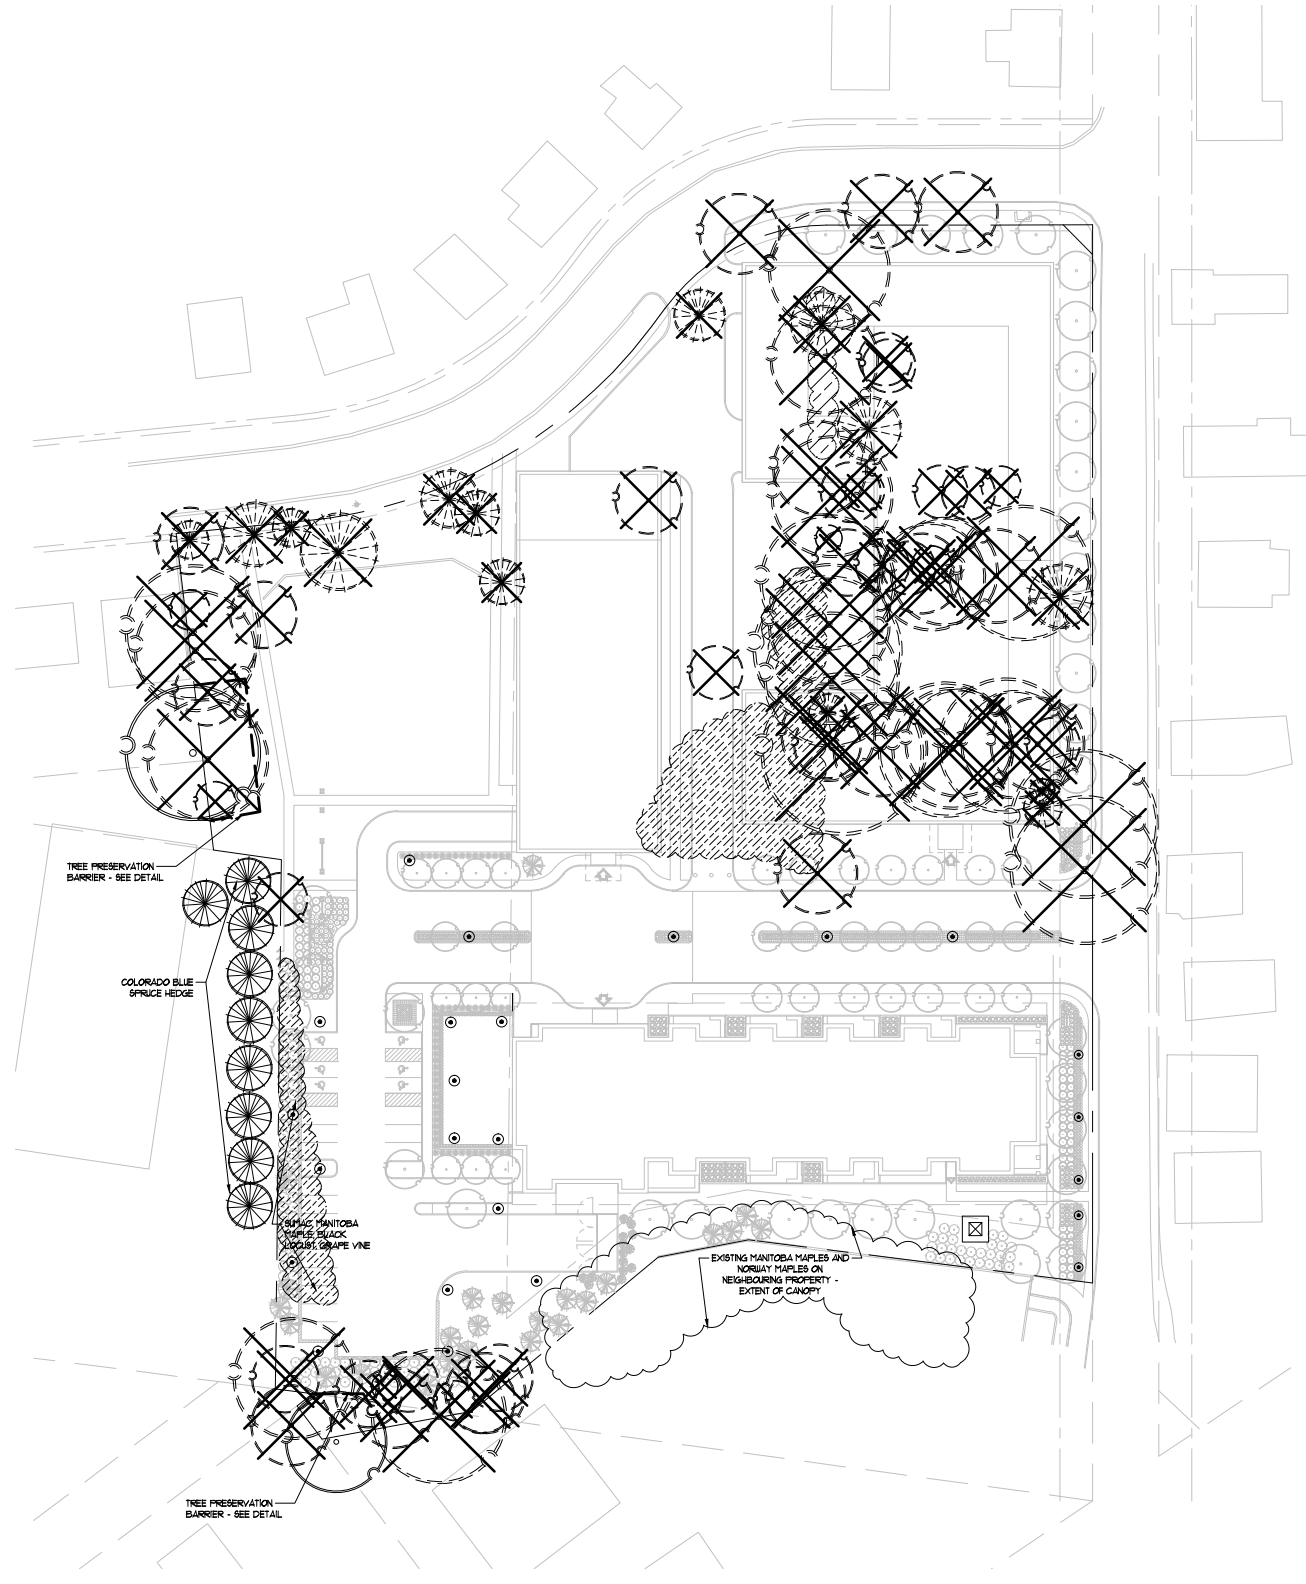
TREE PRESERVATION PLAN
SCALE = 1:500

It is our recommendation that a Tree Preservation Barrier shall be established and maintained for trees 1 and 2. There are no interior trees to be preserved. Refer to appendices B and C for more details.

No construction, stockpiling, or heavy equipment will be permitted beyond the tree preservation barrier (refer to T-1). Trees in poor condition that are to be removed should be felled carefully to minimize the impact to trees to be preserved (refer to pre-construction recommendations). The trees that are to be removed have been indicated by the appropriate symbol (refer to T-1).
