PHASE ONE ENVIRONMENTAL SITE ASSESSMENT 159 CONFEDERATION STREET, HALTON HILLS, ONTARIO

Prepared By: SIRATI & PARTNERS CONSULTANTS LTD.

Project: SP23-01265-00 4-160 Konrad Crescent, Markham ON

Date: January 22, 2024 Tel: (905) 940-1582 Fax: (905) 940-2440

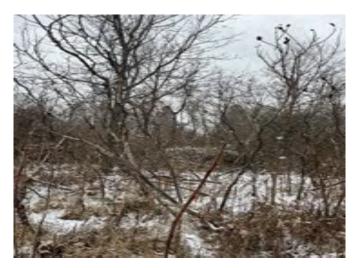
Photograph 2

View of the southeast area of the Description:

Property

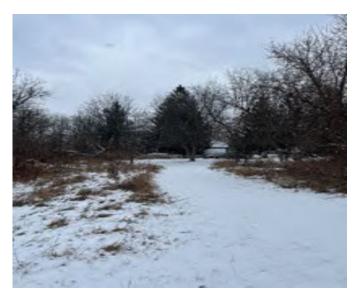
Photograph 3

View of the neighboring Description:

property.

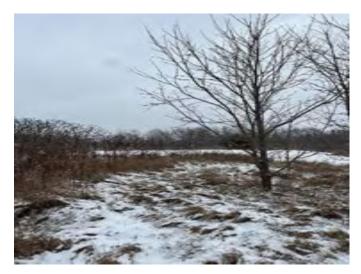
Photograph 8

View of the west portion of Description:

Phase One Property

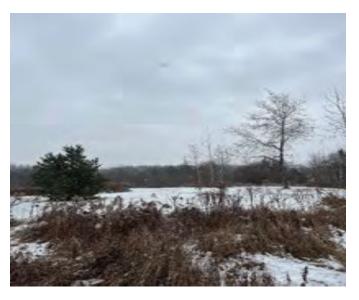
Photograph 9

View of the west portion of Description:

Phase One Property.

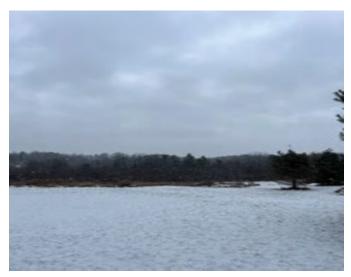
Photograph 11

View of the west portion of Description:

Phase One Property.

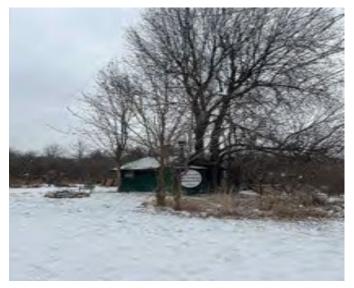
Photograph 12

View of the empty shed located Description:

at the Phase One Property.

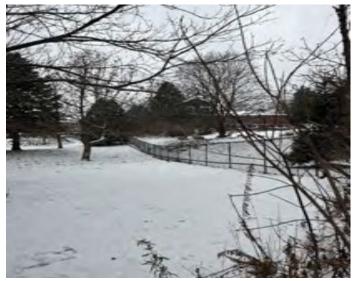
Photograph 15

View of the neighboring Description:

property.
