Tree Inventory & Arborist Report

1 Rosetta St, Georgetown, ON L7G 3P1

September 27 2024

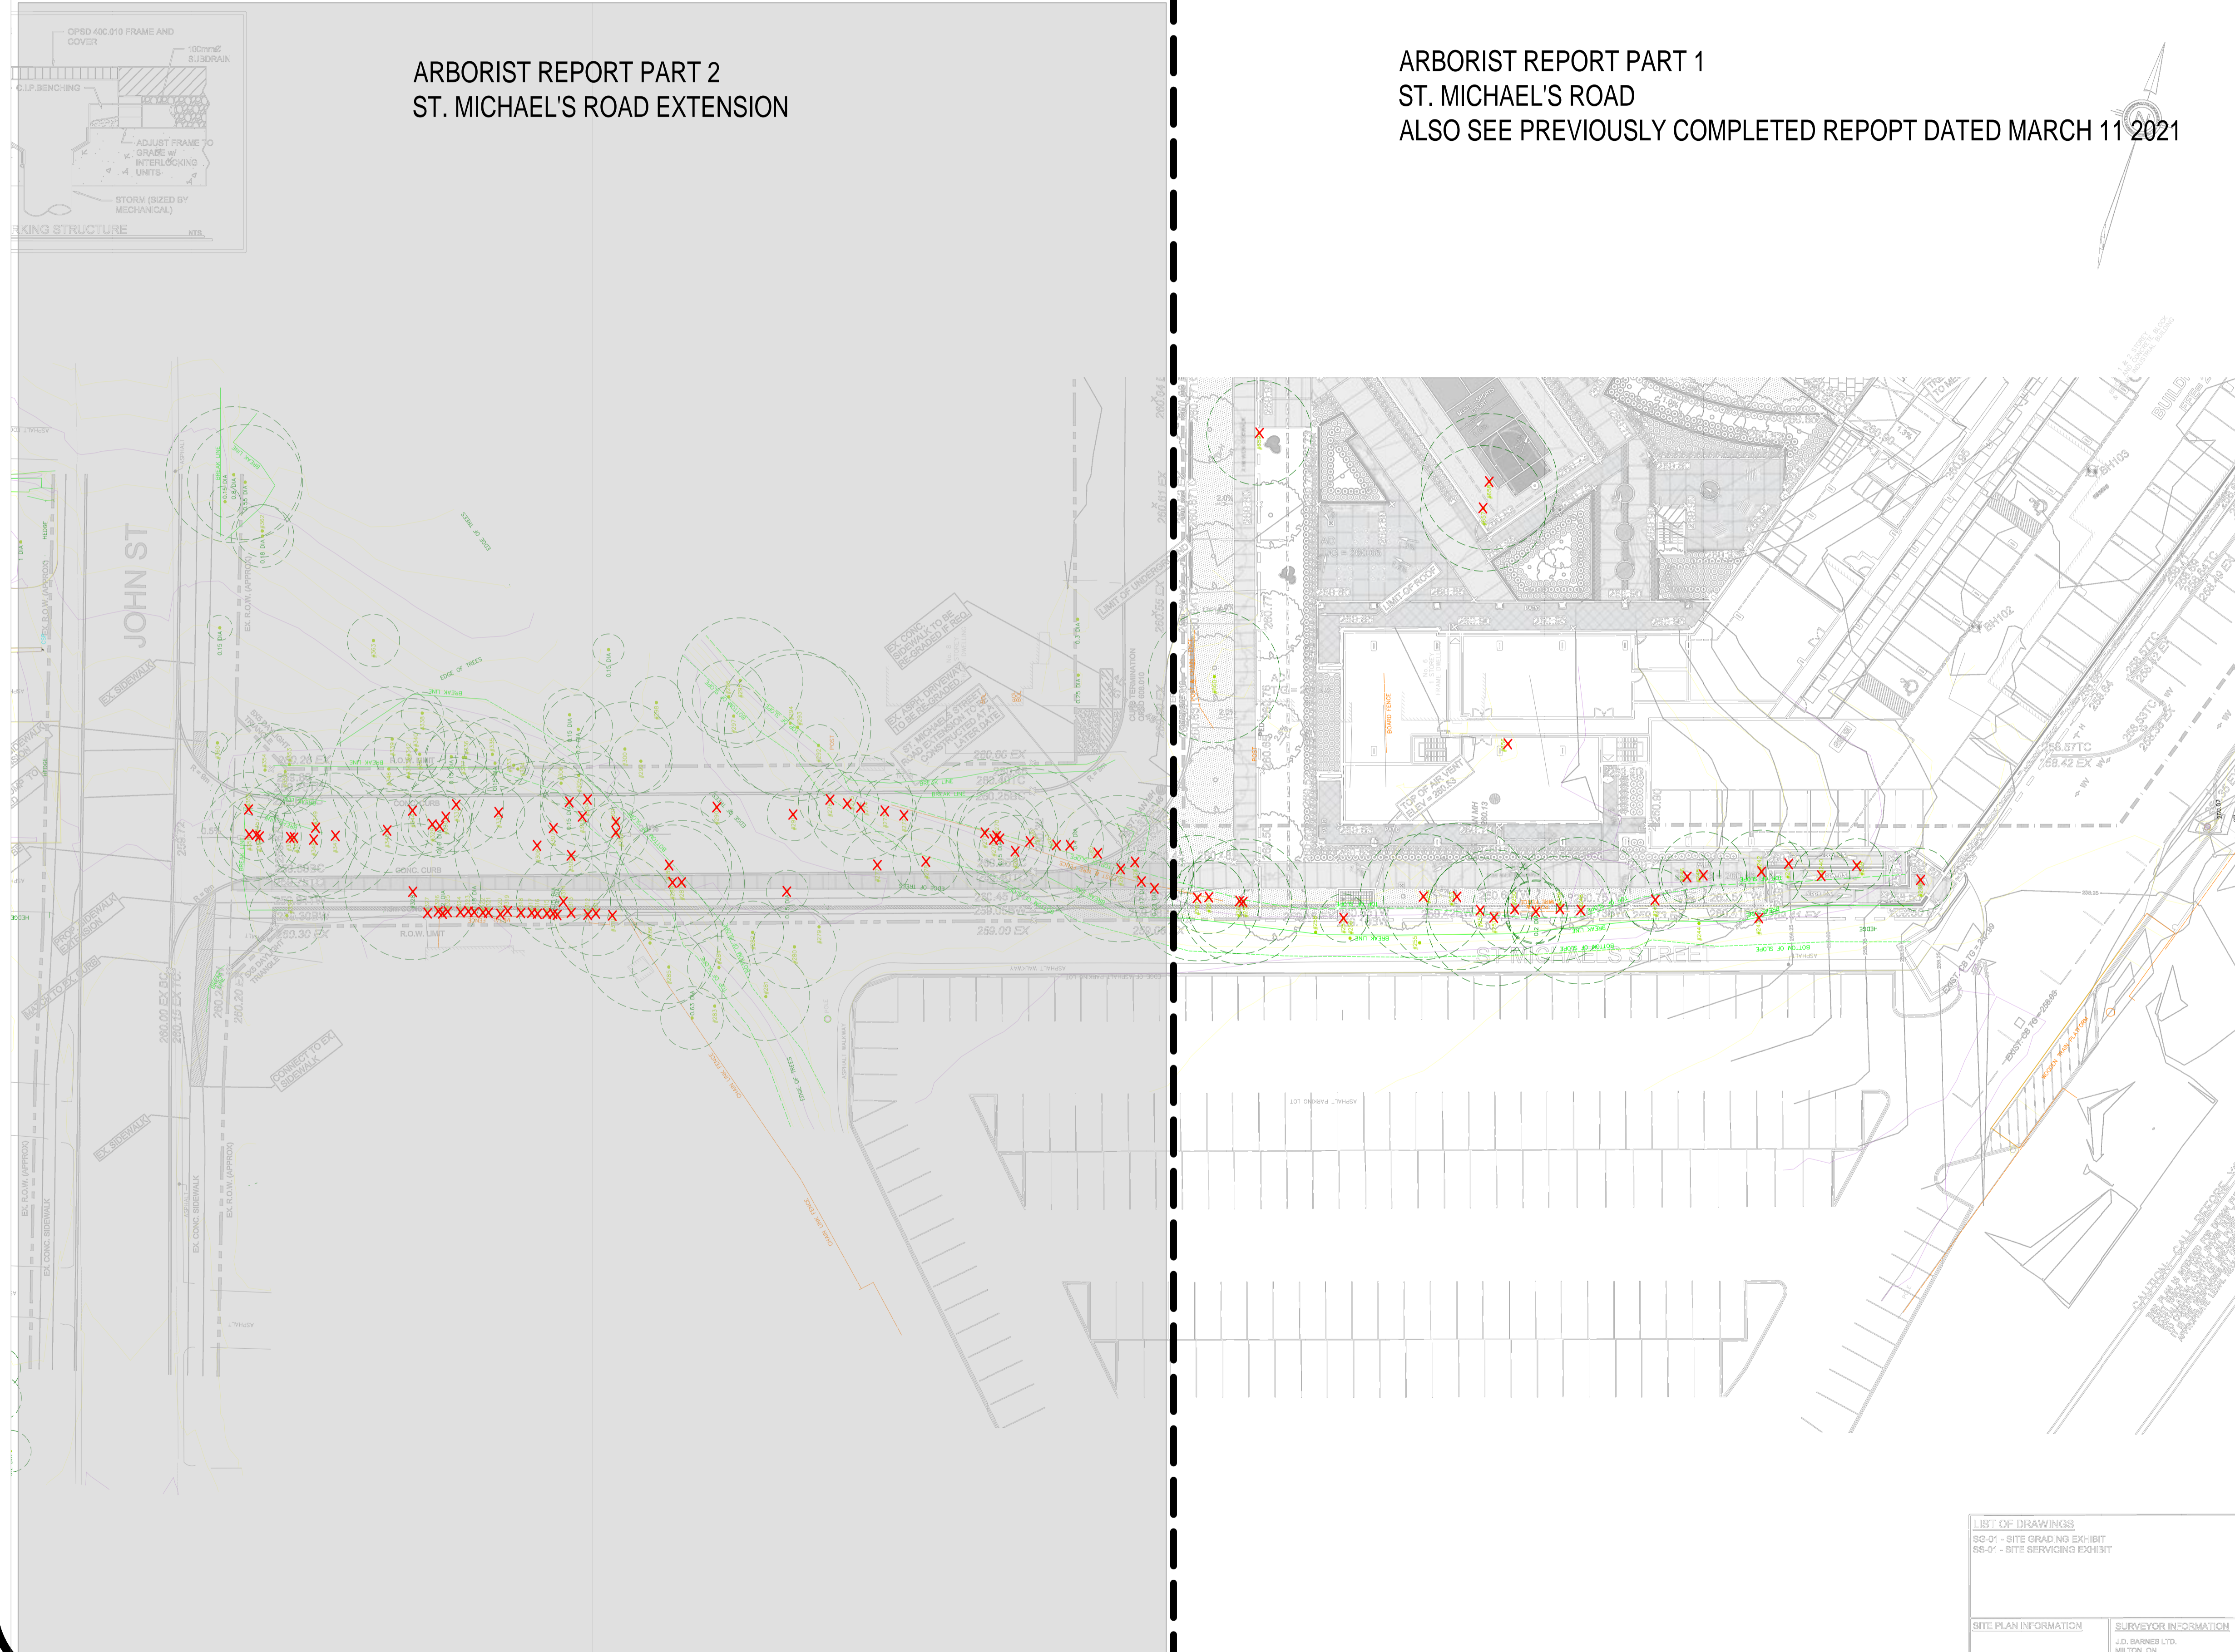
Project Tree Inventory Plan	Sheet TP-1
Date 30.09.2024	
Scale As Noted

Conclusions	Recommendations
31 trees are proposed to be removed that requires a permit to remove.	Apply to remove 31 trees on the subject property.
4 trees are to be retained where the property line and construction site fencing will act as tree protection.	Install construction site fencing.
