Visual Impact Study

Eden Oak

Proposed Subdivision
Part of Lot 20, Concession 9,
Town of Halton Hills, Ontario

Visual Impact Study for Eden Oak

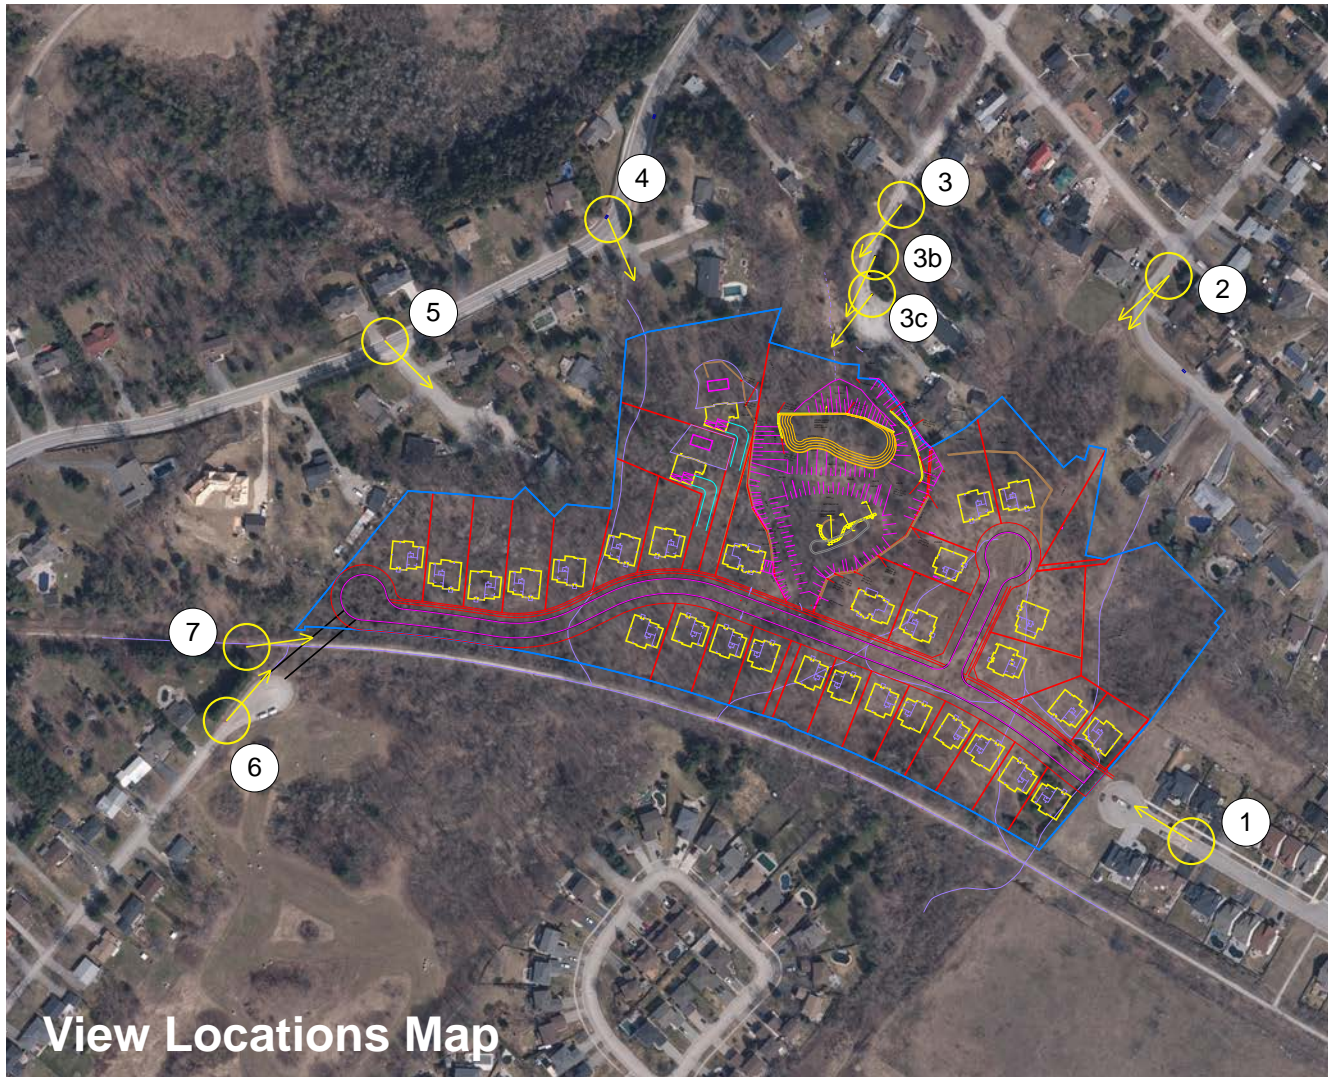
Camera Locations:

- 1. Gamble Street**
- 2. Alexandra Street by
Park Street East**
- 3. Credit Street**
- 4. Park Street at Wildwood Road**
- 5. Chelton Street at Wildwood Road**
- 6. Ann Street**
- 7. Pathway near Ann Street**

James T. Ziegler of Siteline Research took site photography on May 23, 2016 and July 31, 2016 from the locations noted on the View Locations Map on the adjacent page. All photographs were taken with a fixed length normal lens equivalent to a 52mm lens. Typically, the camera viewpoint was set at 1.5 m above grade and shot either level or on an incline upward of 4° -8° and shot from a tripod. This range is within a comfortable and natural viewing angle and is consistent with viewing along the roadway grades. For all locations, the position of the camera was recorded with respect to known landmarks such as hydro poles, edge of pavement or buildings. The camera location was mapped on an aerial ortho-rectified photograph and matched to site drawings.

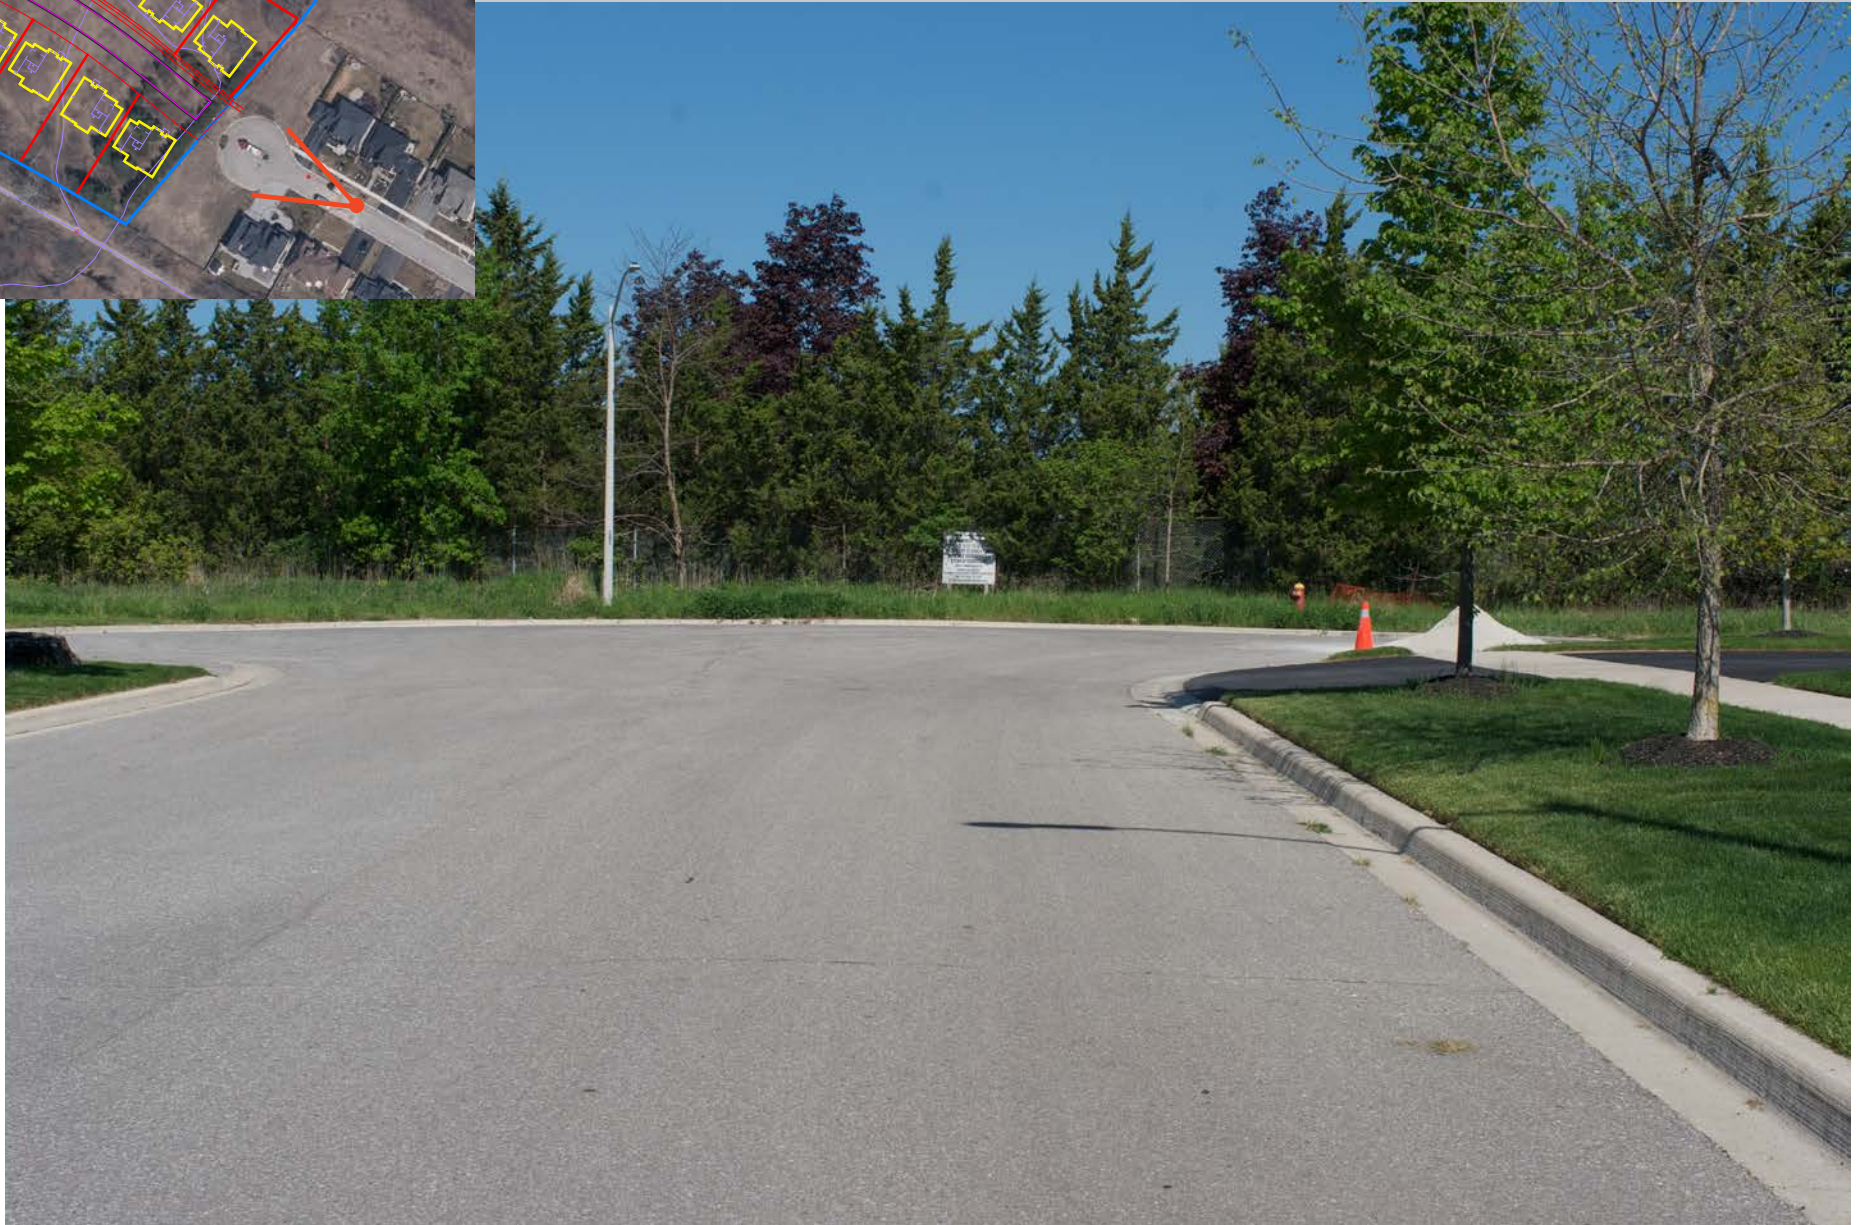
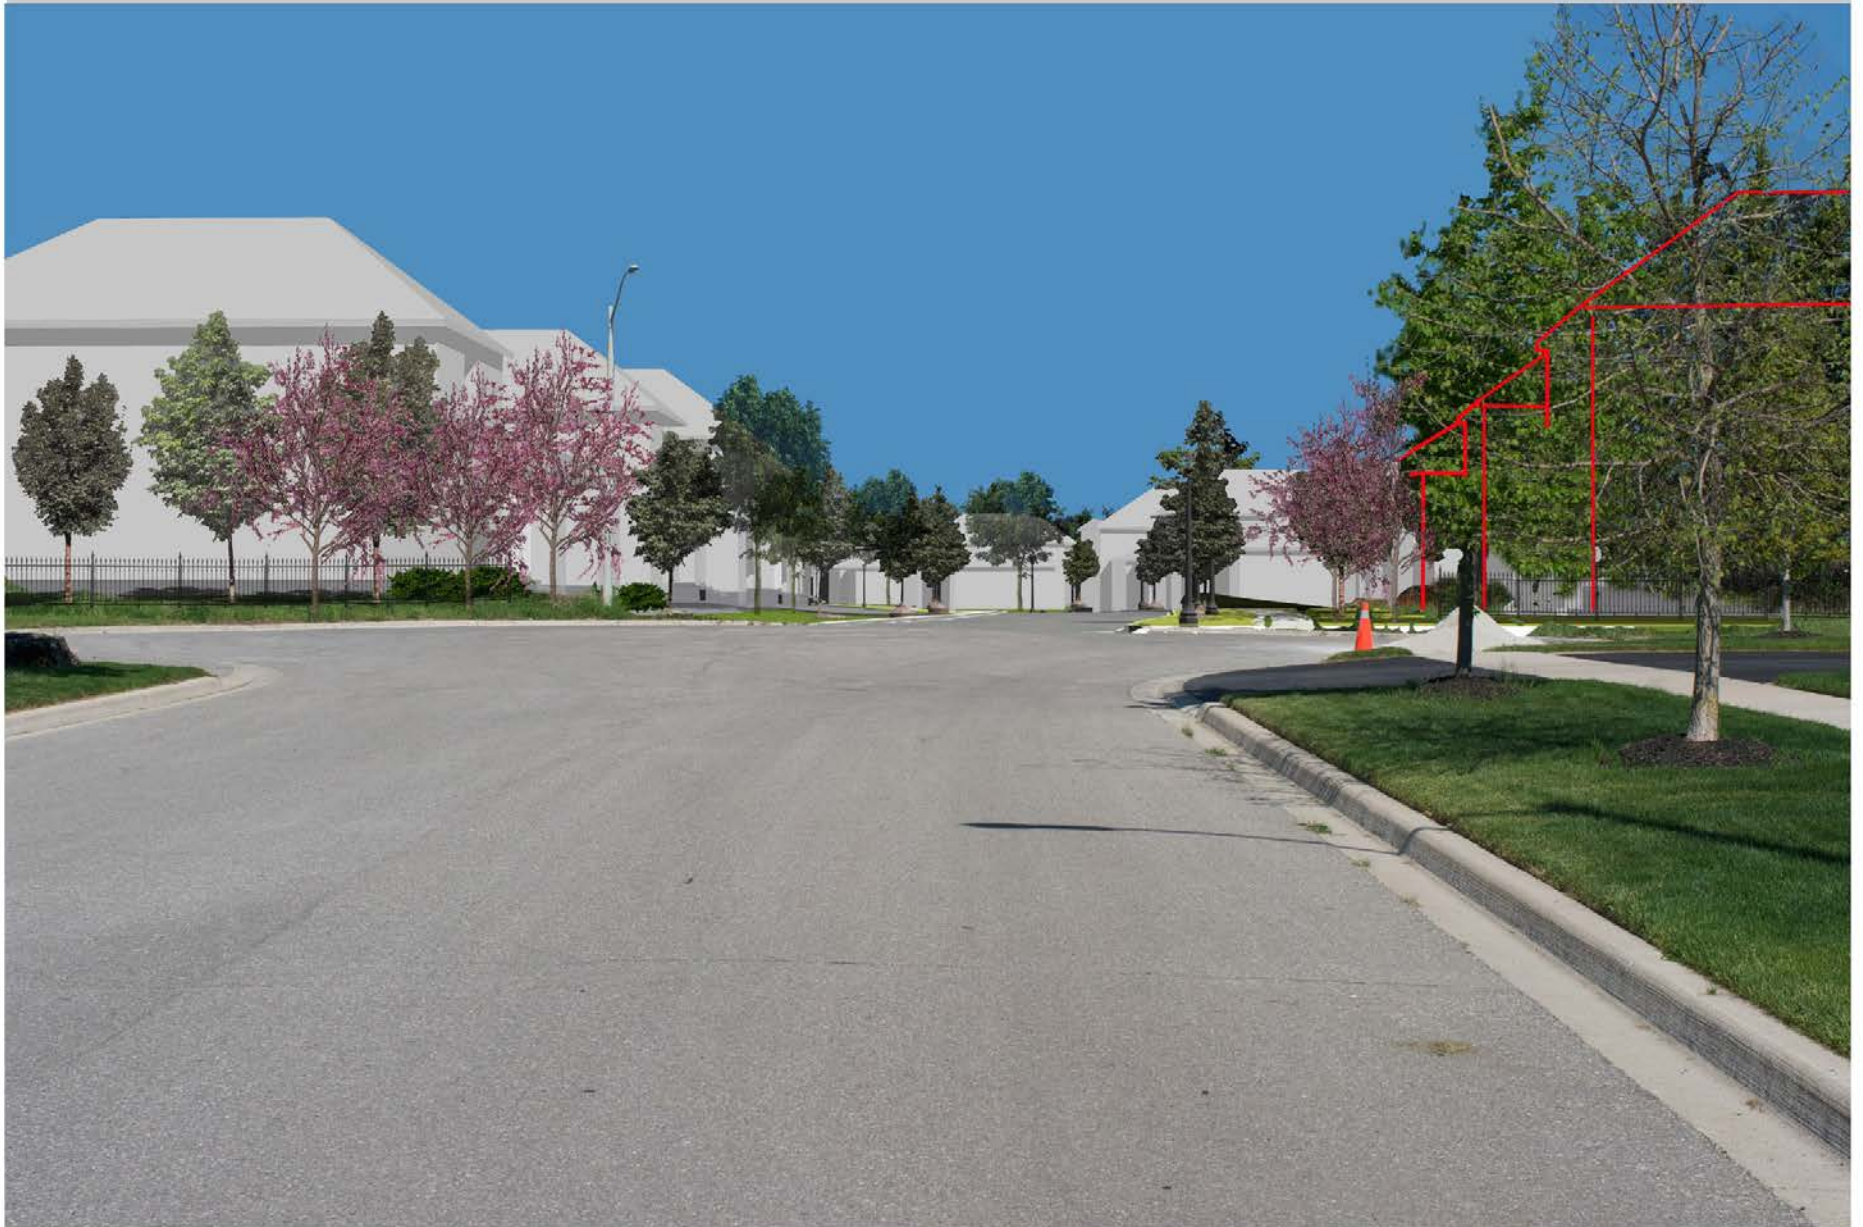
View Point 1, Gamble Street

Existing Conditions

For each view, two images are presented, showing the existing conditions and a composite overlay of the computer simulation with the existing site photo. Best efforts have been made to match the perspective camera view data with the computer imaging camera by geographic location, lens and viewing angle to present a true image of what a viewer would see in terms of the height and massing of the proposed Development with respect to the view locations. Where the foreground vegetation obscures the view to the proposed Development, an outline of the building massing and relevant retaining walls is overlaid on the photograph of the existing view.

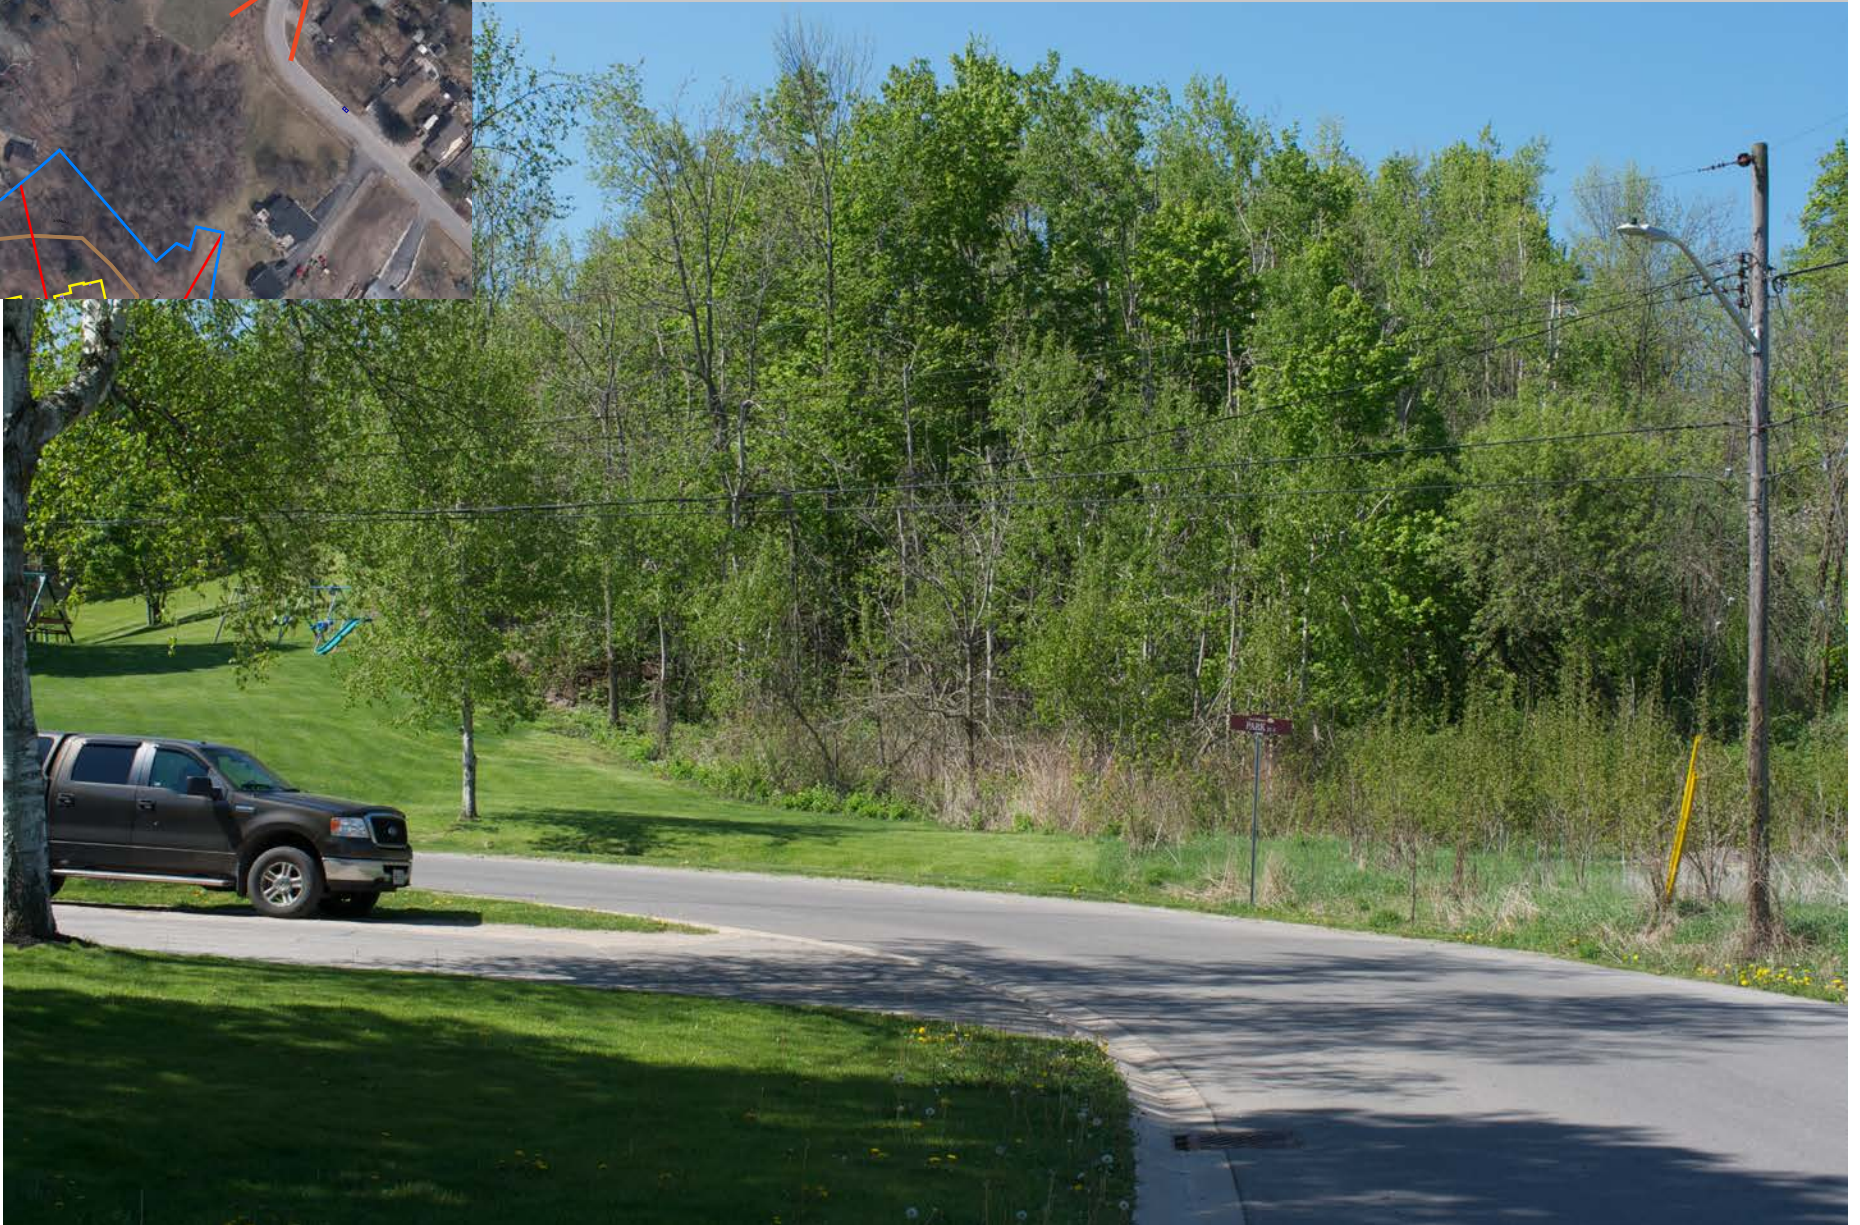
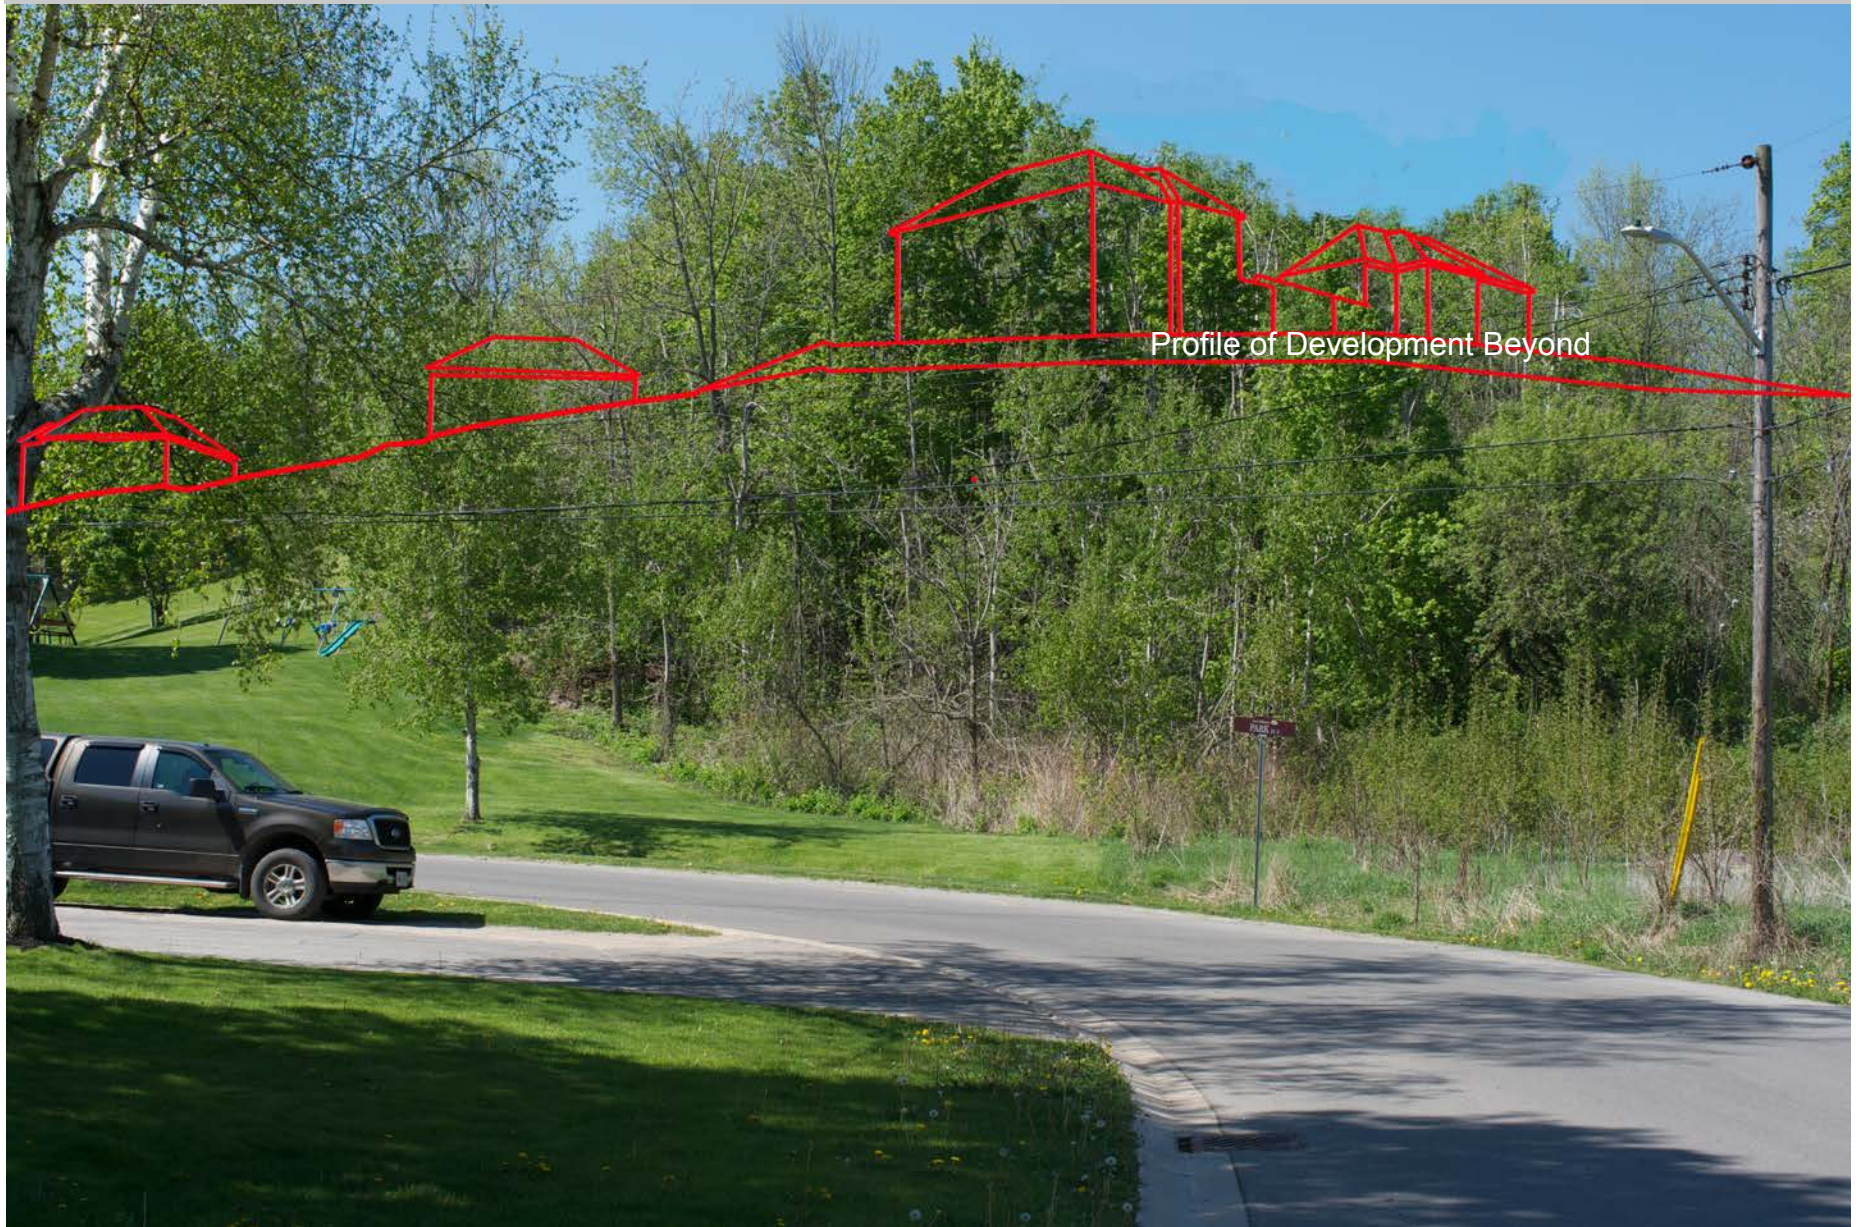
View Point 2a, Alexandra Street at Park Street East

Existing Conditions

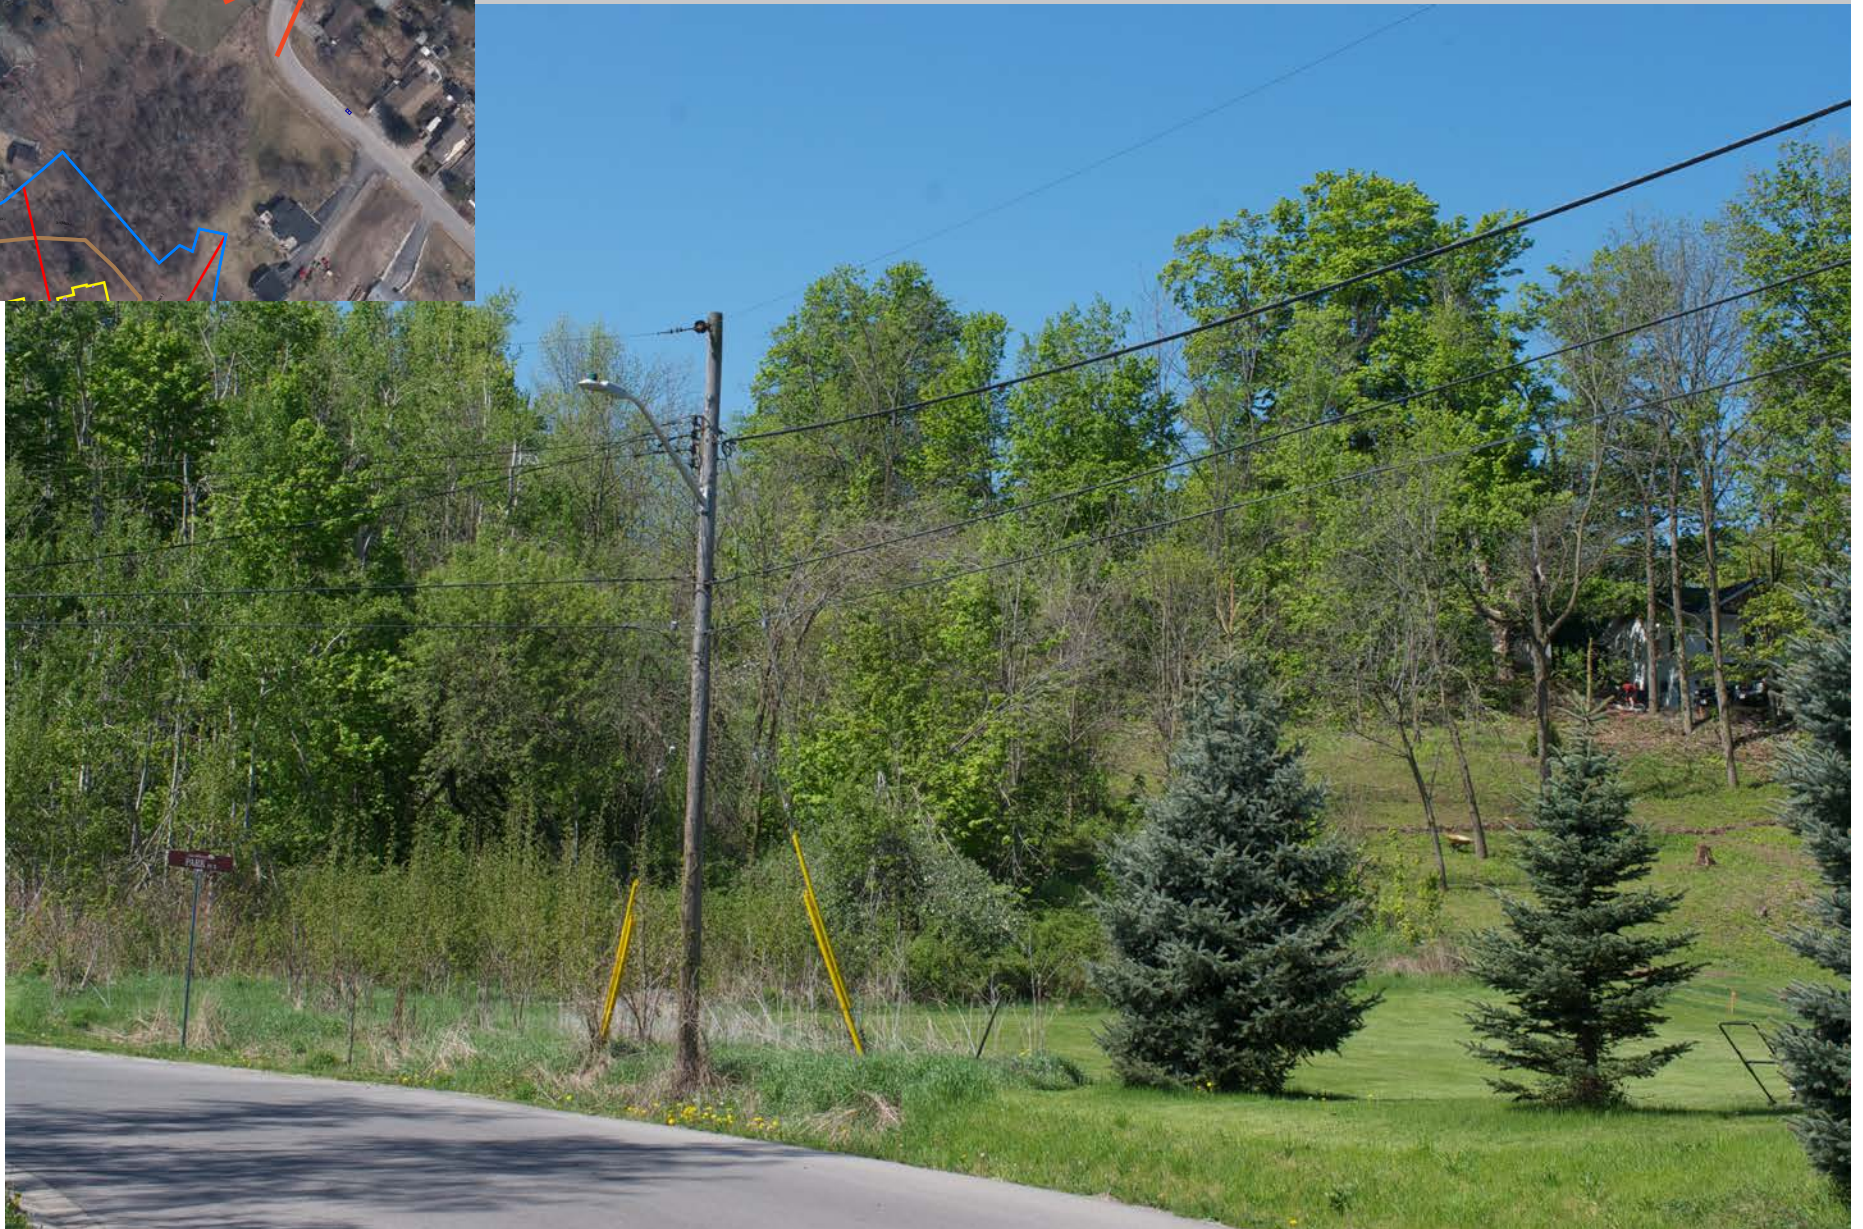
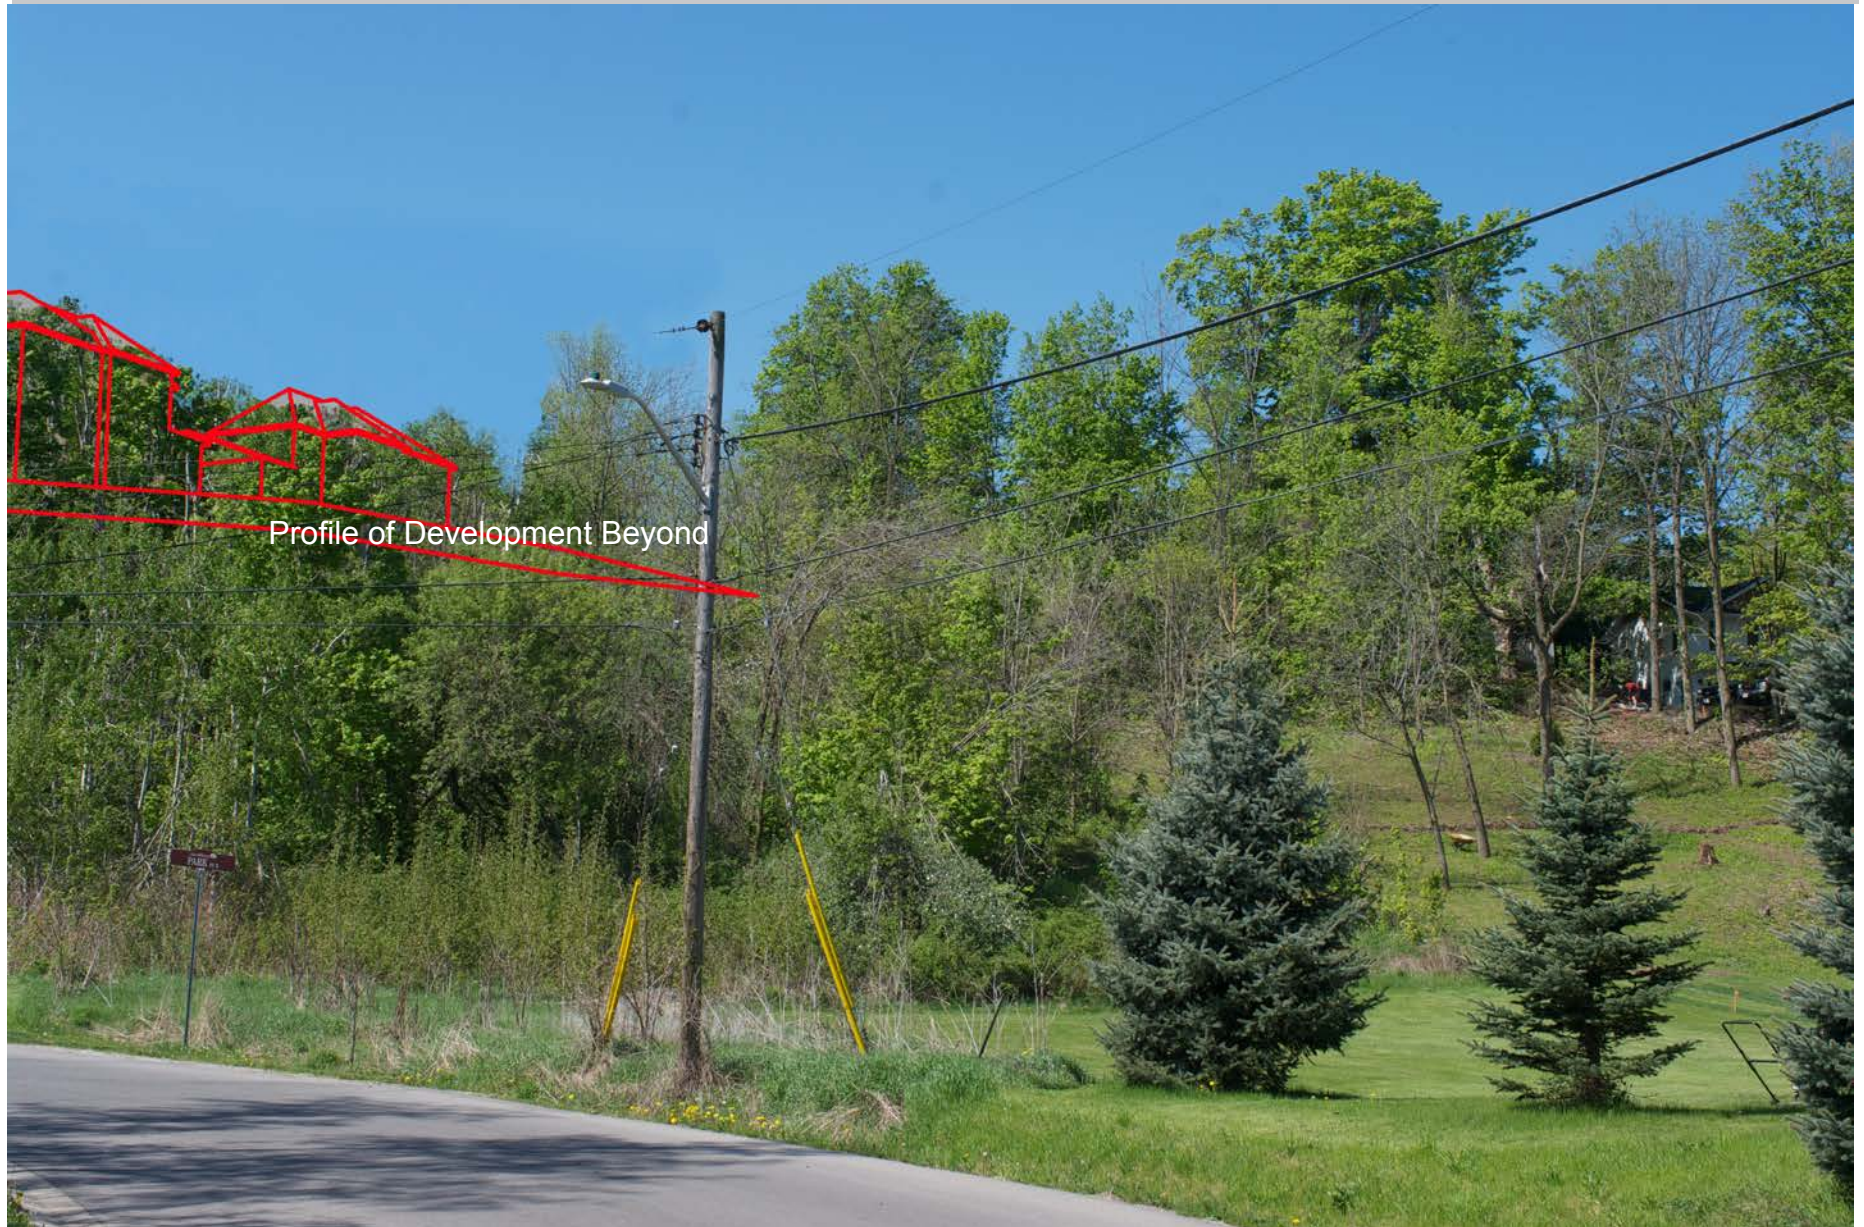
View Point 2b, Alexandra Street at Park Street East

Existing Conditions

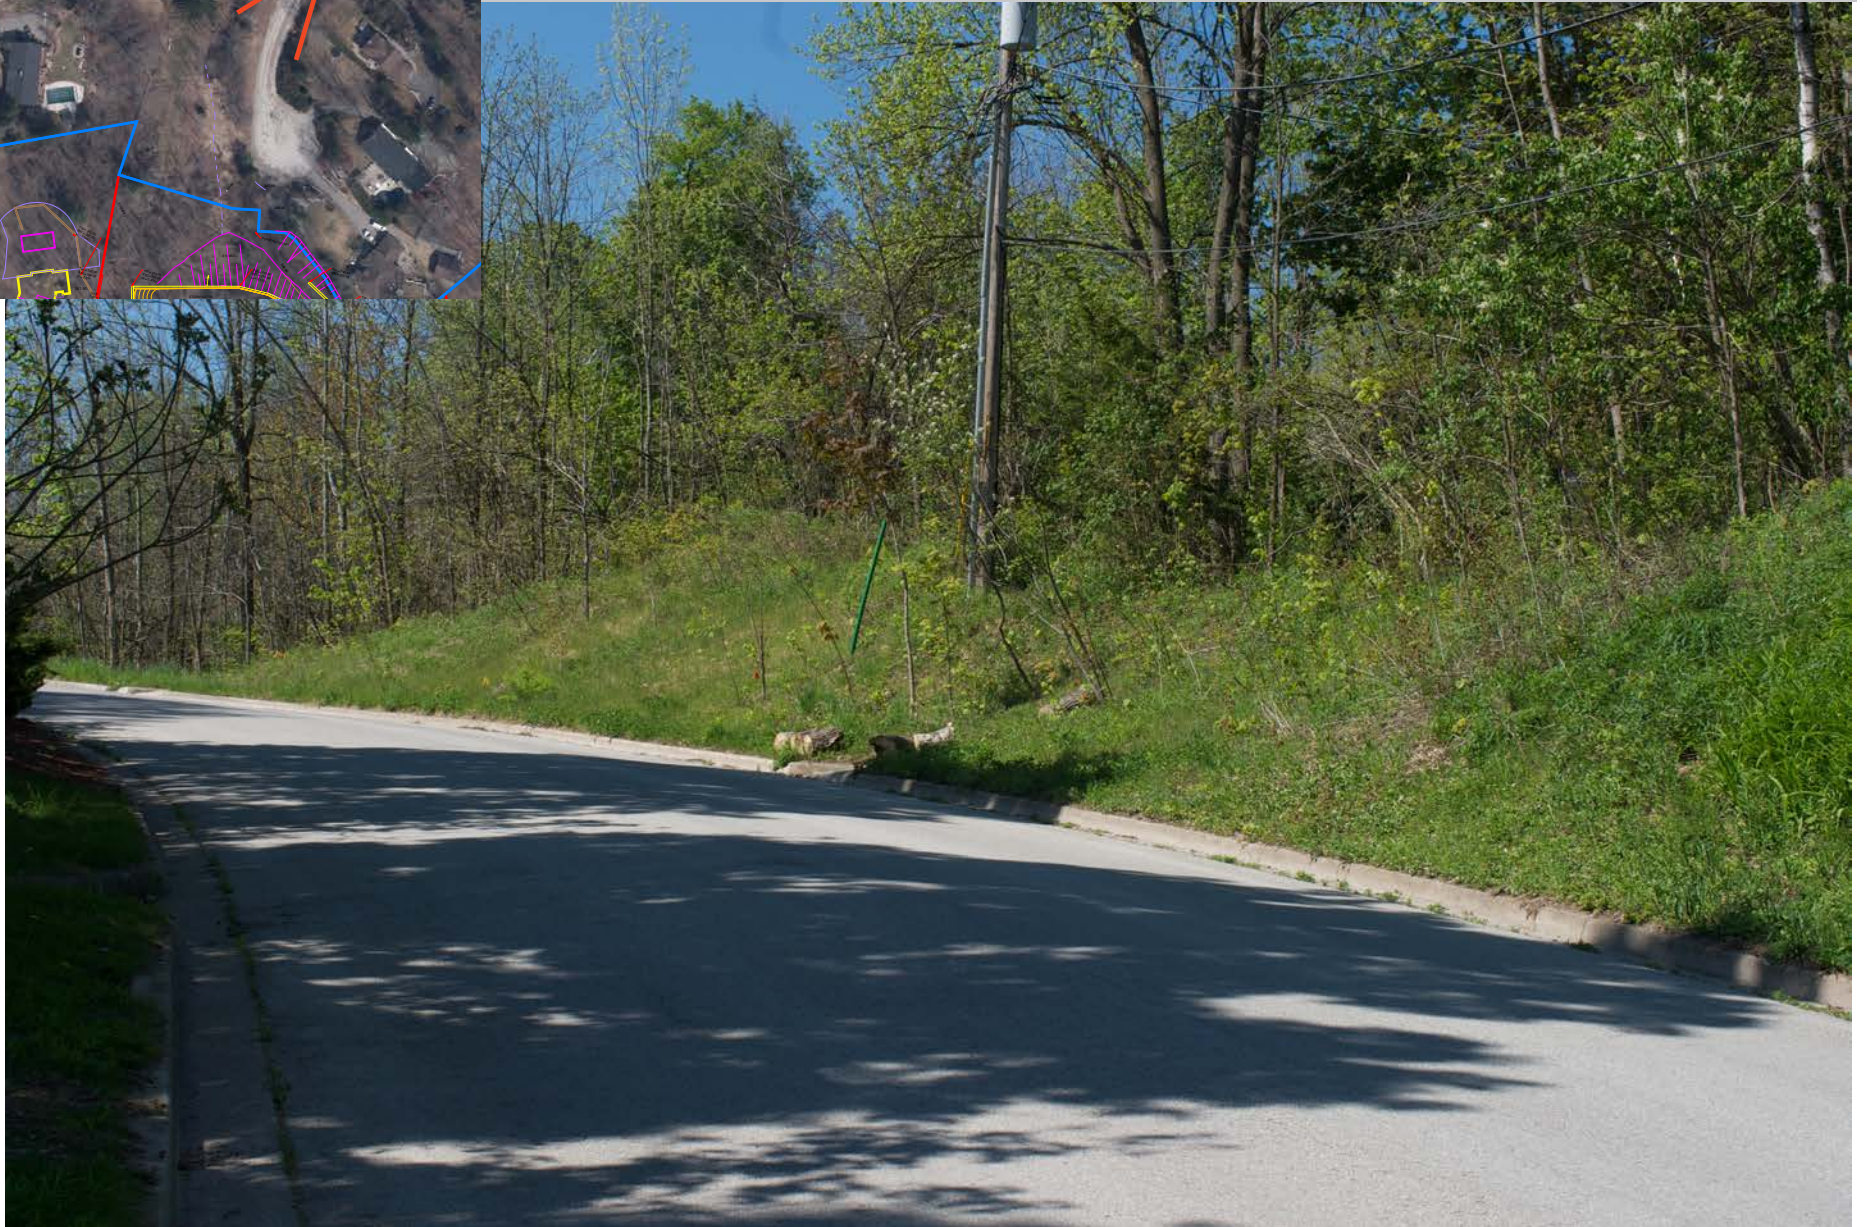
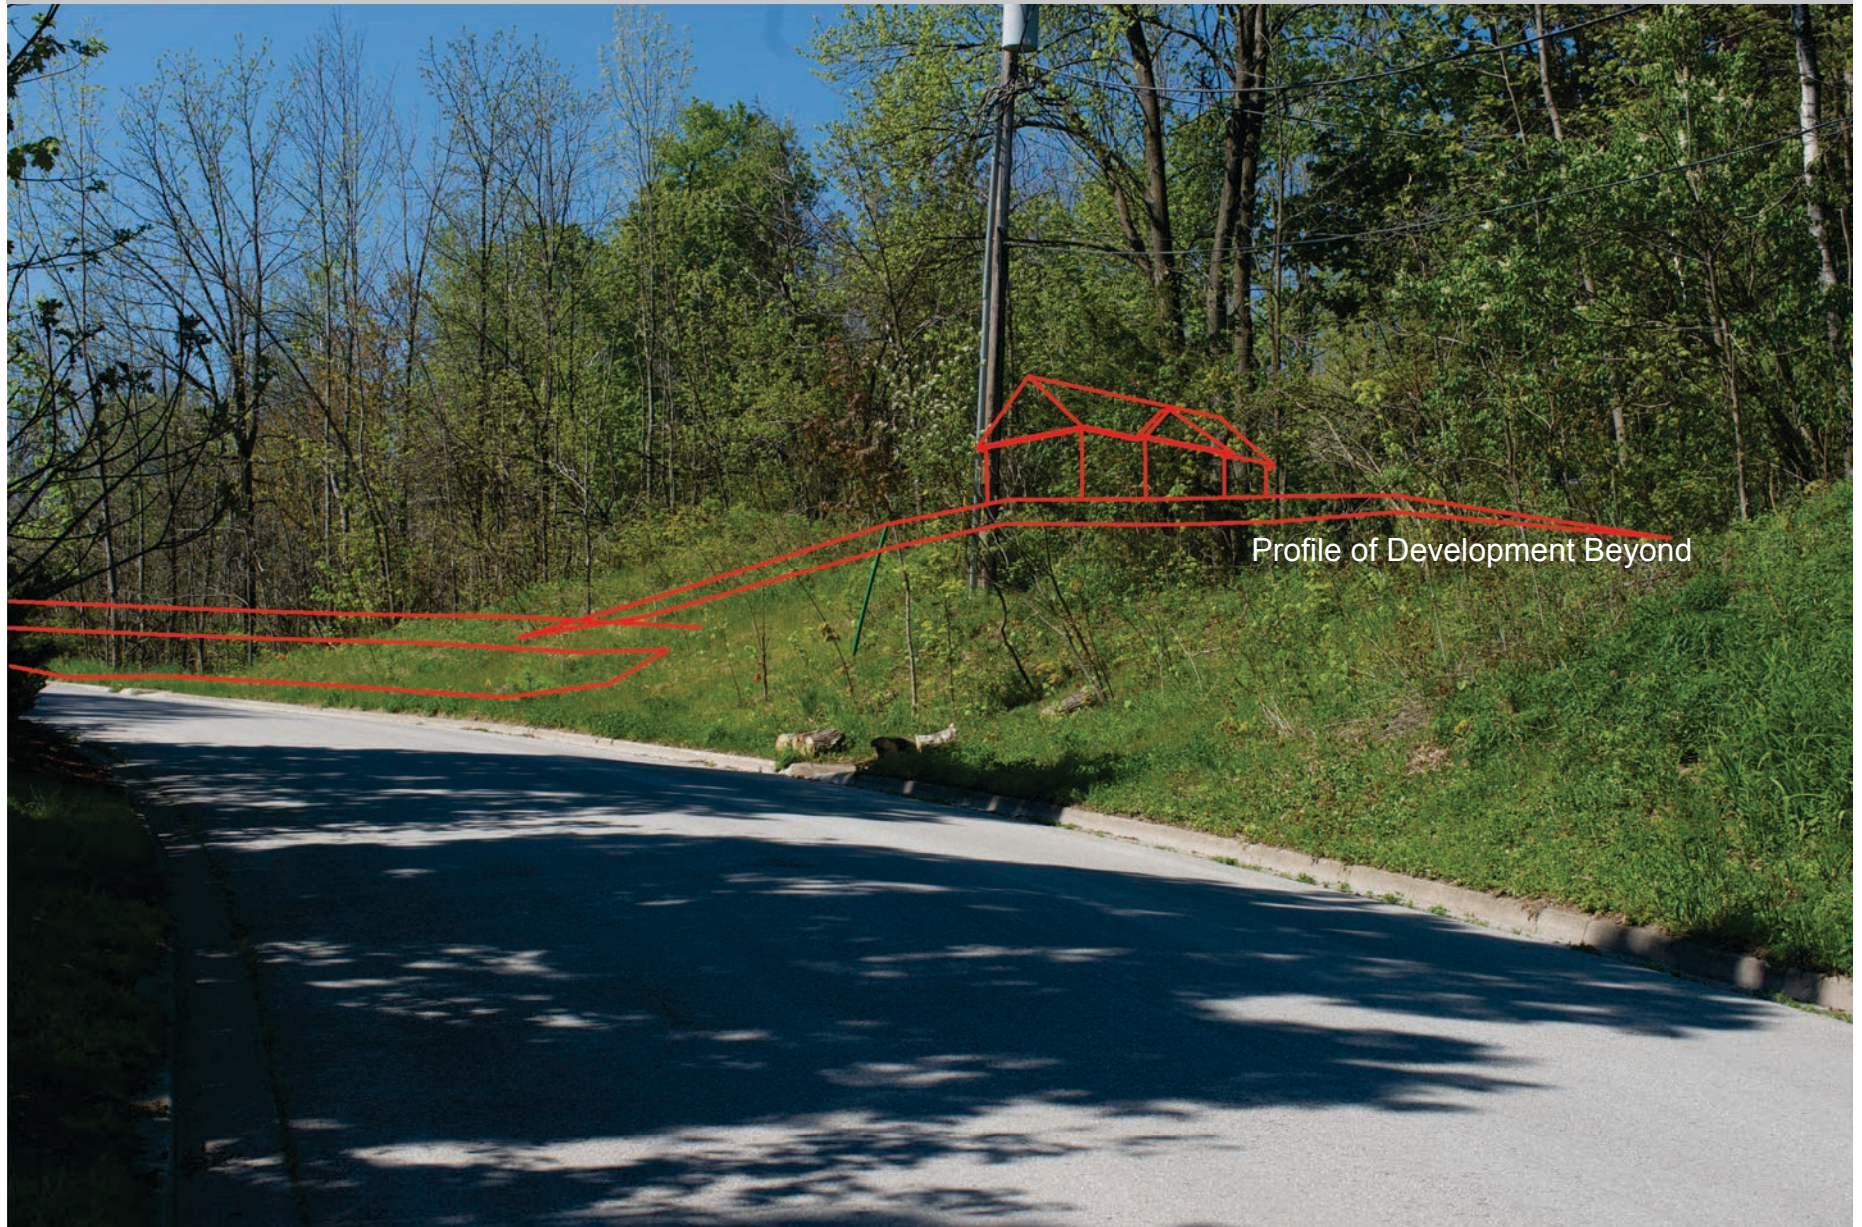
View Point 3, Credit Street

Existing Conditions

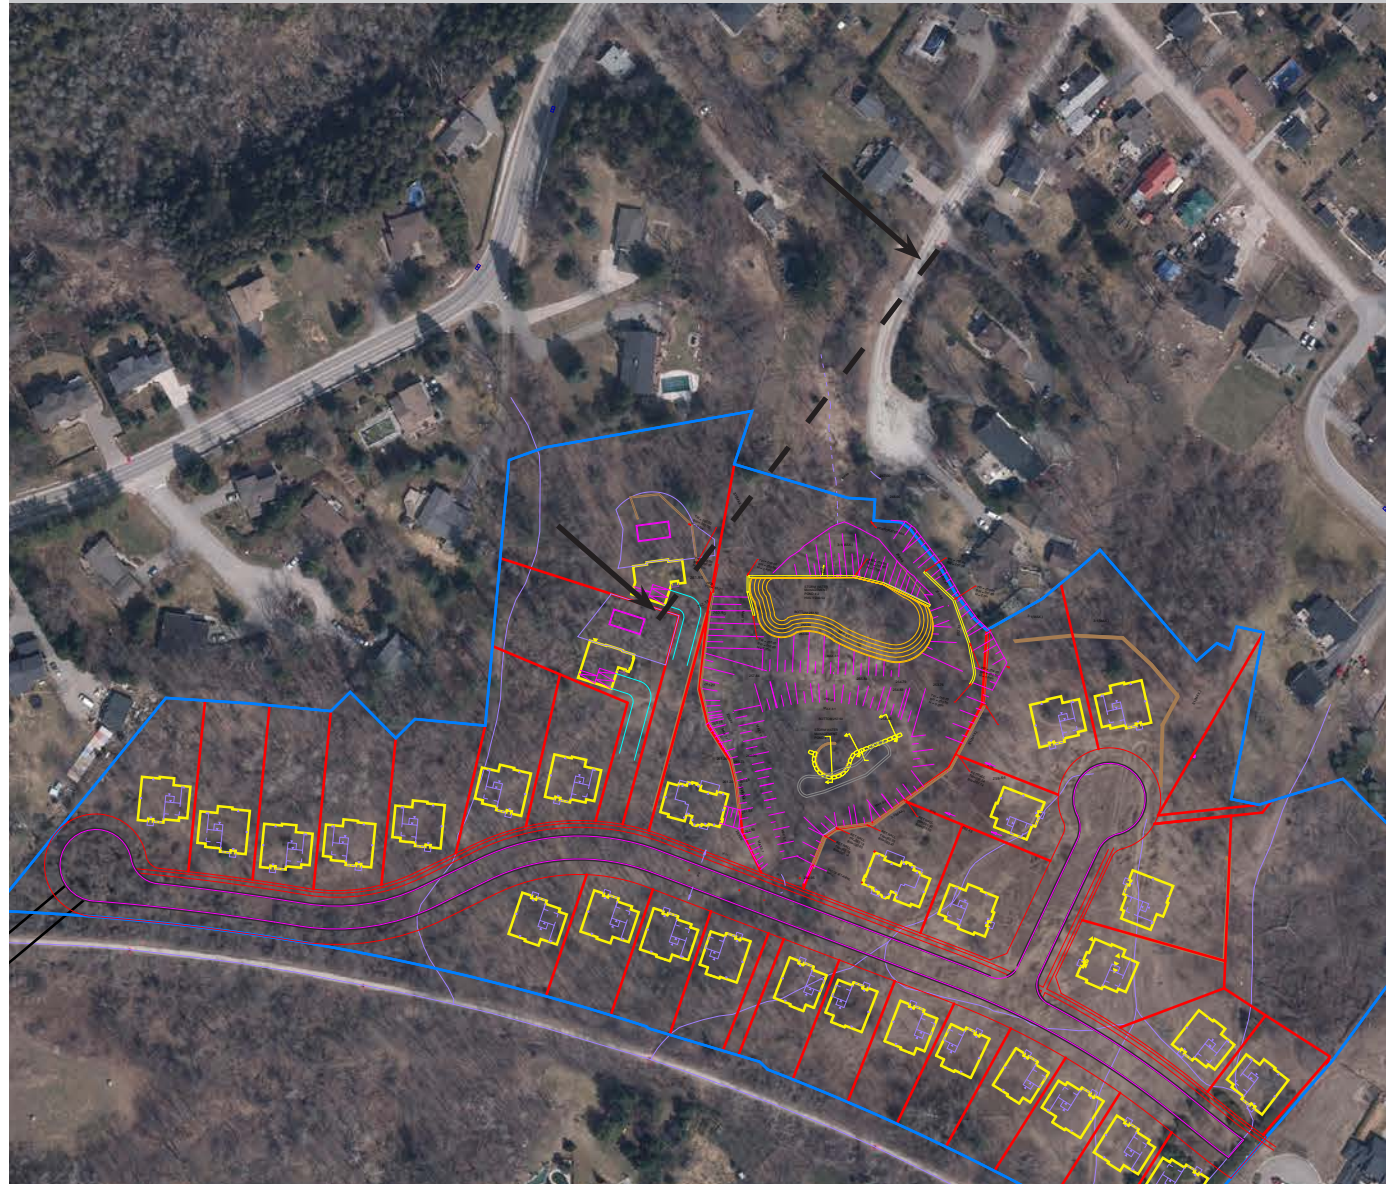
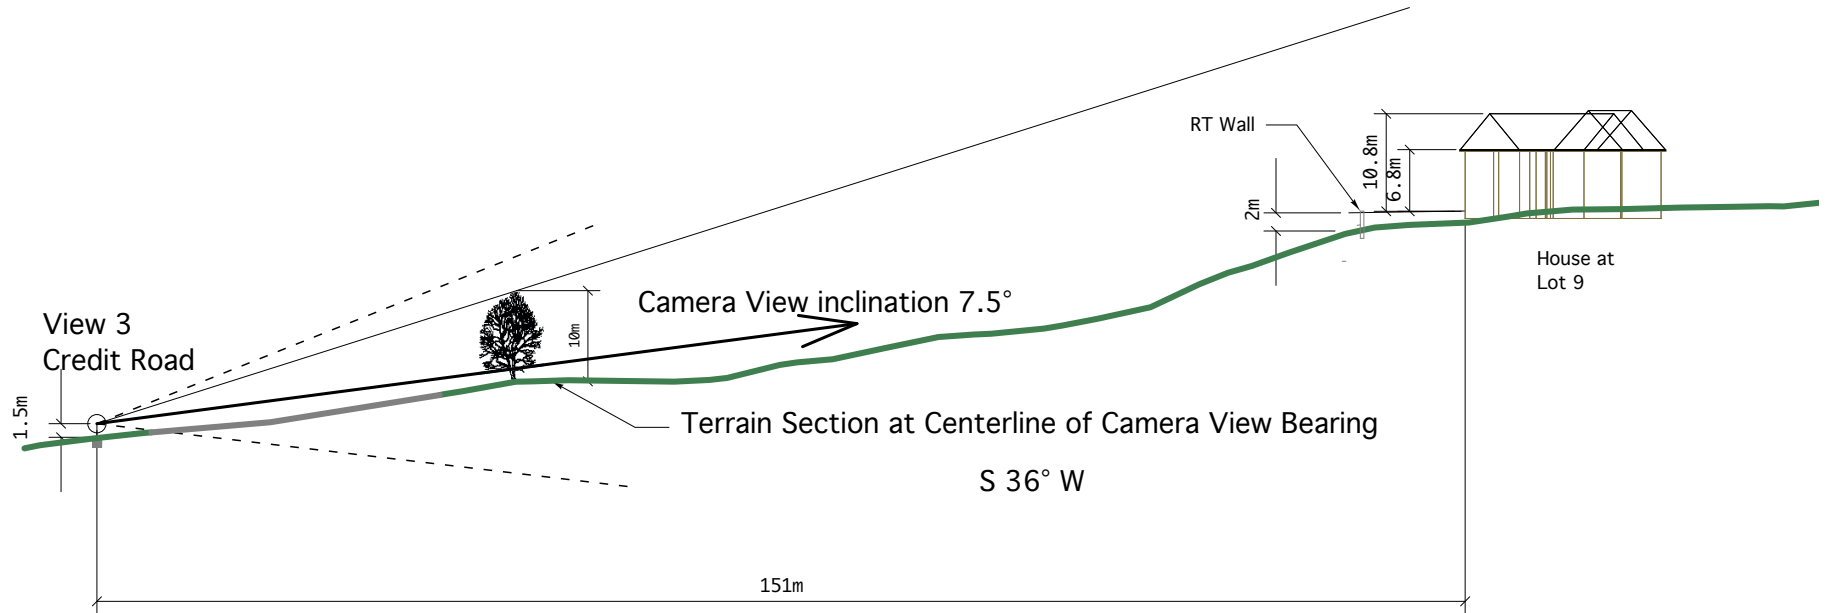
View Point 3, Credit Street

Profile of Development Beyond

Section Line along Camera Bearing

Note: Section drawing derived from 3D computer model

The images in this report compare the existing conditions with computer simulations of the proposed Development massing. Analysis of these images provides a reliable basis to assess the potential impact of the Development on the view sheds from the adjacent residential streets. Site reference photography was matched to computer simulations from the same viewpoints with modeling of the proposed Development. The computer simulations and existing conditions were overlaid to create a composite image illustrating the massing of the proposed Development as it would appear from the camera location. Images for Viewpoints 2, 3, 4 and 5 are mostly or fully obscured by the existing tree foliage. The site photographs of the existing conditions are overlaid with an outline of the proposed Development beyond the tree canopy. To further illustrate the relationship of the overlays to the site photographs, an example section for Viewpoint 3, at Credit Street, is shown on page 13.
