Visual Impact Study

Eden Oak

Proposed Subdivision
Part of Lot 20, Concession 9,
Town of Halton Hills, Ontario

Visual Impact Study for Eden Oak

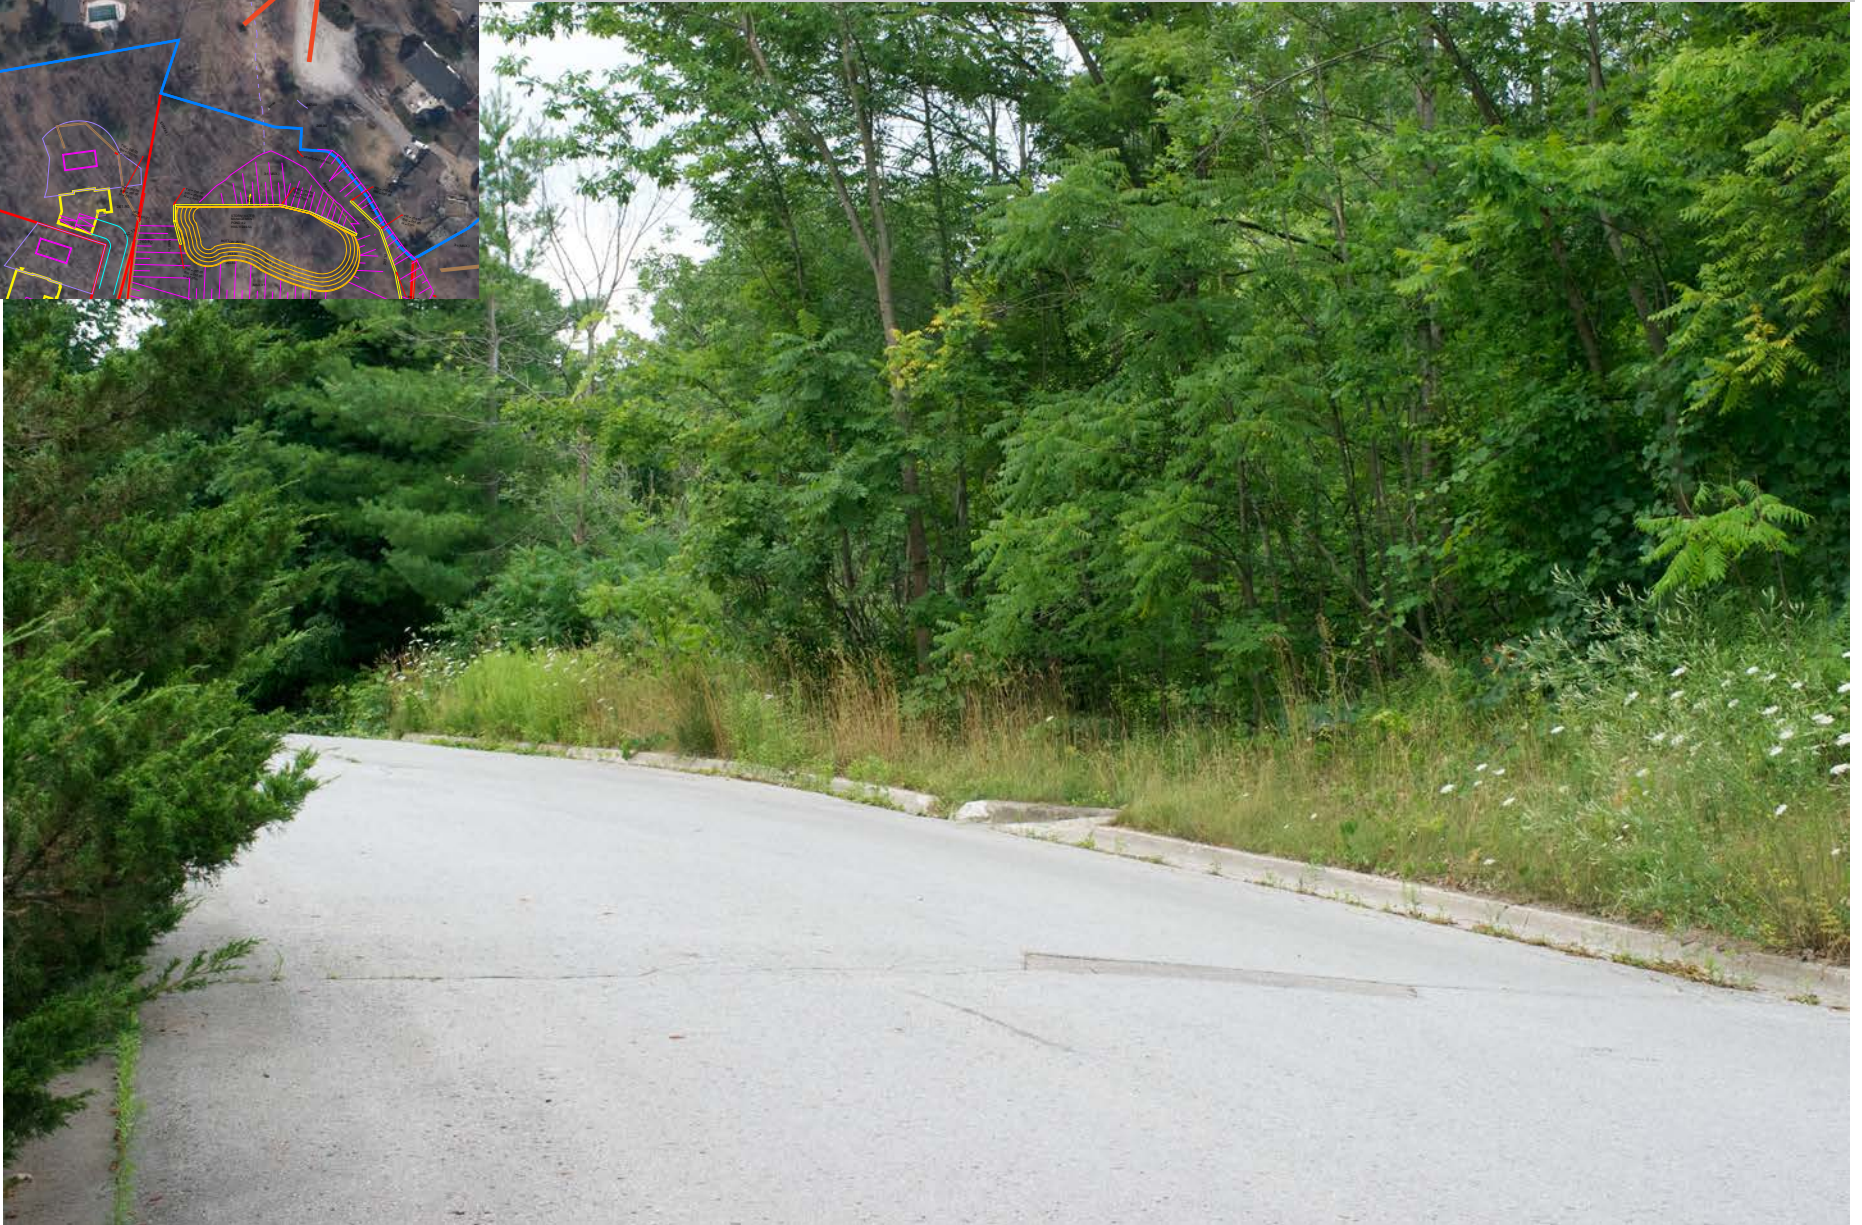
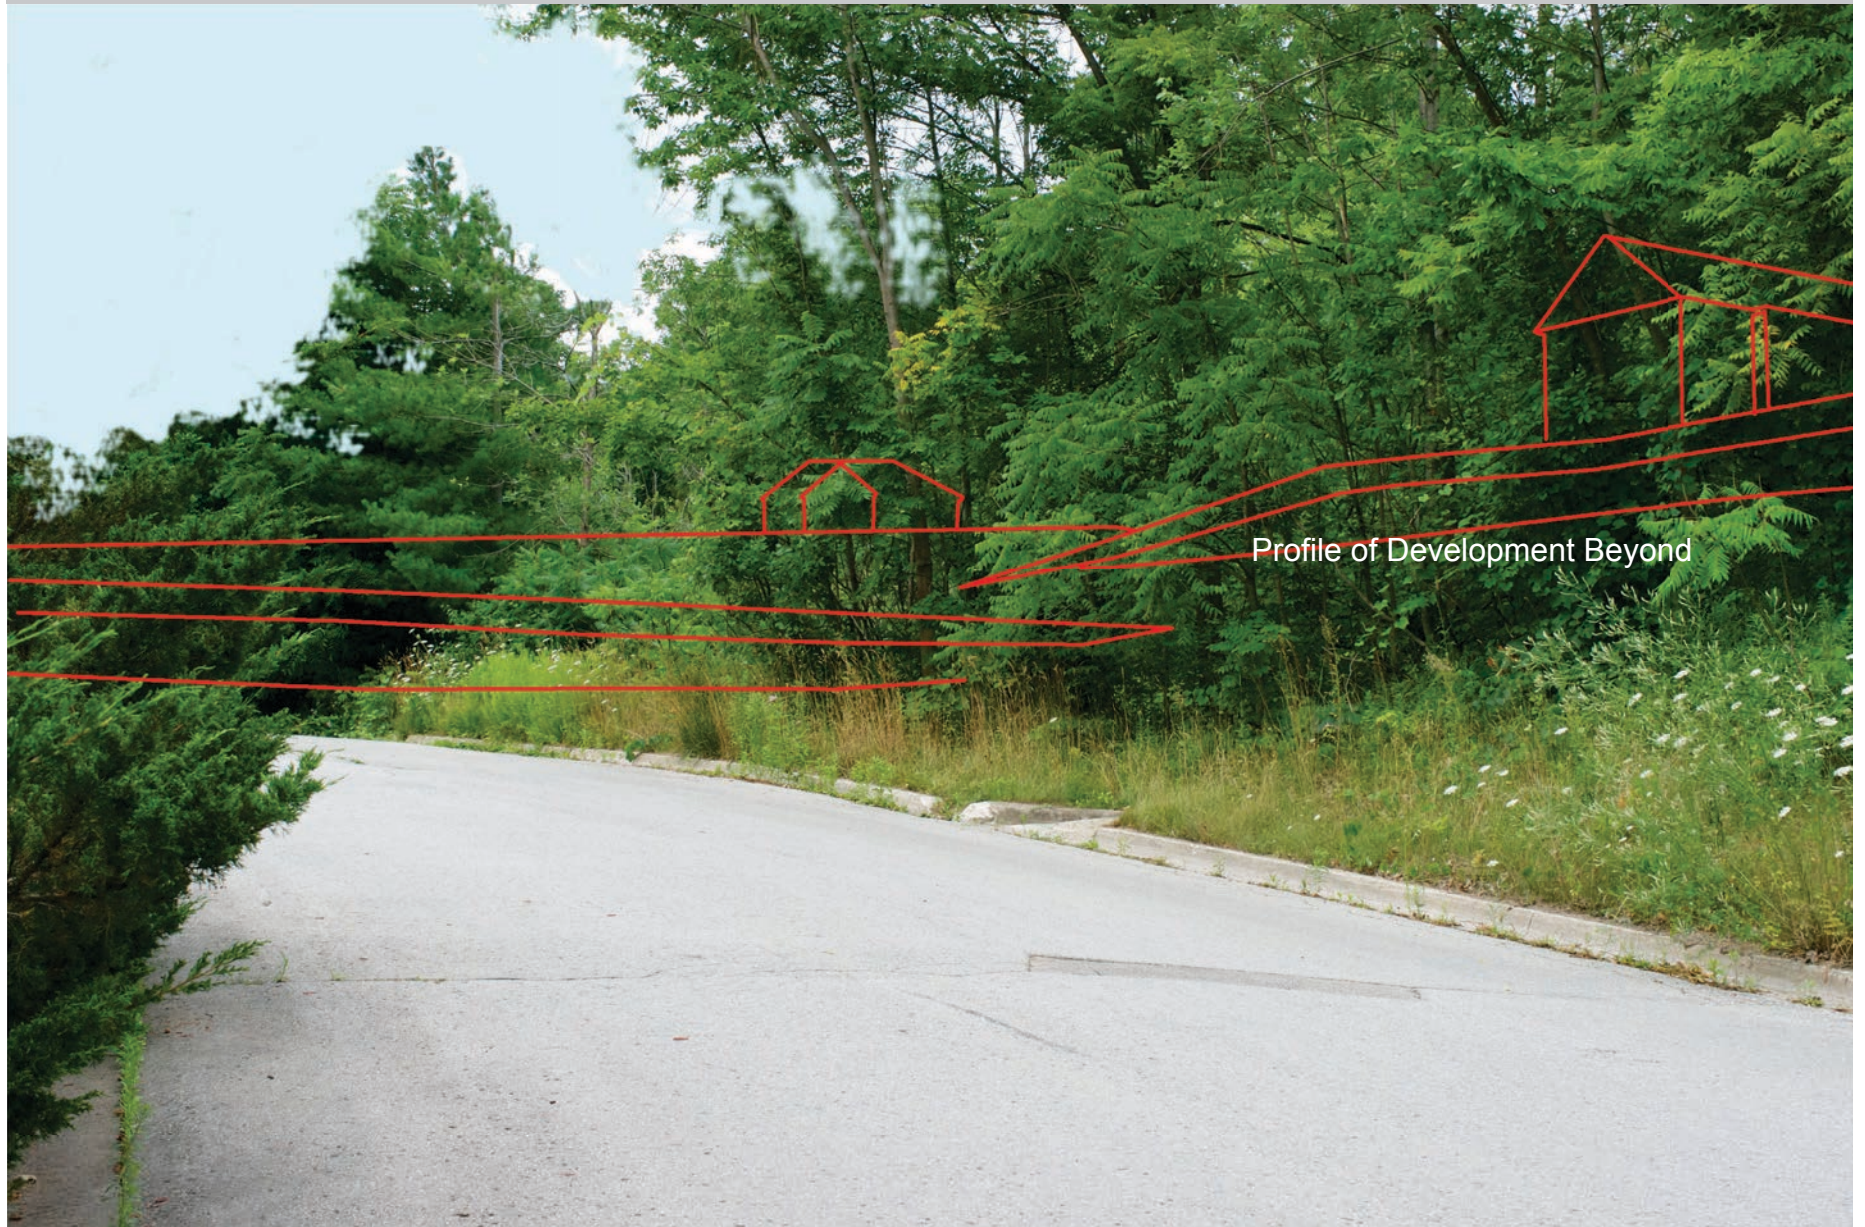
View Point 3b, Credit Street

Existing Conditions

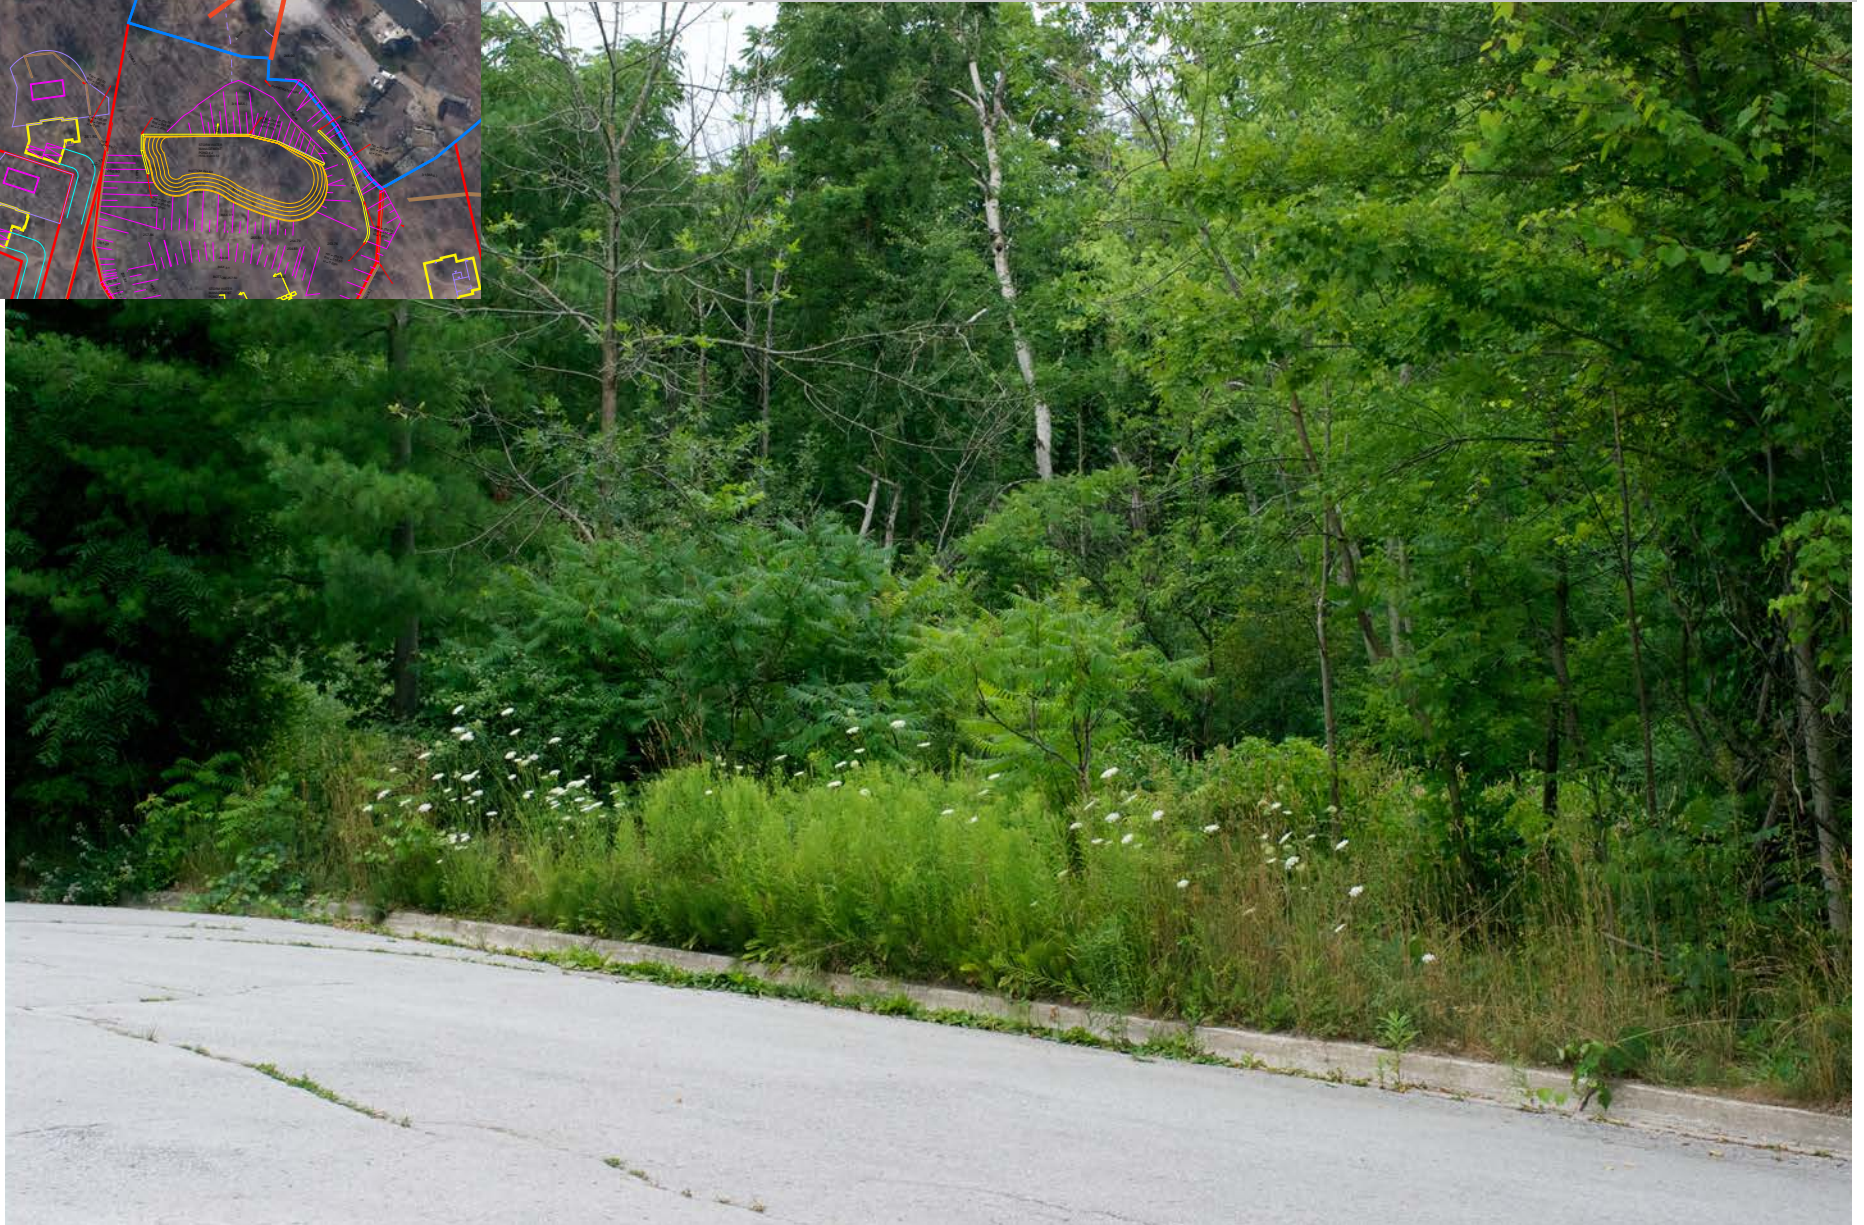
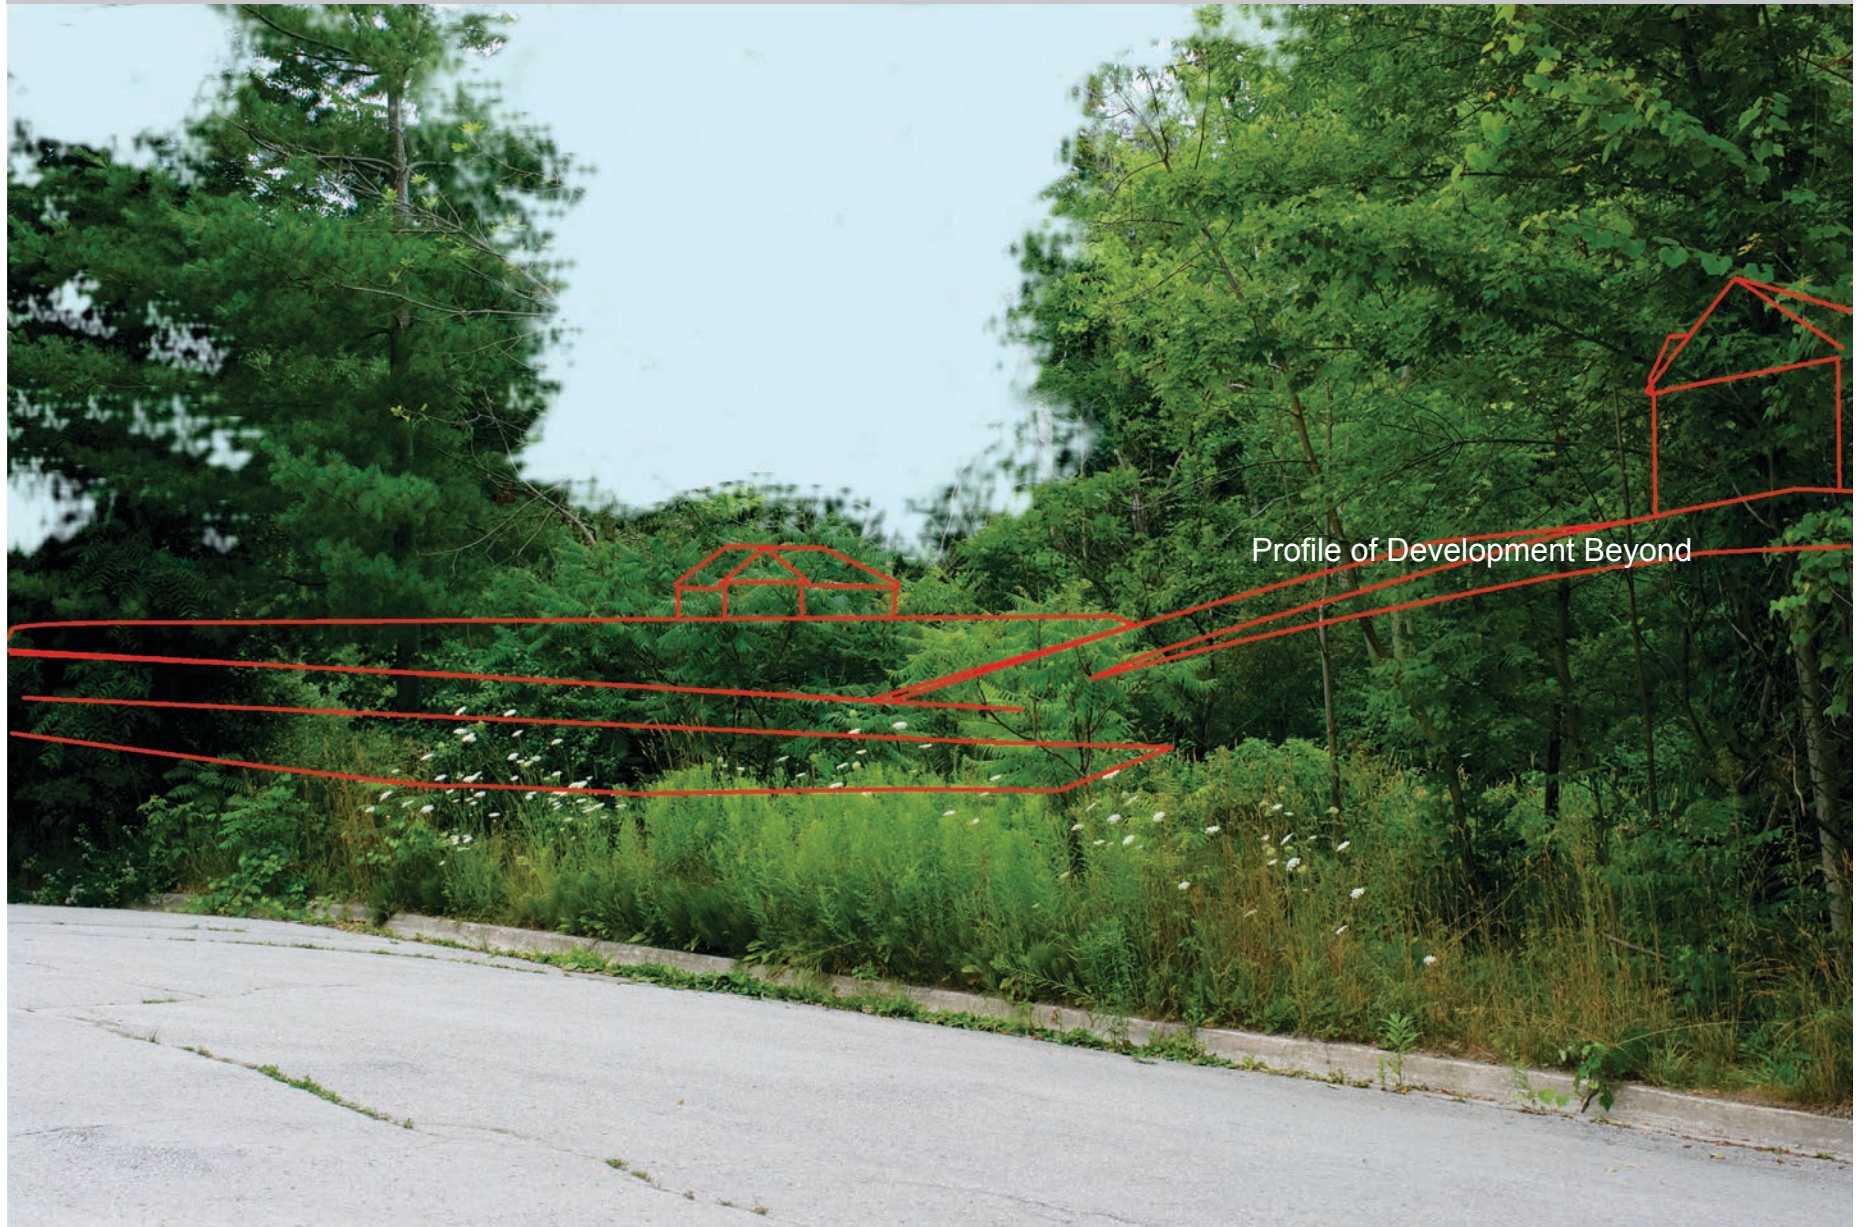
View Point 3c, Credit Street

Existing Conditions

Profile of Development Beyond

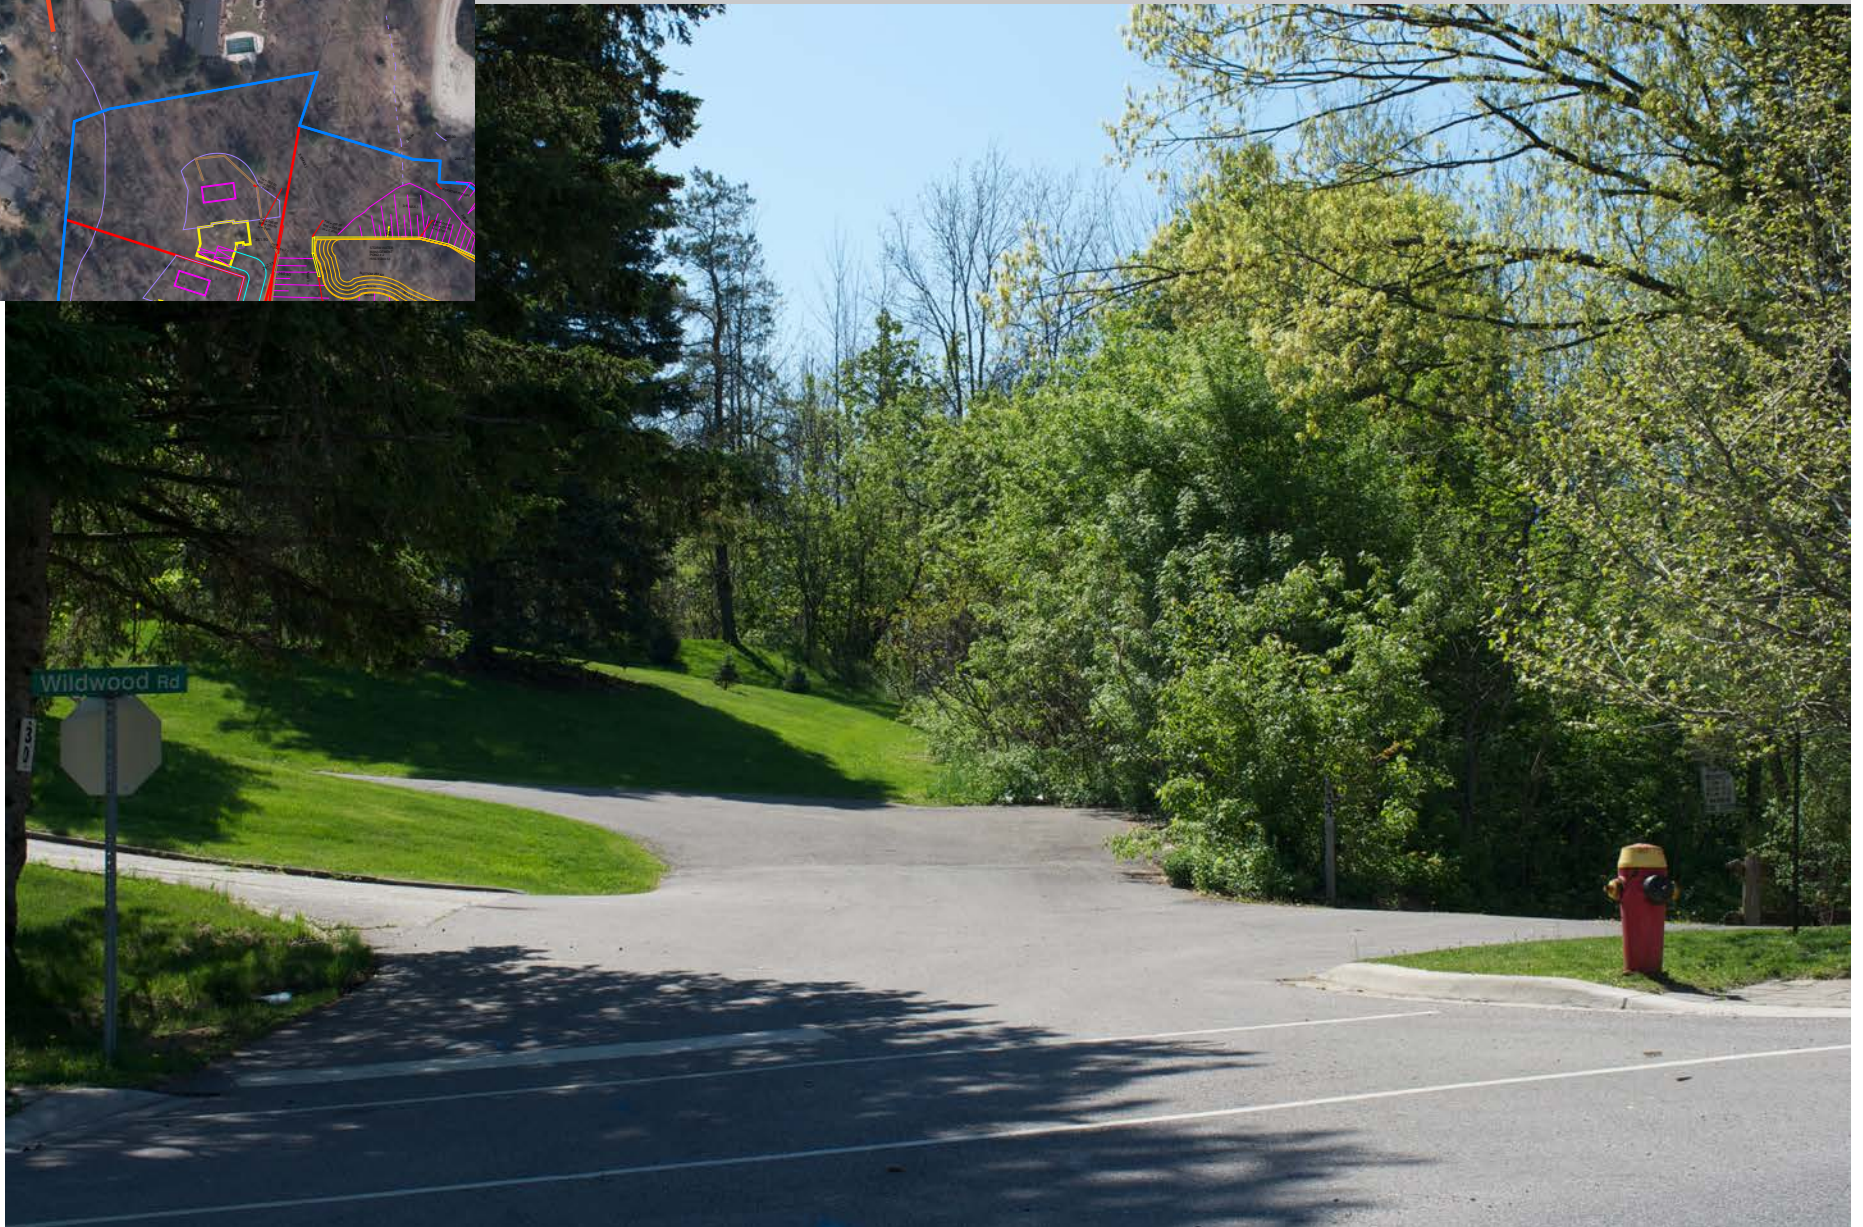
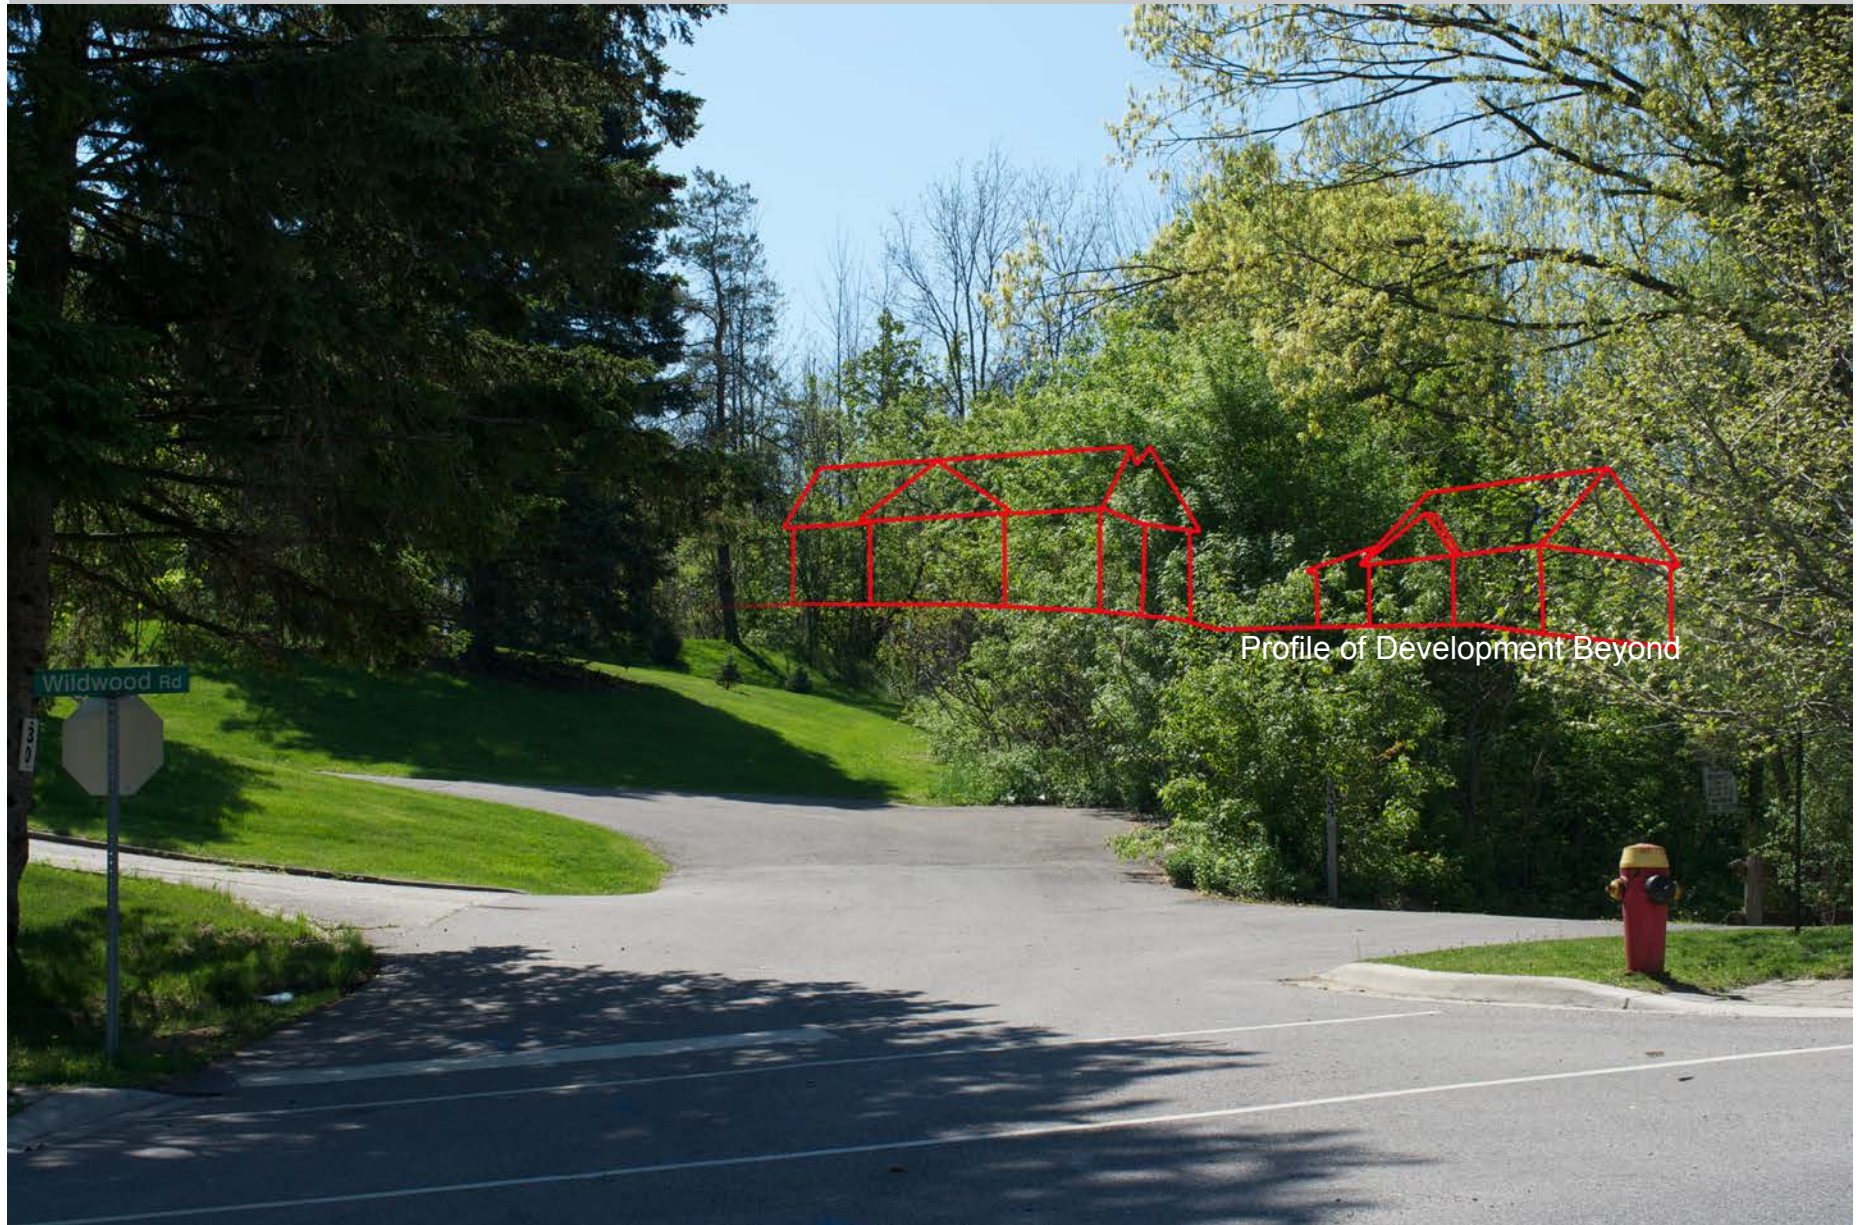
View Point 4, Park Street at Wildwood Road

Existing Conditions

Profile of Development Beyond

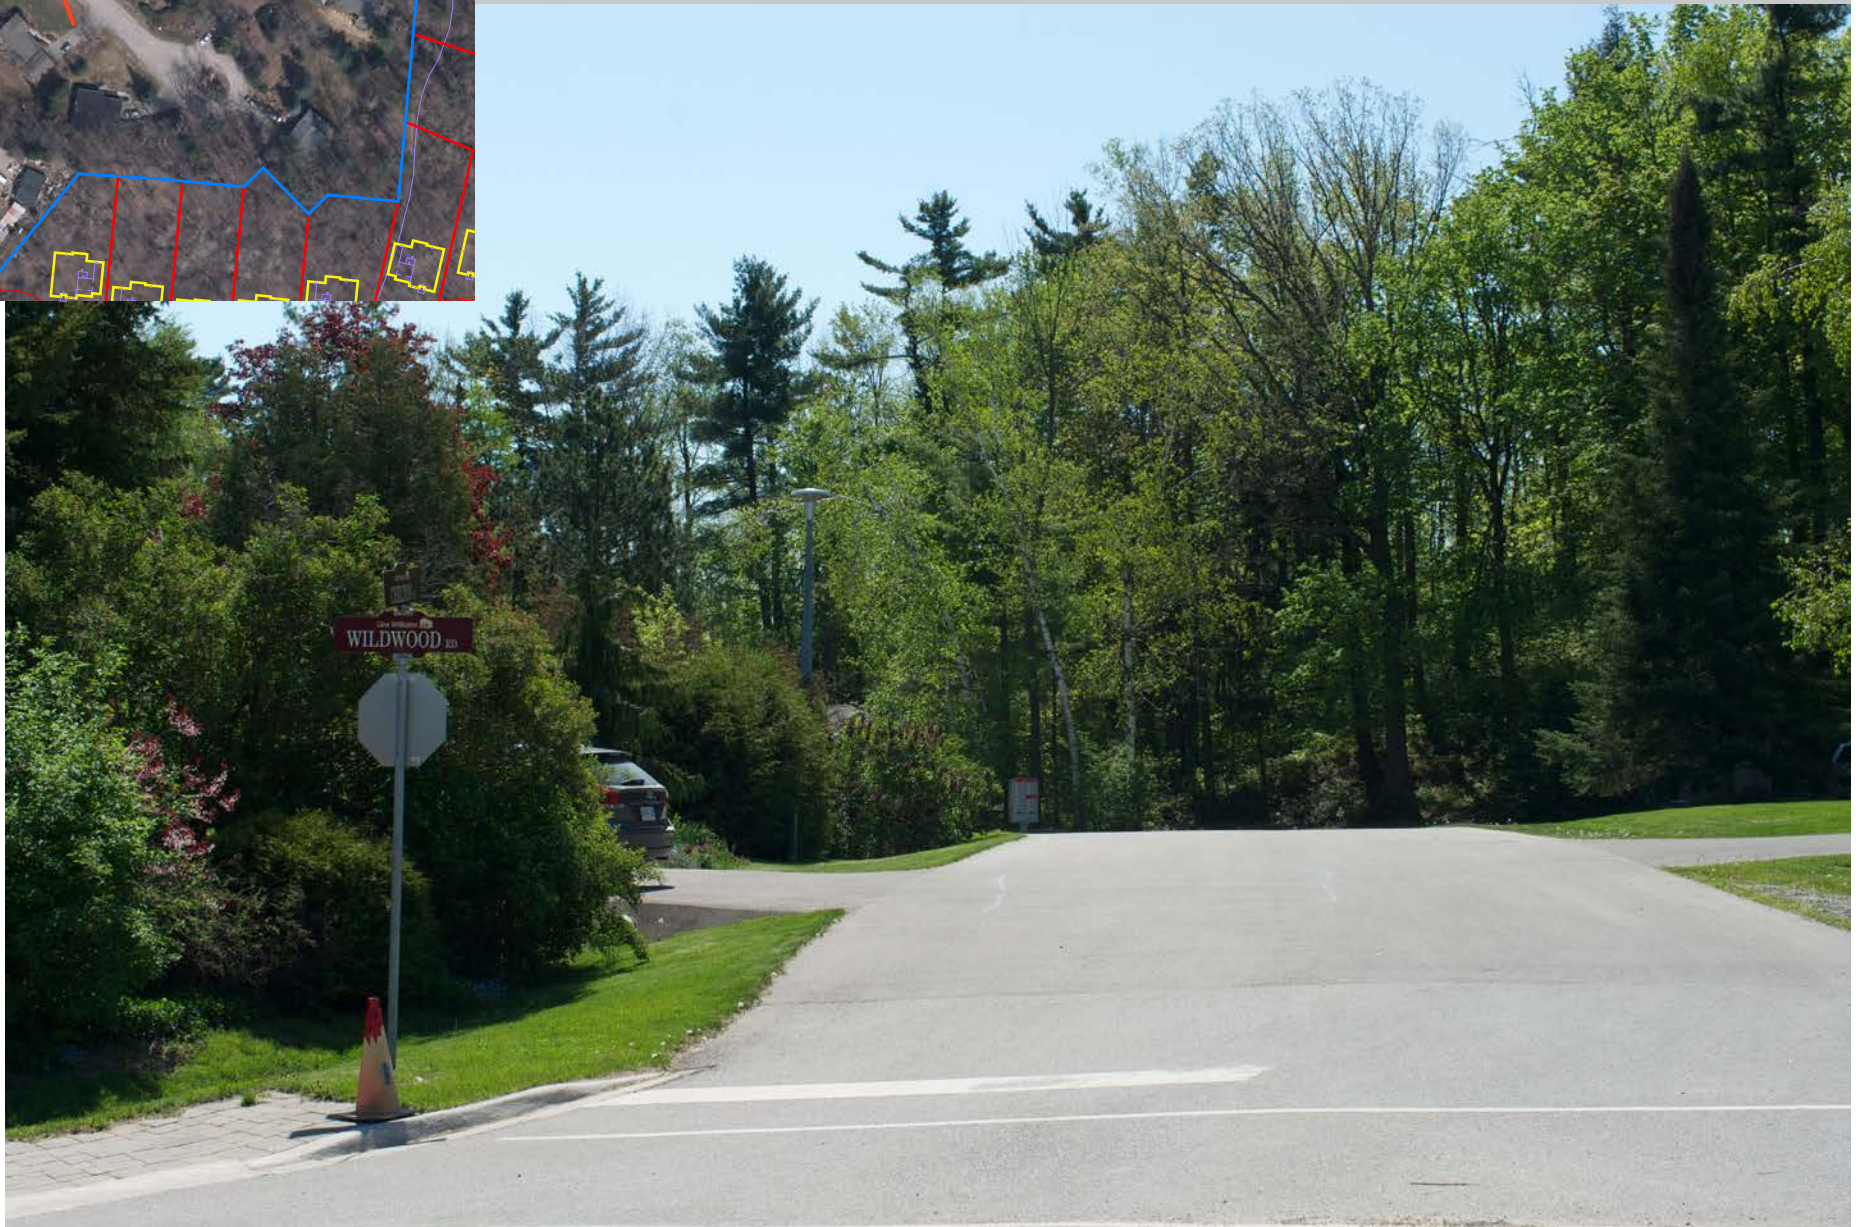
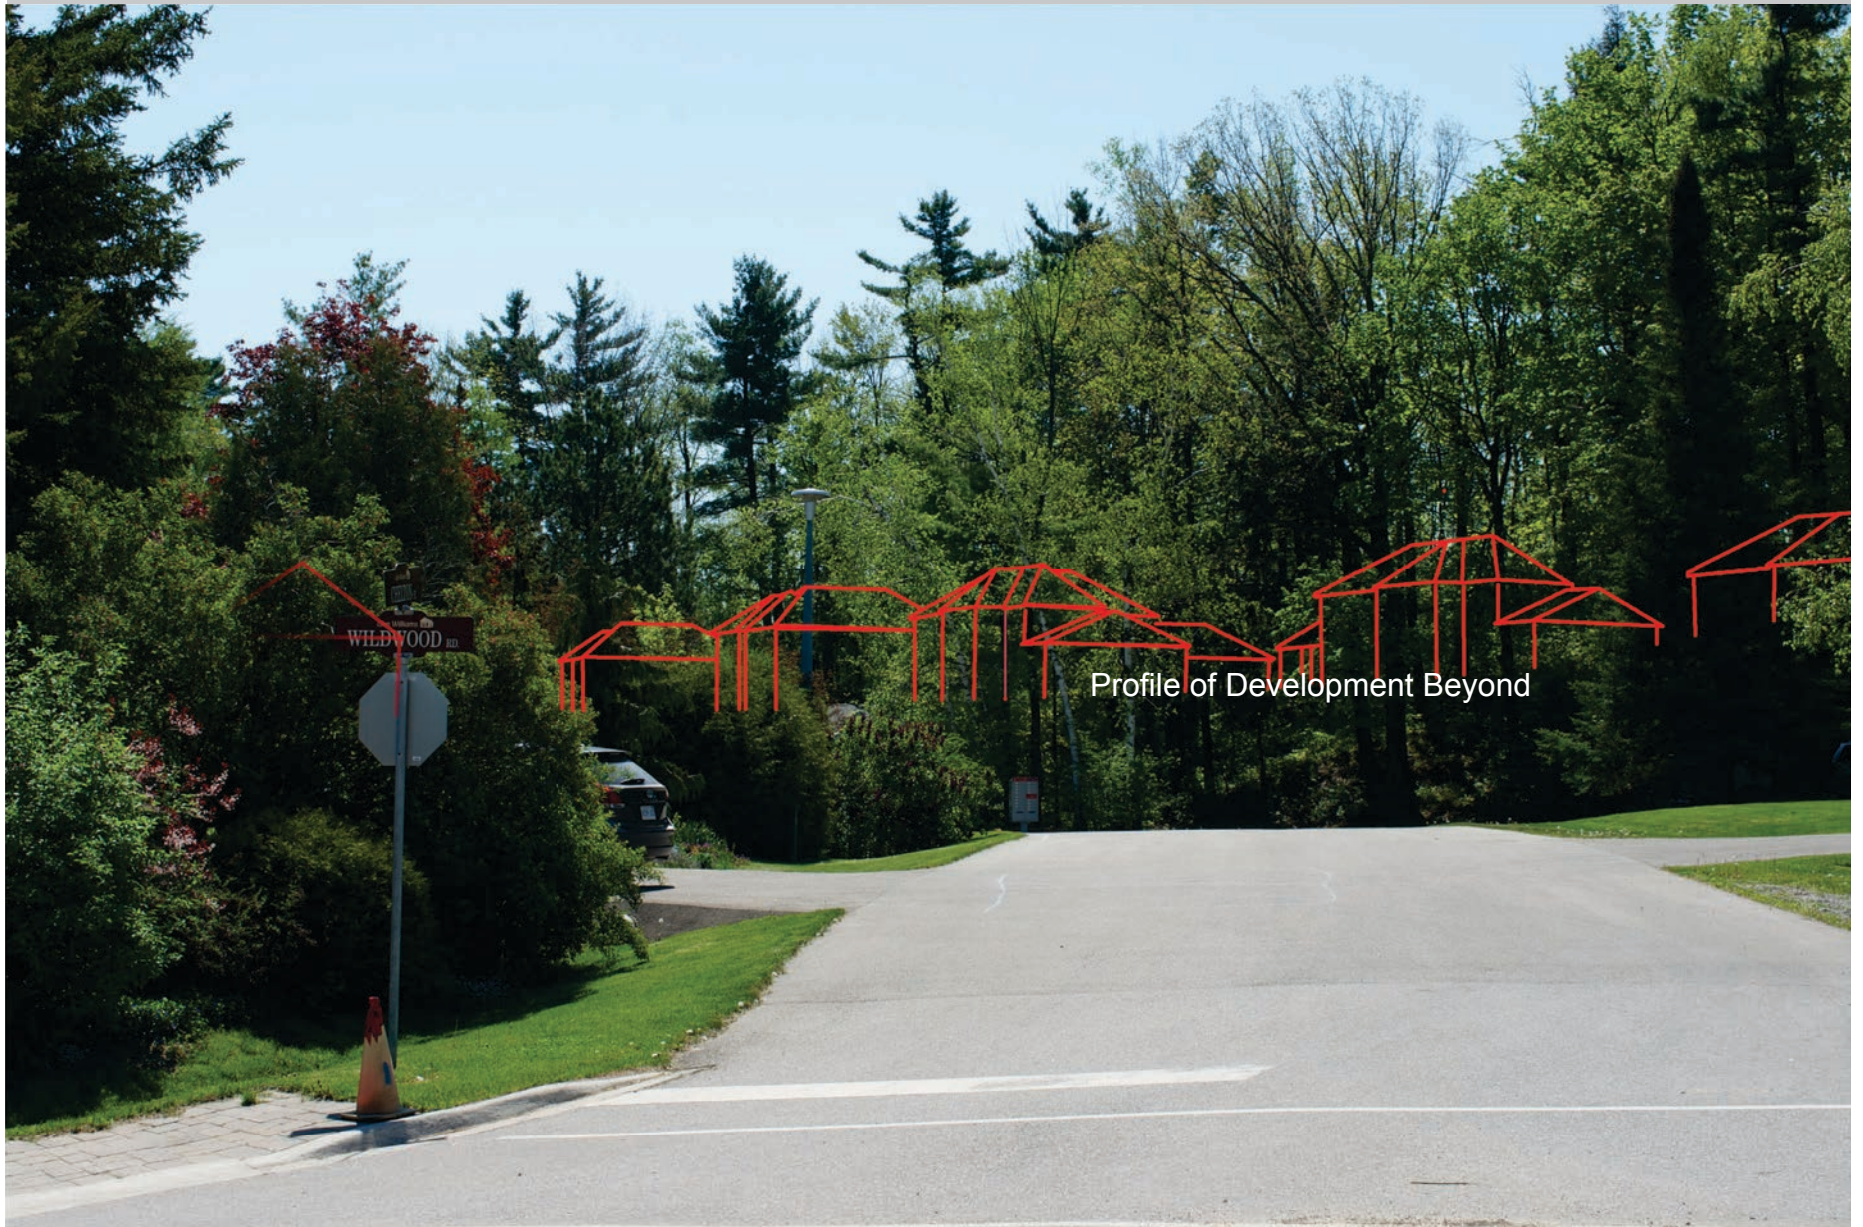
View Point 5, Chelton Street at Wildwood Rd.

Existing Conditions

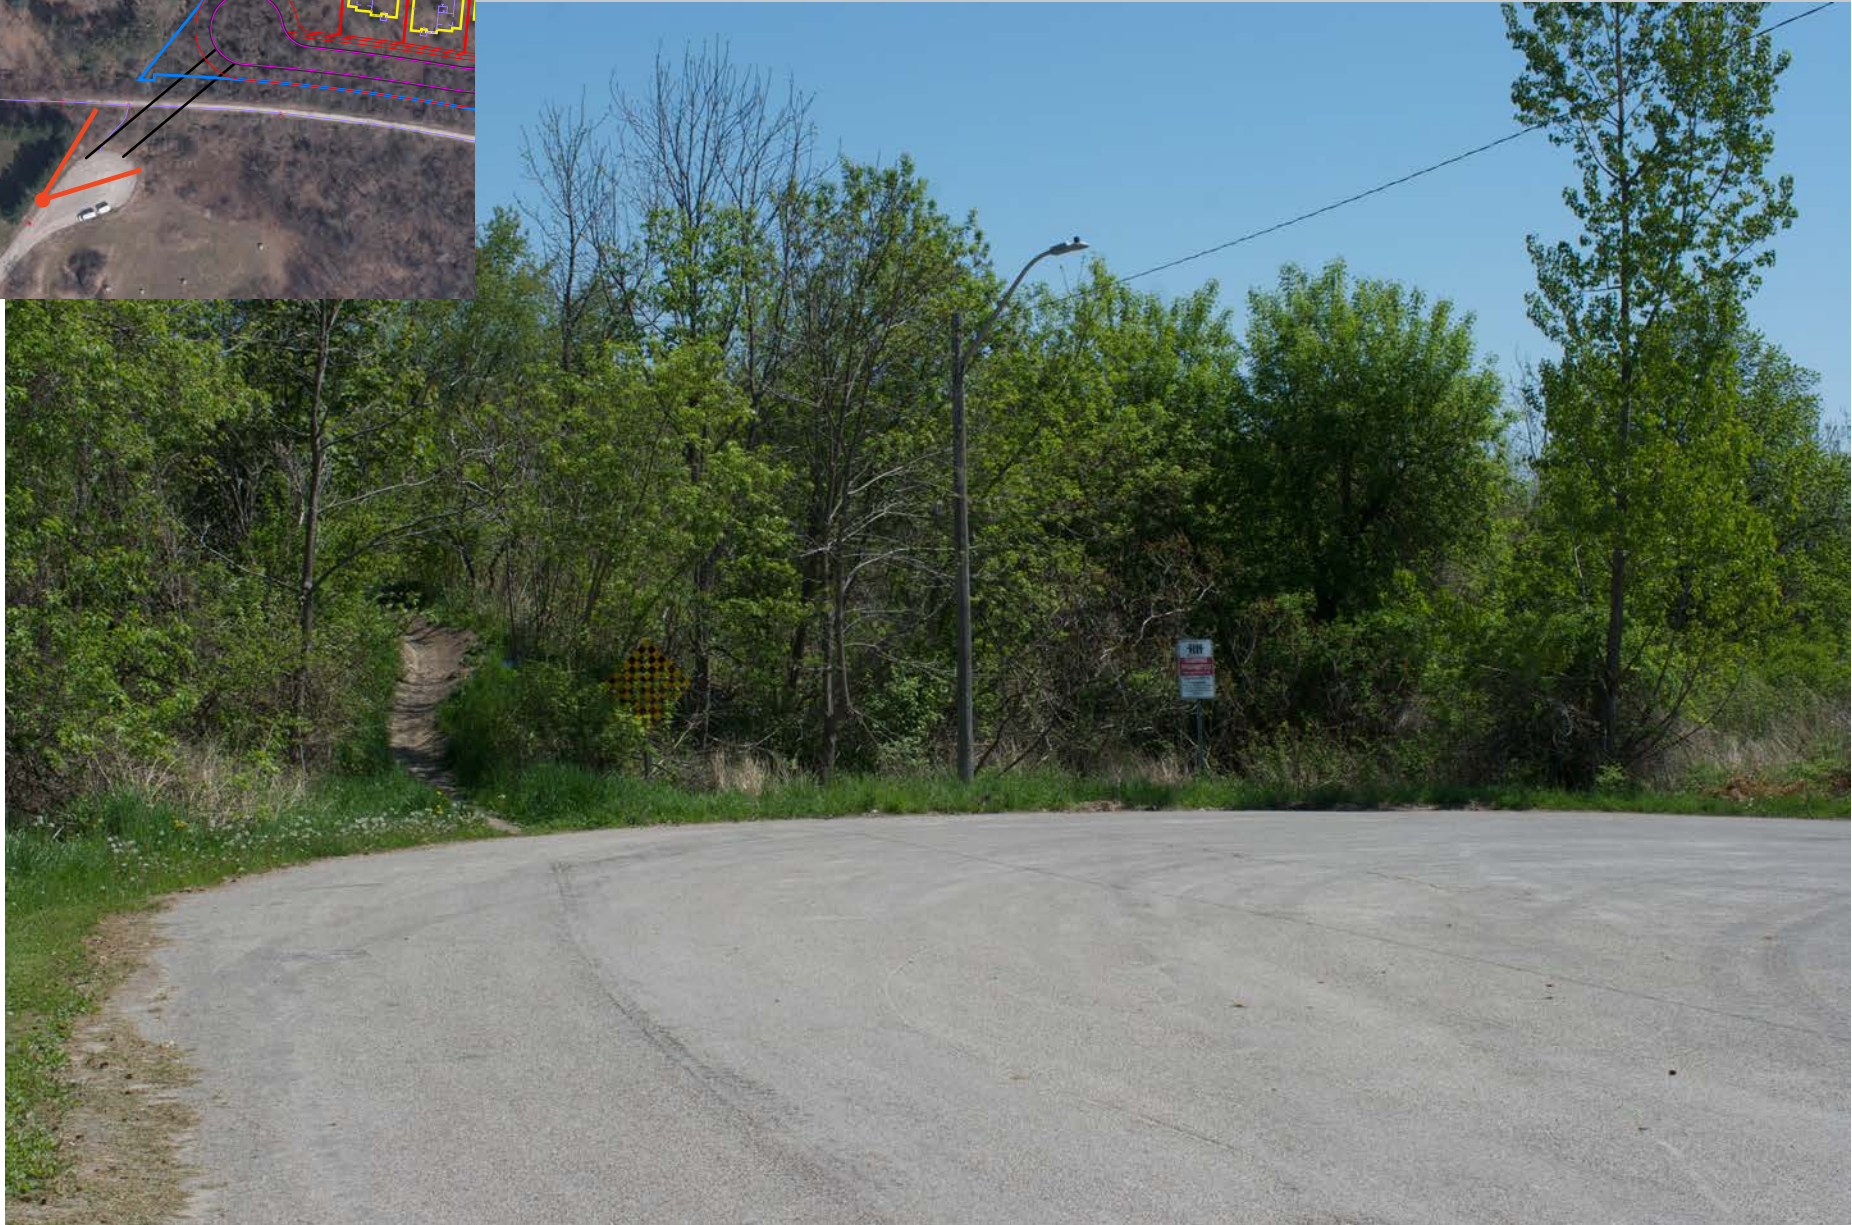
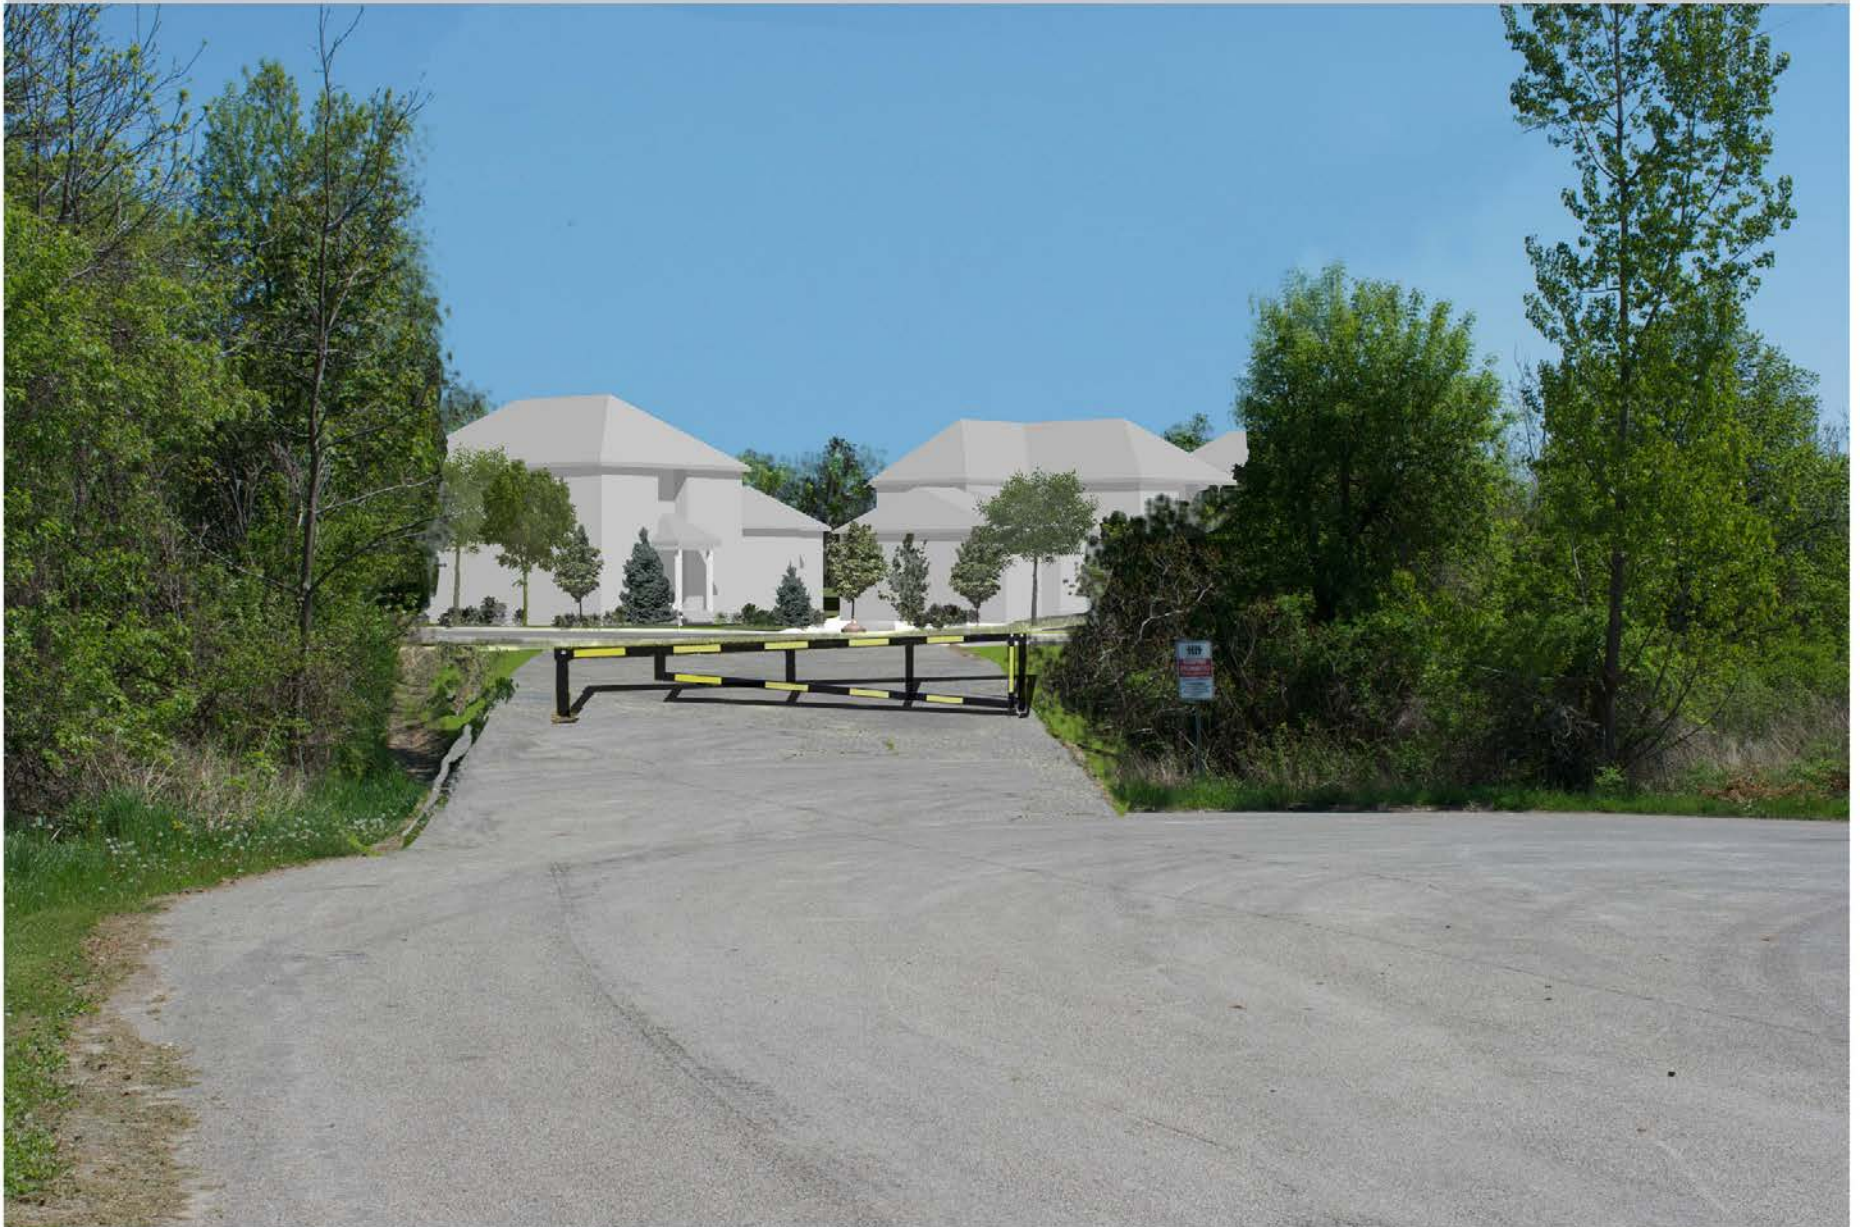
View Point 6, Ann Street

Existing Conditions
