Visual Impact Study

Eden Oak

Proposed Subdivision
Part of Lot 20, Concession 9,
Town of Halton Hills, Ontario

Visual Impact Study for Eden Oak

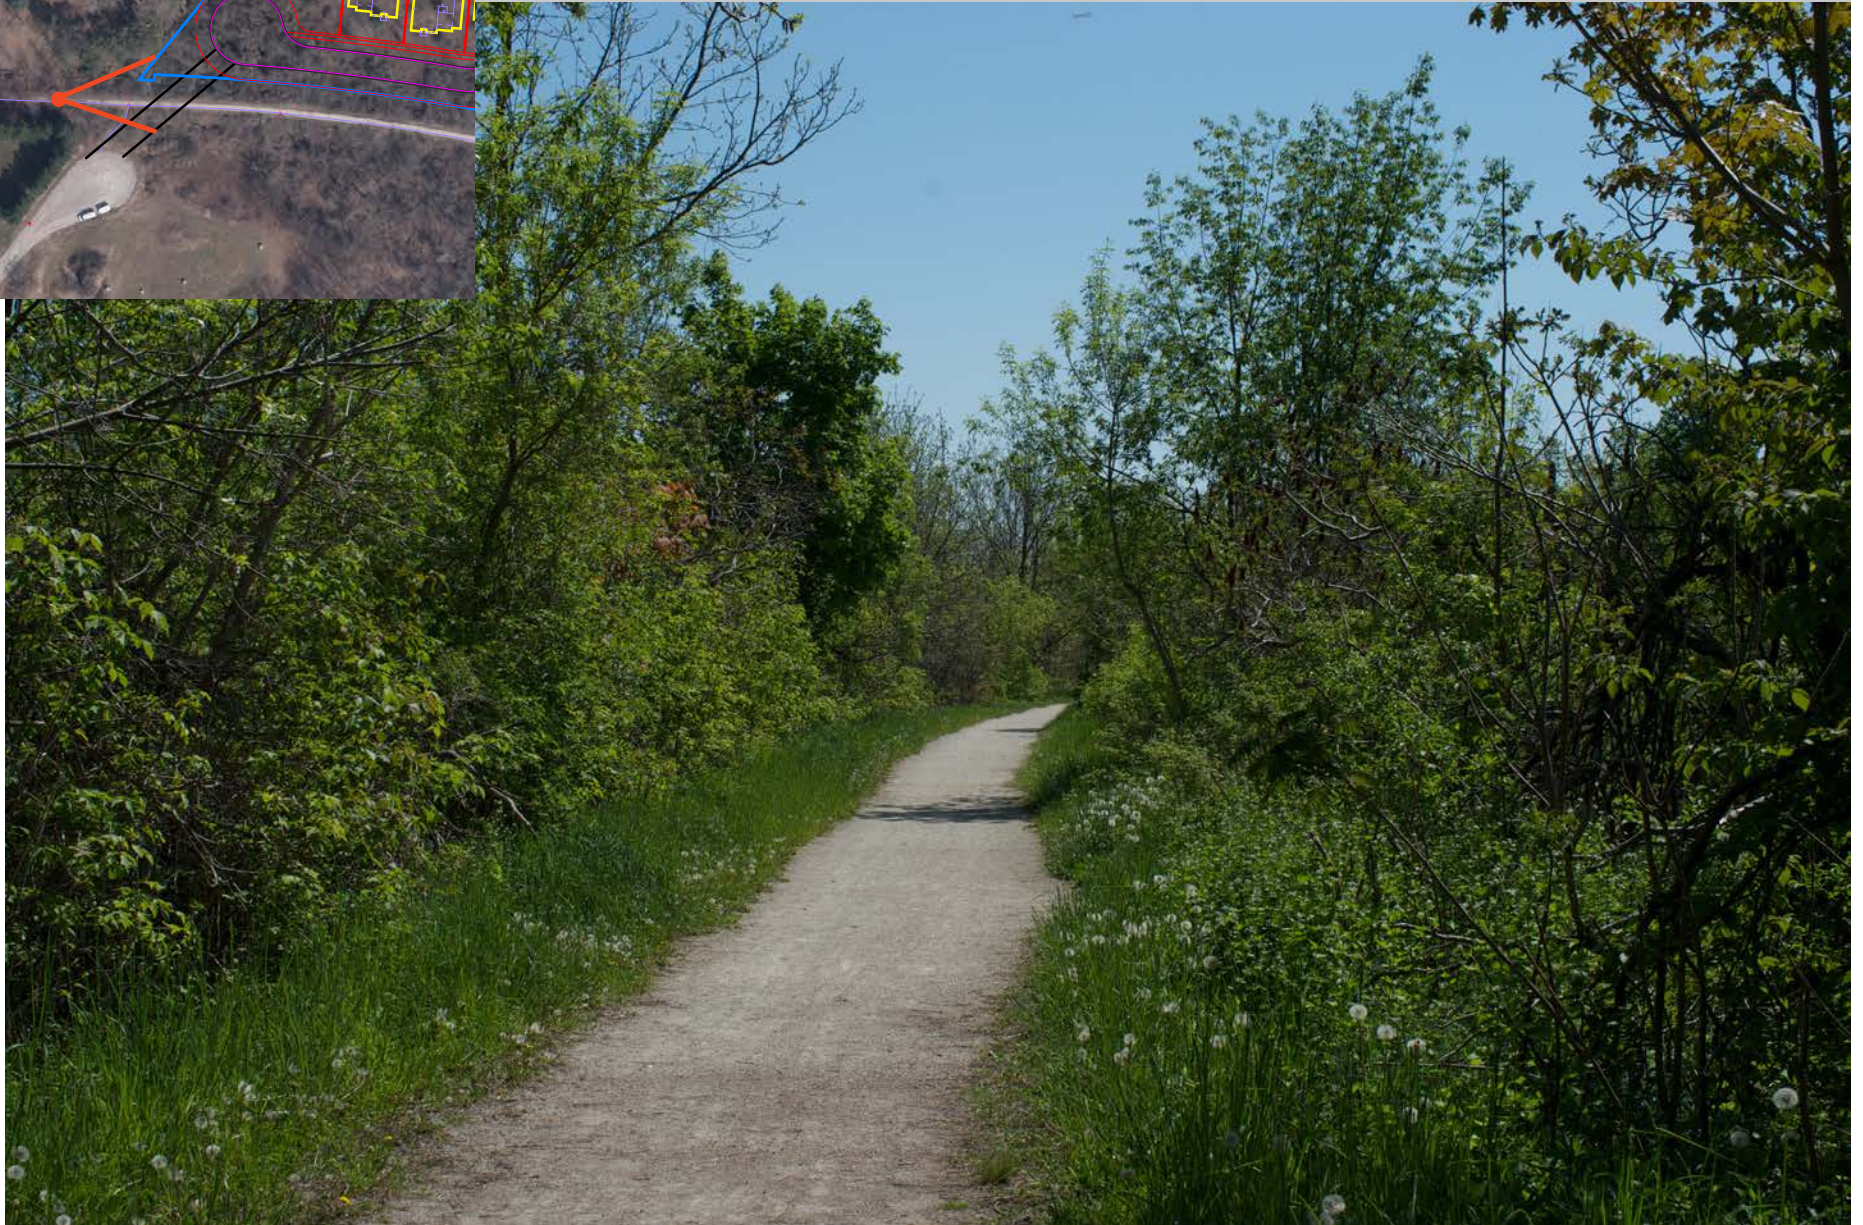
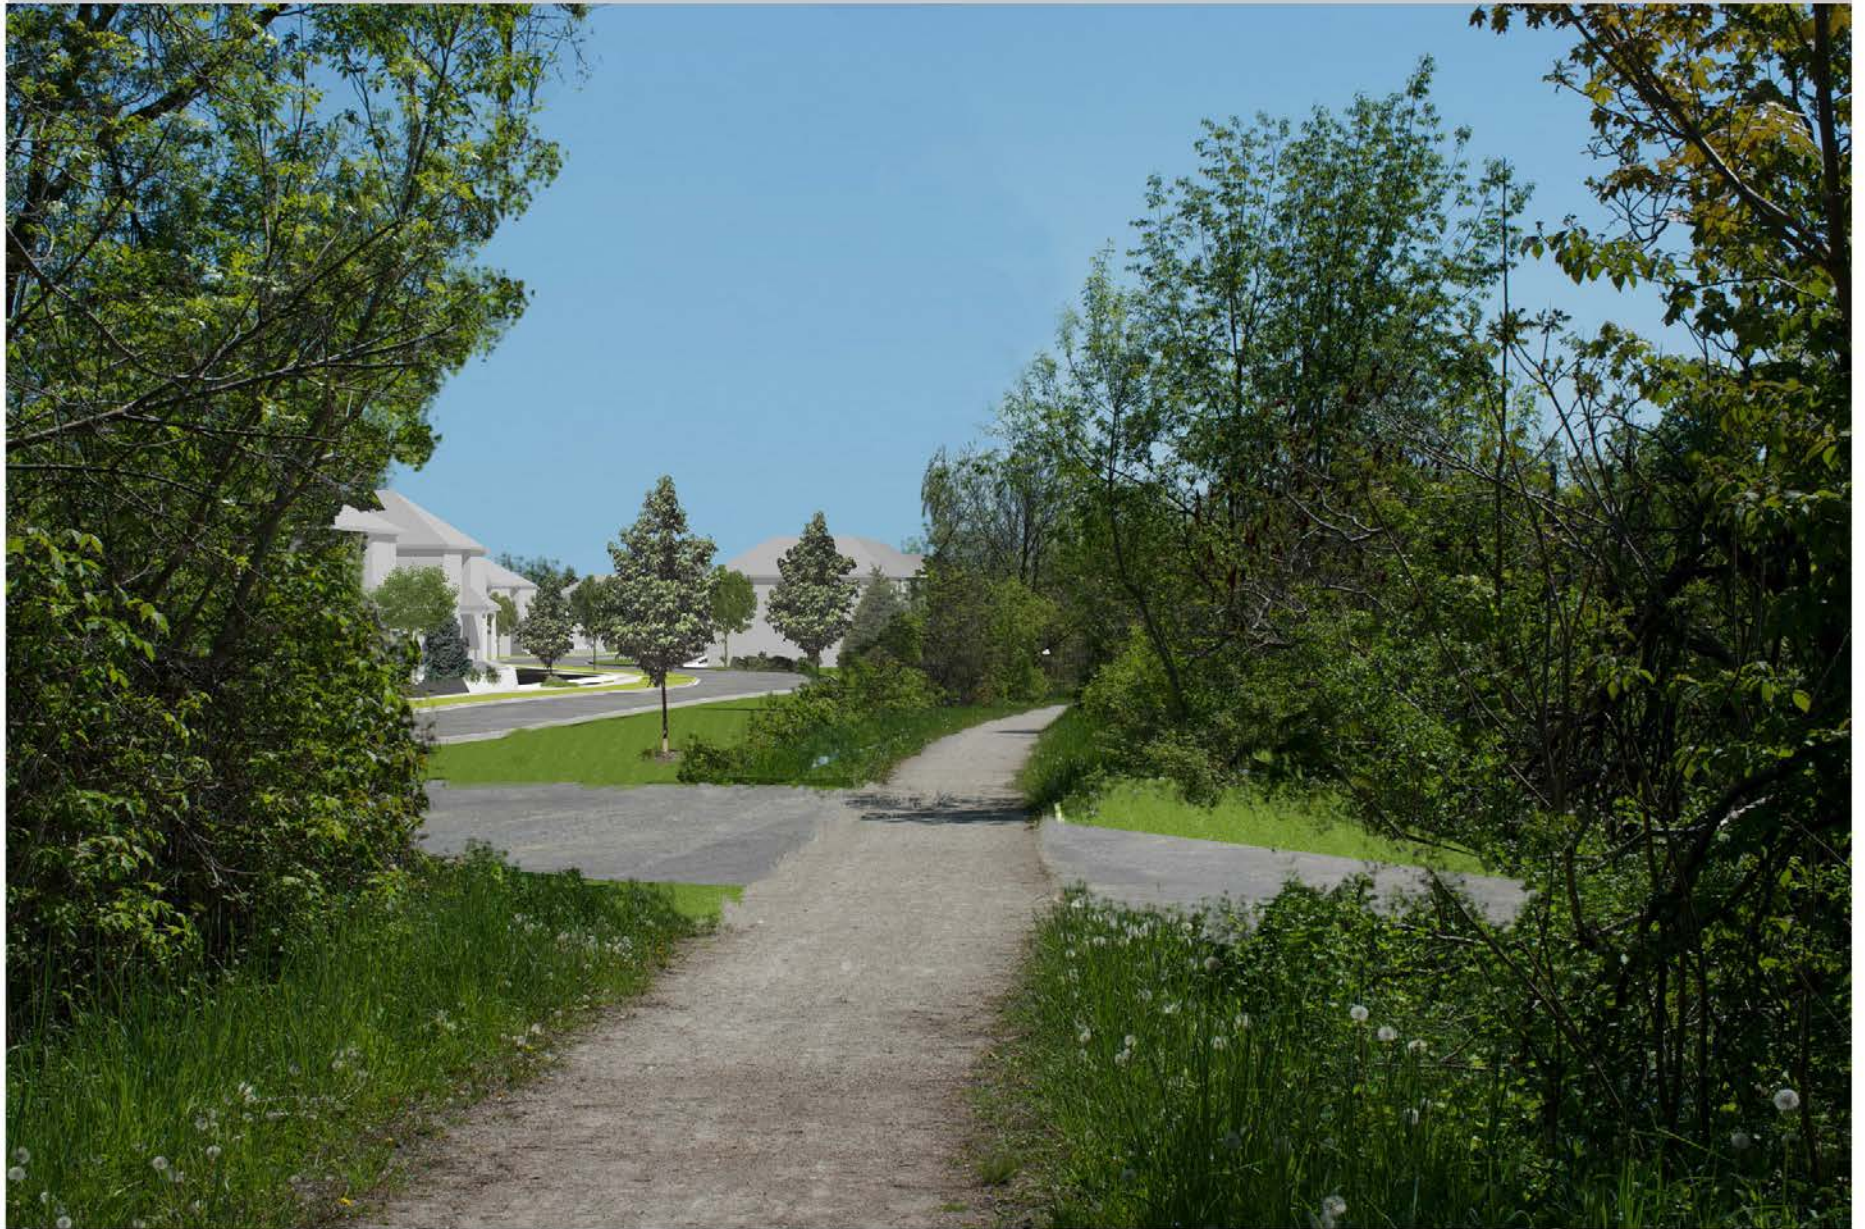
View Point 7, Pathway by Ann Street

Existing Conditions
