Fairy Lake Water Quality Study

Report

AECOM

December, 2009

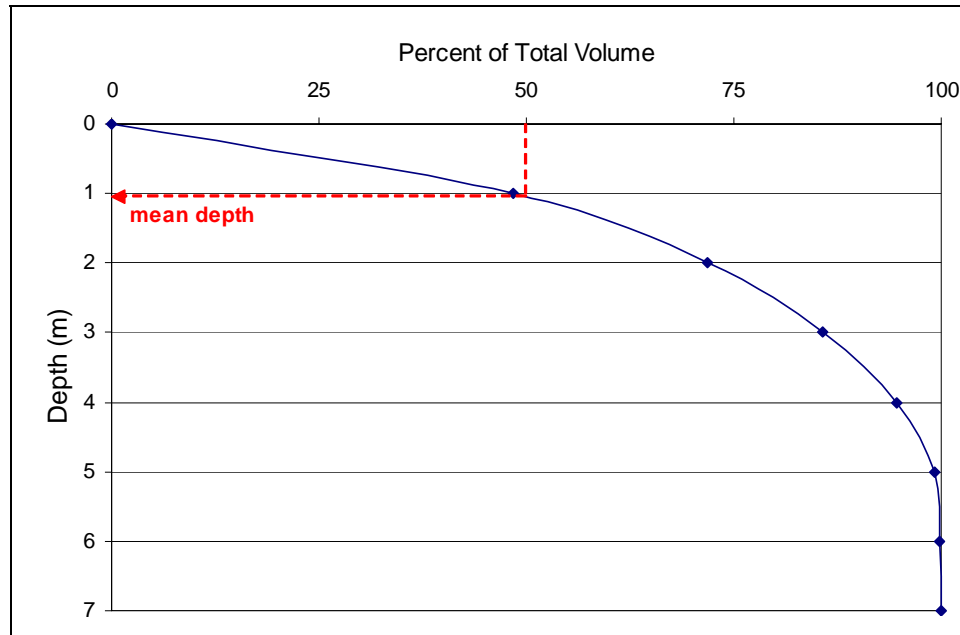
Figure 5: Fairy Lake hypsographic curve

A bathymetric map with 1-m depth contours for Fairy Lake is shown in Figure 4. The lake has a surface area of 26 ha and a perimeter of 4.6 km. Most of the south portion of lake is less than 2m deep. The maximum measured depth was 7m, but this deeper water was restricted to small areas in the main basin and the north finger of the lake. The volume of the lake is 400,656 m³. Based on the hypsographic curve for Fairy Lake, which describes the relationship between lake depth and volume, 95% of the volume of water in the lake is in the top 4m, and approximately 75% of the volume is in the top 2m (Figure 5). The mean depth of Fairy Lake is just over 1m, as approximated from the hypsographic curve (the depth above which 50% of the lake volume occurs).

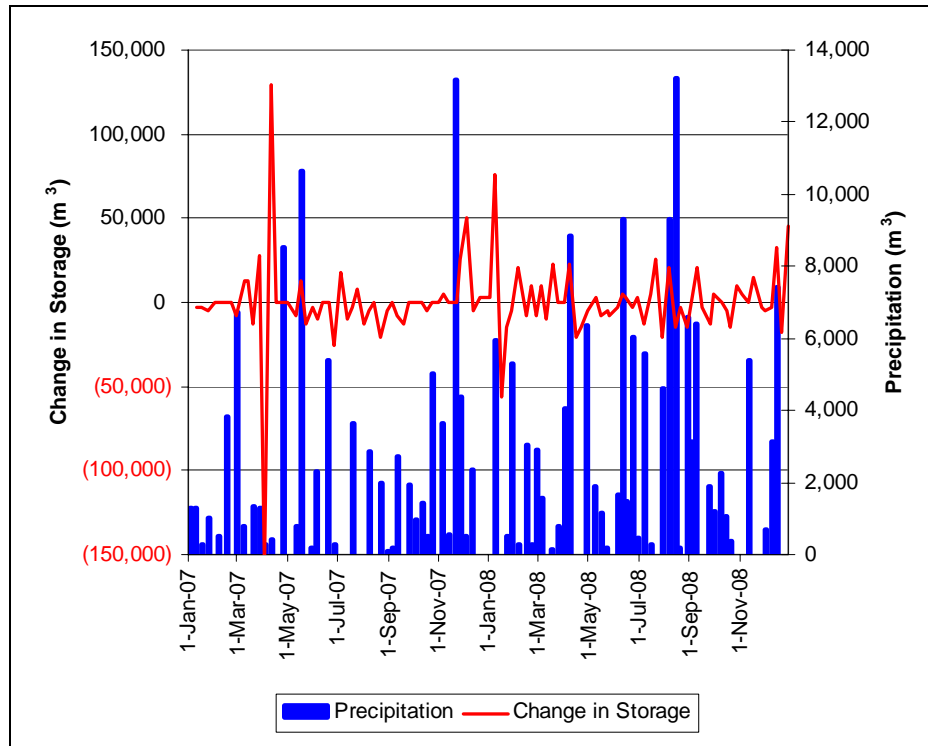
Figure 6: Fairy Lake changes in storage shown with precipitation for 2007 and 2008

Outflow, precipitation and change in lake storage data are available for Fairy Lake for 2007 and 2008. The relationship between precipitation and change in storage is shown in Figure 6. Evaporation was estimated as outlined below.

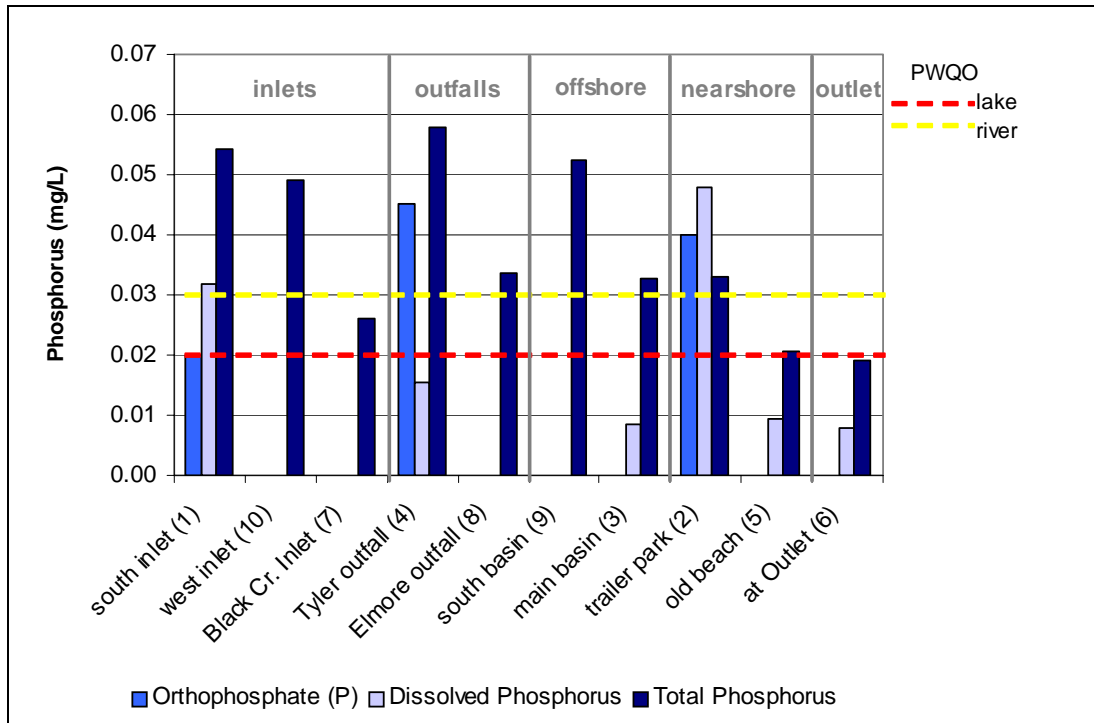
Figure 8: Mean Phosphorus Concentrations in Fairy Lake

Overall, nutrient concentrations including phosphorus and nitrogen were elevated at all of the sampling locations in Fairy Lake, indicative of productive conditions (Tables 3 and 4, Figure 8). Total phosphorus concentrations in the offshore areas of the lake exceeded the PWQO of 0.020 mg/L for the protection against nuisance algal growth. These concentrations were similar to the concentrations of the surface source waters from the inlets and stormwater outfalls, which except for the Black Creek inlet (site 7), exceeded the PWQO of 0.030 mg/L for rivers and streams. The net phosphorus concentration in the lake, as indicated at the outlet to Black Creek, was 0.019 mg/L, indicating typical trophic status for an urban lake and some assimilation of phosphorus within the lake. Orthophosphate⁴ and dissolved phosphorus concentrations were elevated in samples collected from the south inlet (site 1), the Tyler outfall (site 4) and nearshore trailer park (site 2). The accuracy of the measured concentrations of these phosphorus fractions is, however, suspect. This is particularly the case for the nearshore trailer park site where the orthophosphate and dissolved phosphorus concentrations exceeded the total phosphorus concentrations. Both orthophosphate and dissolved phosphorus are fractions of total phosphorus and so these concentrations should be less than the concentration of total phosphorus.

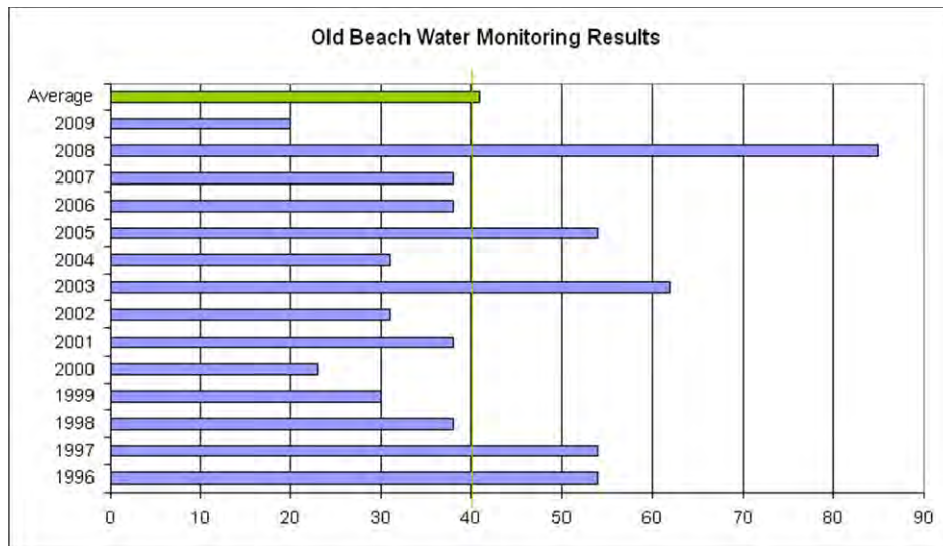
Figure 9: Percentage of Season Old Beach is Closed

Halton Region monitors Old Beach at Fairy Lake bacterial water quality, to ensure it is safe for body contact recreation. Based on bacterial water quality, The percentage of the season the Old Beach was closed in 2008 and 2009 was 85% and 18% respectively. The percentage of beach closures in 2008 and 2009 represent the highest and lowest respectively since 1995. The low beach closures in 2009 are likely due to the cooler weather. The average percentage of season in which the beach is closed (since 1995) due to high bacteria is 41 days, almost half of the season.

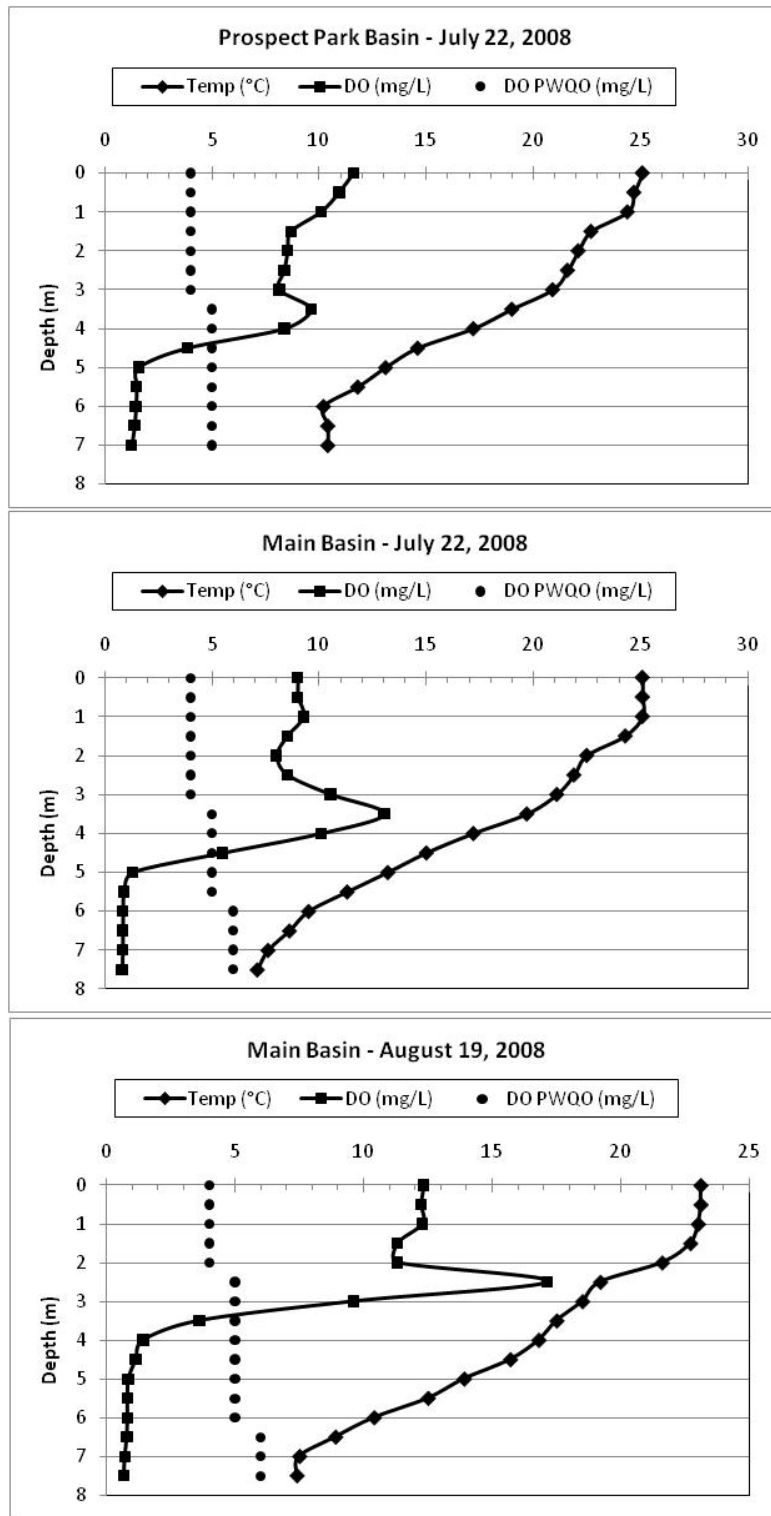
Figure 10: Temperature and dissolved oxygen profiles for Fairy Lake

Note: Dissolved oxygen PWQO is for warm water biota

Temperature and dissolved oxygen profiles taken in the summer of 2008 from the two deep basins (site 3; main basin and site 9; south basin) in Fairy Lake displayed similar patterns. At both locations, surface waters were warm (23°C to 25°C) and temperature of the water declined with depth to between 7°C and 10°C near the lake bottom (Figure 9). Surface waters were well oxygenated to a depth of 3m on July 22th and to 2m on August 19th, where a peak in oxygen concentration occurred, reaching a maximum of 17.1 mg/L on August 19th. This peak in dissolved oxygen concentration is due to oxygen production from photosynthetic activity of algae and/or aquatic plants growing at that depth in the water column. Dissolved oxygen then declined to very low mean concentrations of 0.8 mg/L and 1.4 mg/L in bottom waters below 5 m in the main and north basins, respectively.

The pattern of temperature and dissolved oxygen concentrations observed in Fairy Lake is common in shallow, productive lakes that do not undergo seasonal thermal stratification⁷. During prolonged periods of warm weather and calm winds, however, there may be episodes of little or no mixing of the water column such that a temperature gradient can set up in the water column as was observed in Fairy Lake. At this time, a decline in oxygen can occur in deeper waters as oxygen is consumed by decomposition of organic matter. These bottom waters can become re-oxygenated following a wind or wave event when the water column mixes. Additional temperature and oxygen profiles taken more frequently over the course of the open water season would be required to confirm this mixing regime in Fairy Lake.

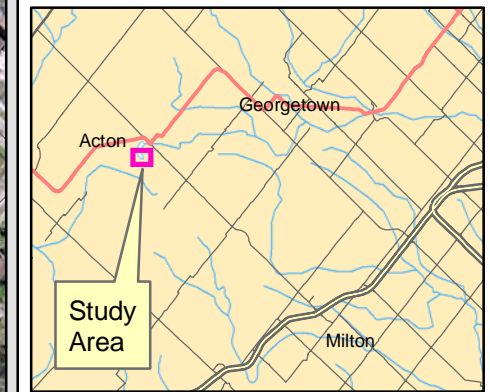
Legend

- Ecological Land Classification
- Turtle Nesting Area
- Boulder Reinforced Shoreline
- Hardend Shoreline
- Intermittent Stream
- Permanent Stream

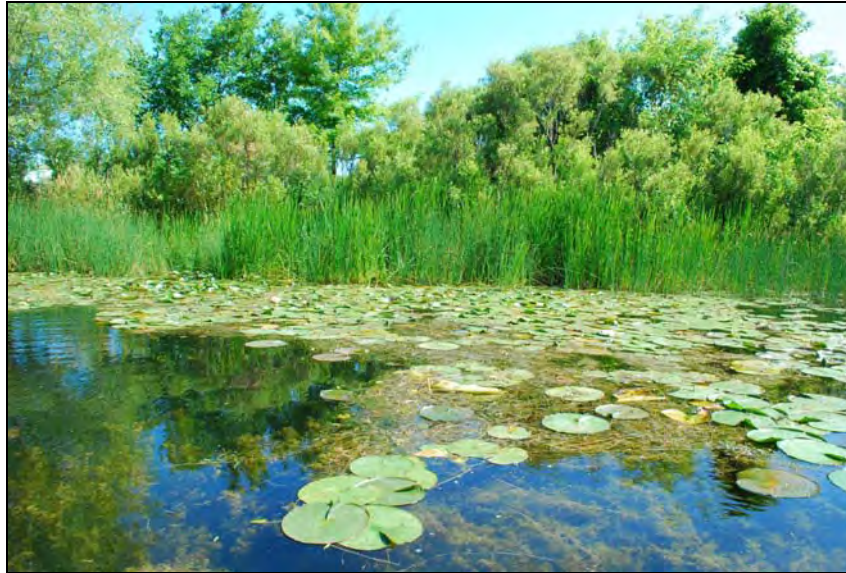
Figure 12: North end of Fairy Lake showing Water Milfoil Mixed Aquatic (SAM 1-7) in front of Bulrush Shallow Mineral Marsh (MAS2-2) and Willow Mineral Thicket Swamp (SWT2-2)

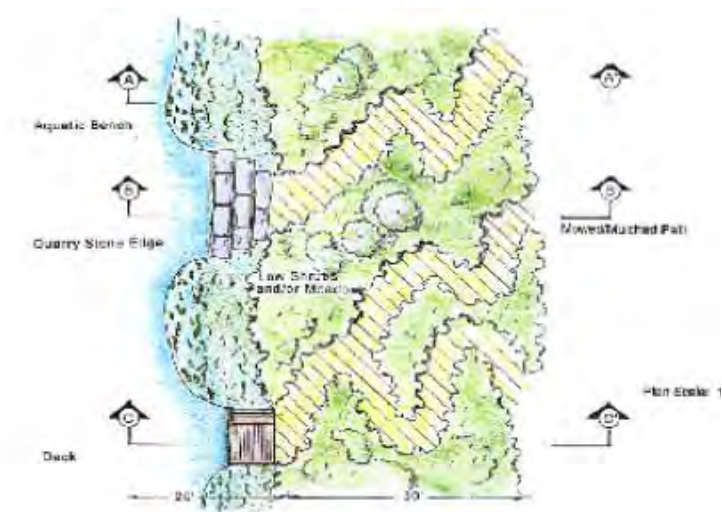
Figure 13: Using landscaping to obstruct views of shoreline

- **Obstruct views of the shoreline.** Reducing sightlines to less than nine metres makes geese feel uncomfortable (Carr, 2000). Planning the way vegetation is maintained can discourage goose access as shown Figure 13. In this landscaping configuration sinuous mowed pathways provide easy human access to the water while obstructing views for geese.

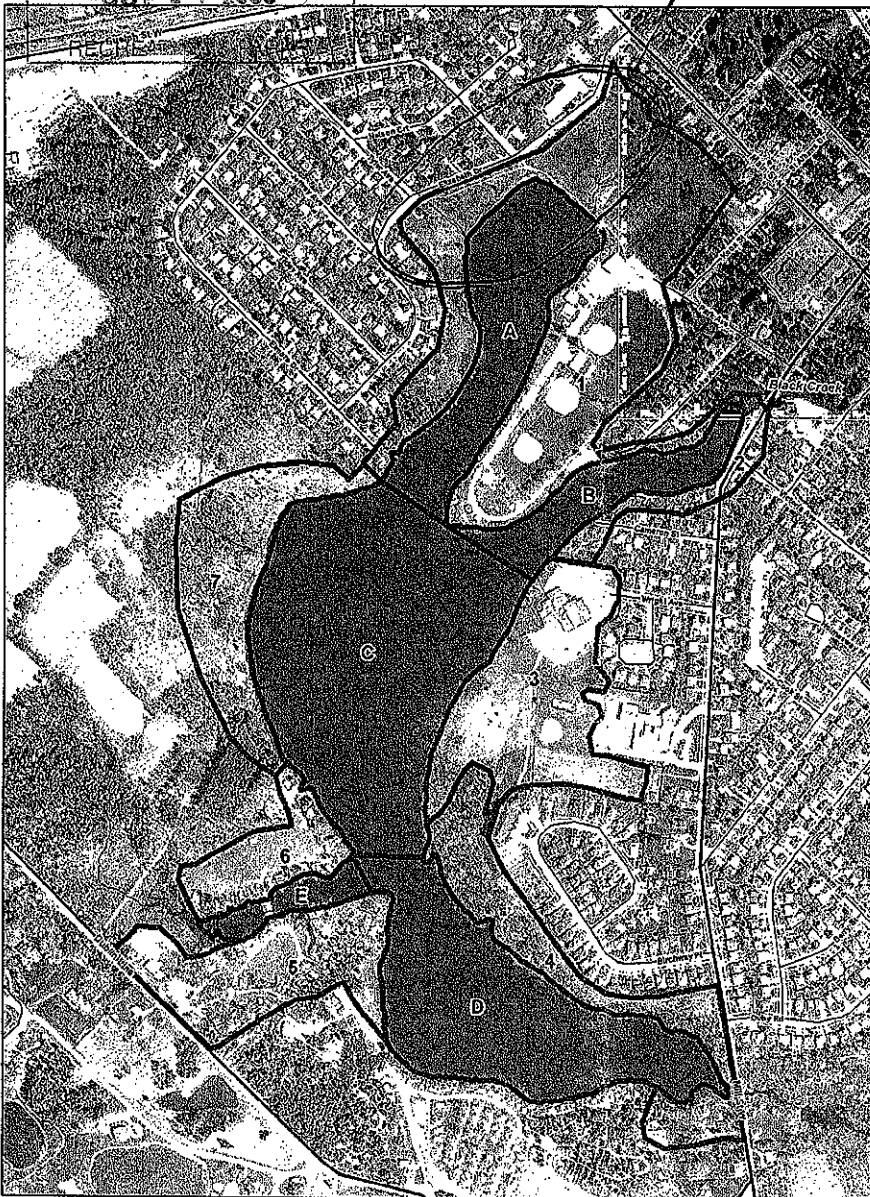
This data not used in report. Dates ^{not} interesting - no sighting or away. Obs=?
 AREA OF SILEY (for some reason) ?

Fairy Lake Canada Goose Monitoring Sheet			
Date:	Time:	Weather:	
Observers:			
Area	# and age of Geese	Behaviour	Comments
eg: A,B,C,D...	eg: 5 adult, 15 young	eg: Grazing, Roosting, Loafing, Flying Overhead...	Please provide any additional observations
21.15 Aug	23 in park	4 on water	
17 Aug.	13 in park	53 on water	(roosting in shady area)
21			
22	no birds		
Sun 24	14 in park	fly in. 50 plus 20 10 on water	
25 th	40 in park	(in shade under trees)	
Wed 27 th		20+ on water	
Fri 29	10+ in park		
Sun 31 st		20+ on water	
Wed 3. Sept	20+ in park	14 on water	
Fri 5 "		20+ on water	
Sun 7 "		14 on water 2 nd group 12+	
Thurs. 11 "	20+ in park		
Mon 15 "	30+ in park	12 on water	
Wed 17 "	50+ in park		
Thurs 18 "		50+ in water fly-in 20	
Sat 20 "	100+ in park		
Sun 21 "	100+ "	4 on water

On August 8, 2009 and on a 2009 visit by AECOM biologist, numerous (60-70) young were observed. This is equivalent to about 10 nests. It is possible that nearby nesting geese bring their young to the lake to be reared. These nests may be in the wetland to the east of Mill St at the south-eastern extension of Fairy Lake or they also are likely to be in the golf course to the southwest – it is a fairly easy walk for geese from this golf course.

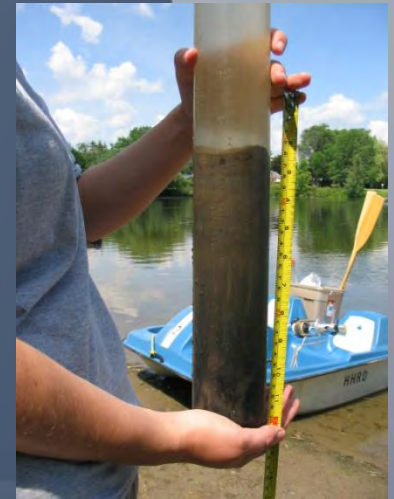
- 3 sediment cores (south, main, Prospect Park basins)
- Highly organic with elevated nutrient concentrations
- Source is primarily biological - from aquatic plant production

Parameter	Unit	Prospect Park Basin	South Basin	Main Basin	PSQG LEL	PSQG SEL
Total Organic Carbon	mg/kg	53,000	94,000	43,000	10,000	100,000
Phosphorus	µg/g	940	430	830	600	2,000
Total Kjeldahl Nitrogen	µg/g	3,180	8,875	2,820	550	4,800

Organic lacustrine surface sediments in Fairy Lake likely represent the amount of sediment accumulation that has occurred since dredging of the lake in the fall of 1967 and spring of 1968 (see Appendix B for dredging articles published in the Acton Free Press). The extent of the dredging that occurred is unknown, but assuming that large portions of the lake was dredged to remove all lacustrine sediments since damming of the lake, the present depth of organic sediments represent approximately 41 years of accumulation. Based on observed organic sediment depths in Fairy Lake, the average sedimentation in the north end of Fairy Lake is ~0.9 cm per year, and 1.2 cm per year in the shallow south end of the lake. These sedimentation rates are typical for productive systems with high organic content. Note that these sedimentation rate estimates are gross estimates that do not consider compaction or consolidation of the sediments.
