**SUBWATERSHED IMPACT STUDY
HALTON HILLS GENERATING STATION**

Prepared for:

TransCanada Energy Limited
In business to deliver

March 2008

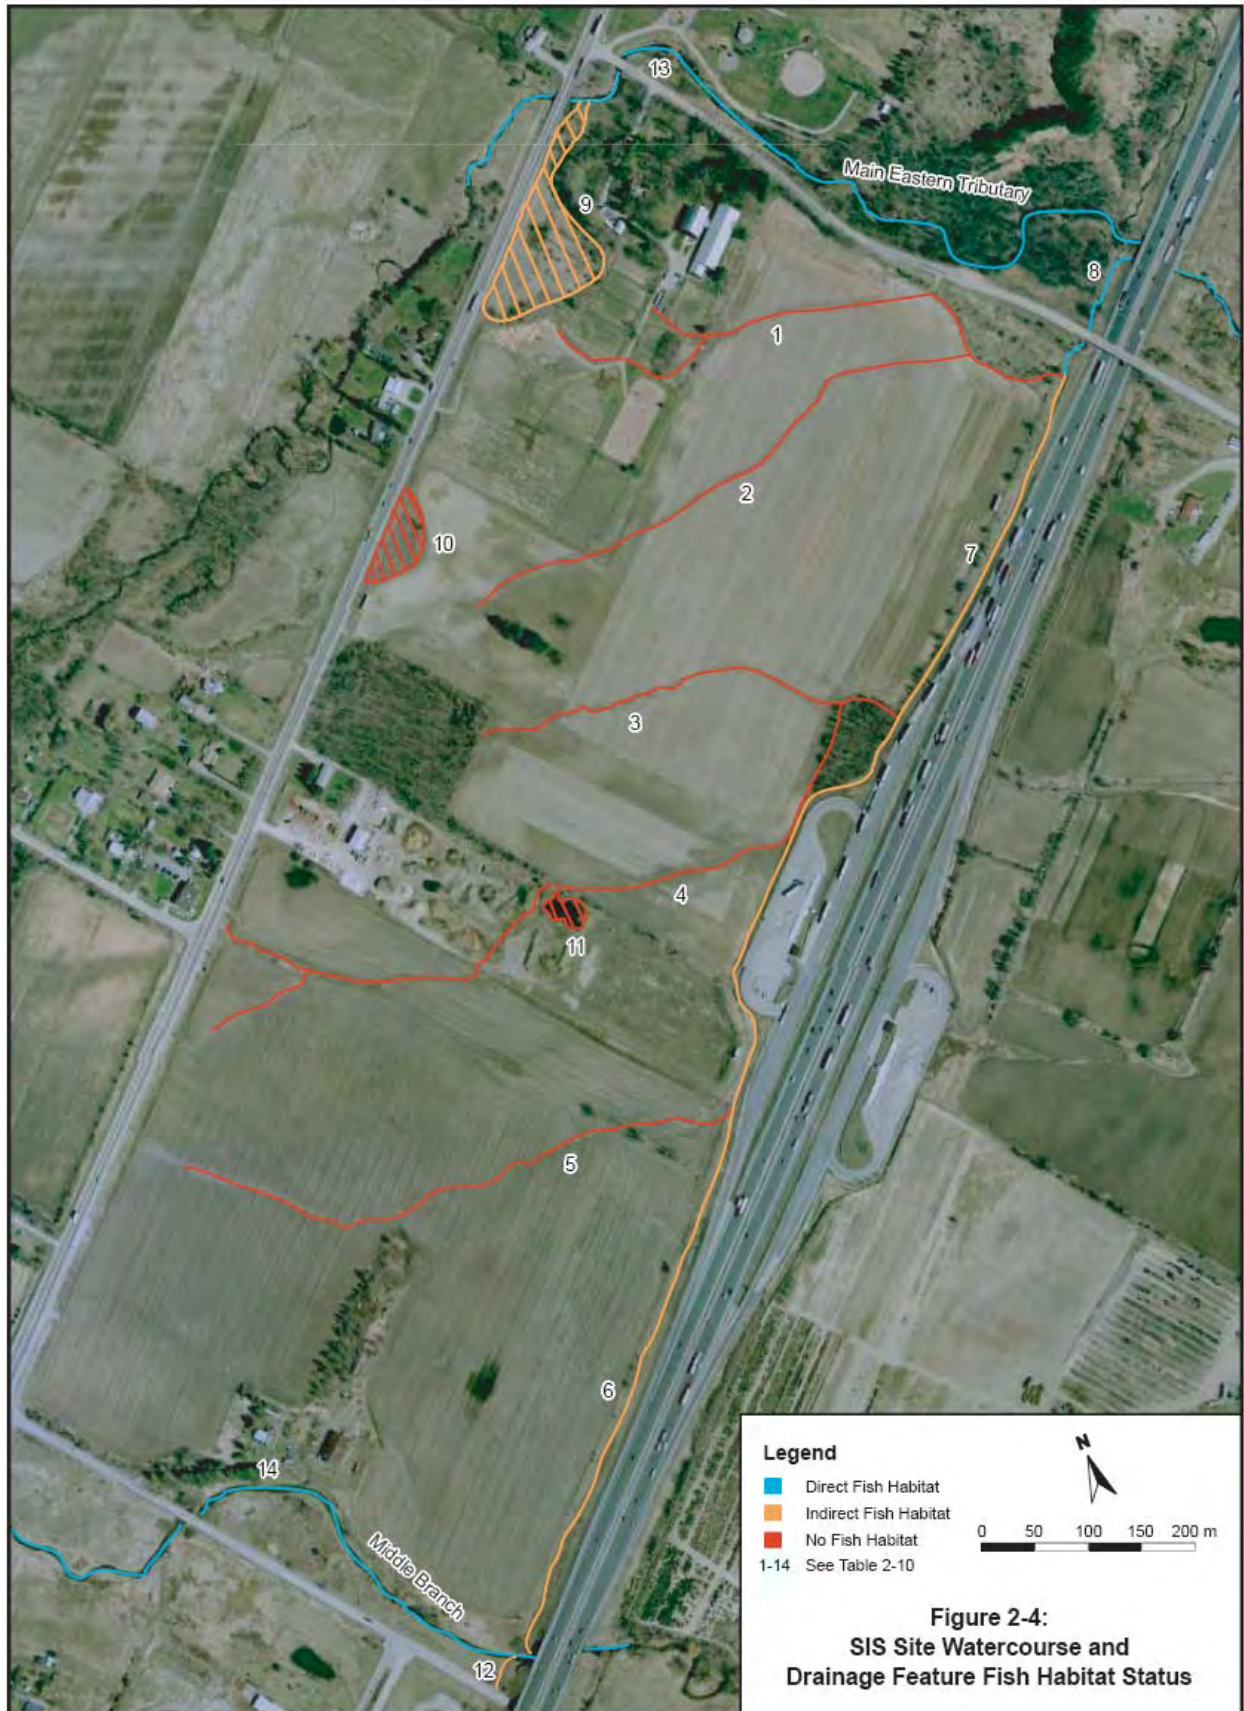
Figure 2-4 presents the fish habitat status of the watercourses and drainage features on the SIS site, whereas Table 2-10 provides a summary of the site drainage feature characteristics. Photographs of the watercourses and drainage features are provided in Appendix B.

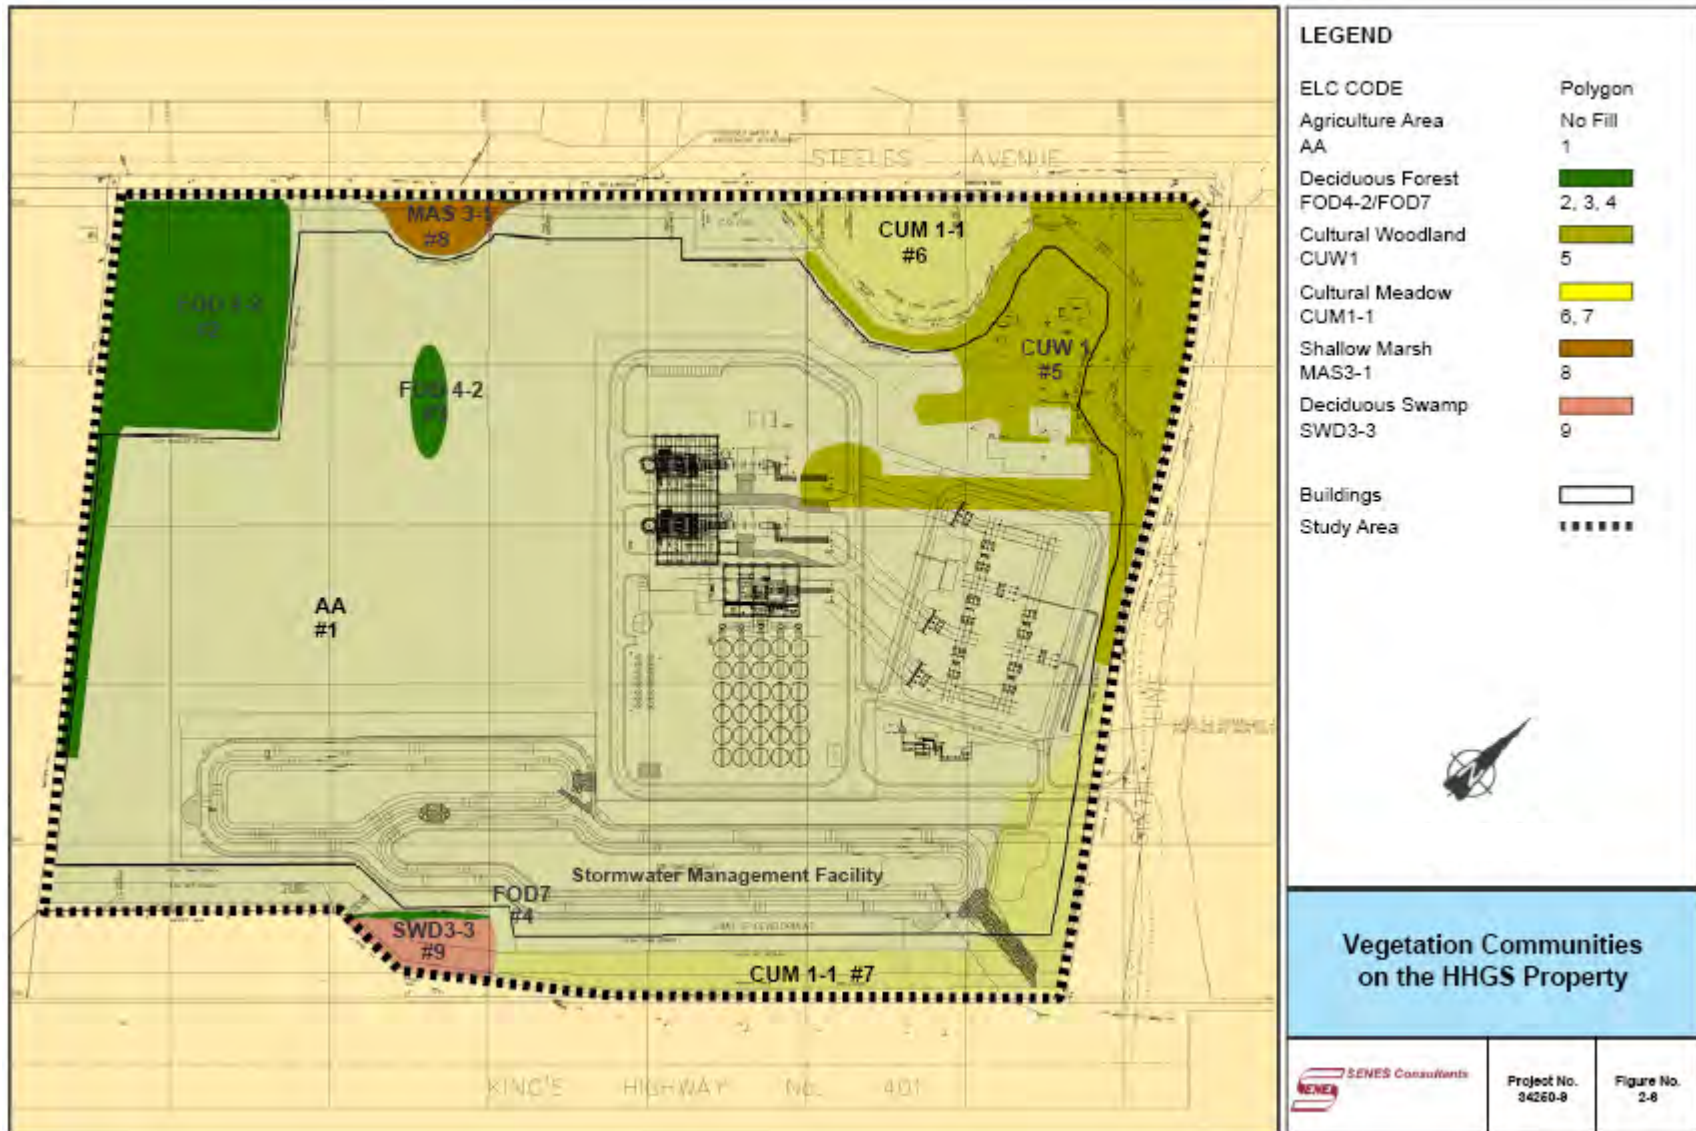
The deciduous forest community type is present at three locations (see Figure 2-6). The largest parcel, classified as a Dry-Fresh White Ash Deciduous Forest (FOD4-2) community, is located on the northwest corner of the property, identified by Dillon (2000) as DF1 and C2 (the southern hedgerow extension of the woodlot). A small fragment of the same forest community type (FOD4-2), identified by Dillon (2000) as C6, is located to the east of the large woodlot. The third parcel, classified as a Fresh to Moist Lowland Deciduous Forest (FOD7) community, is located along the northern edge of a Swamp Maple Mineral Deciduous Swamp (SWD3-3) community, identified by Dillon (2000) as WF2. This woodlot consisting of the two vegetation community types is located along the southern portion of the property.

The Fresh to Moist Lowland Deciduous Forest (FOD7#4) community flanks the northern edge of the woodlot located along the southern boundary of the HHGS property (Figure 2-6). This

The Swamp Maple Mineral Deciduous Swamp (SWD3-3#9) community comprises approximately 80% of the woodlot located along the southern boundary of the HHGS property (Figure 2-6). This community is dominated by young to mid-aged hybrid maple (*Acer x freemania*), with white elm, box elder and green ash being locally abundant. Bur oak and crack willow (*Salix fragilis*) form lesser associates. No standing water was observed on the surface or within pits dug for soil sampling. However, there was evidence in the central and southern portions of the community to suggest that seasonal ponding does occur. Drainage conditions in the woodlot have been substantially altered by the construction of ditches along the perimeter of the site. The perimeter ditches intercept runoff from the broader catchment area and prevent flow into the woodlot. In response to this, it appears that more upland species are being recruited in the ground and understory strata. While this transition may eventually result in the transition of this swamp community to a lowland forest community, current conditions are still reflective of a wetland system (see Appendix C).

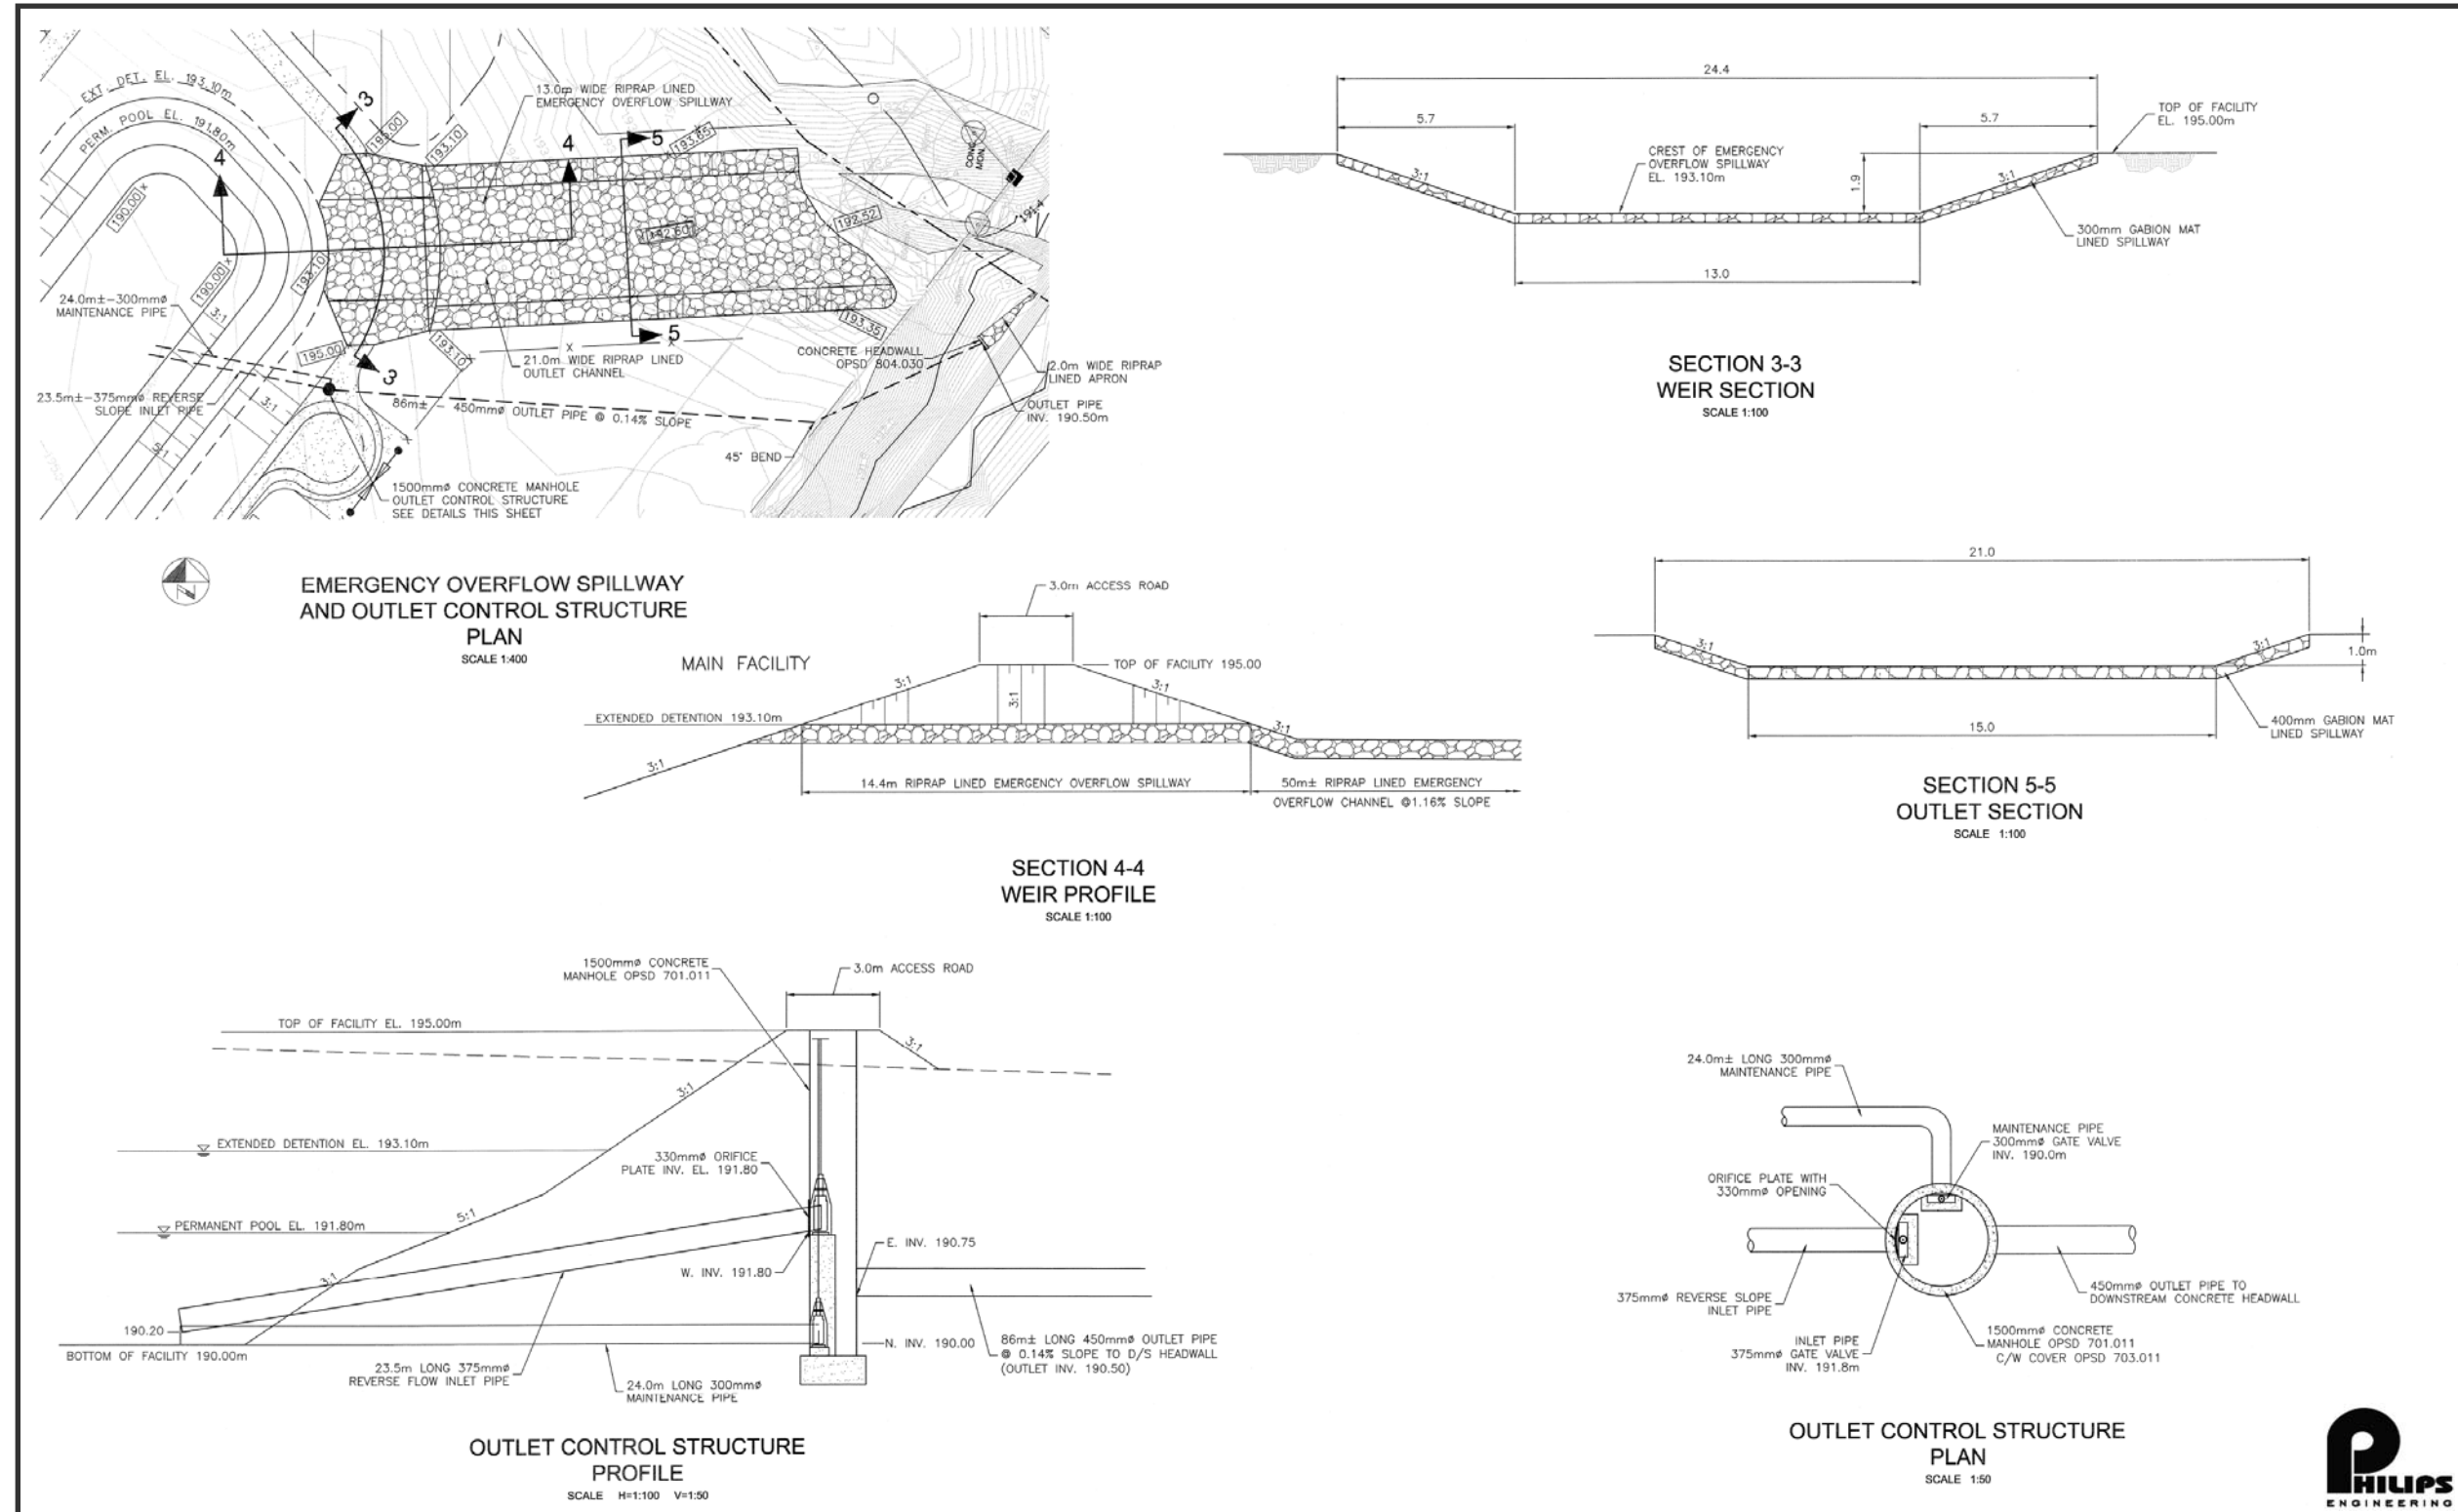
FIGURE 3-2
QUANTITY WEIR/EMERGENCY OVERFLOW SPILLWAY AND OUTFLOW CONTROL

Quantity Control Outlet Structure and Emergency Spillway

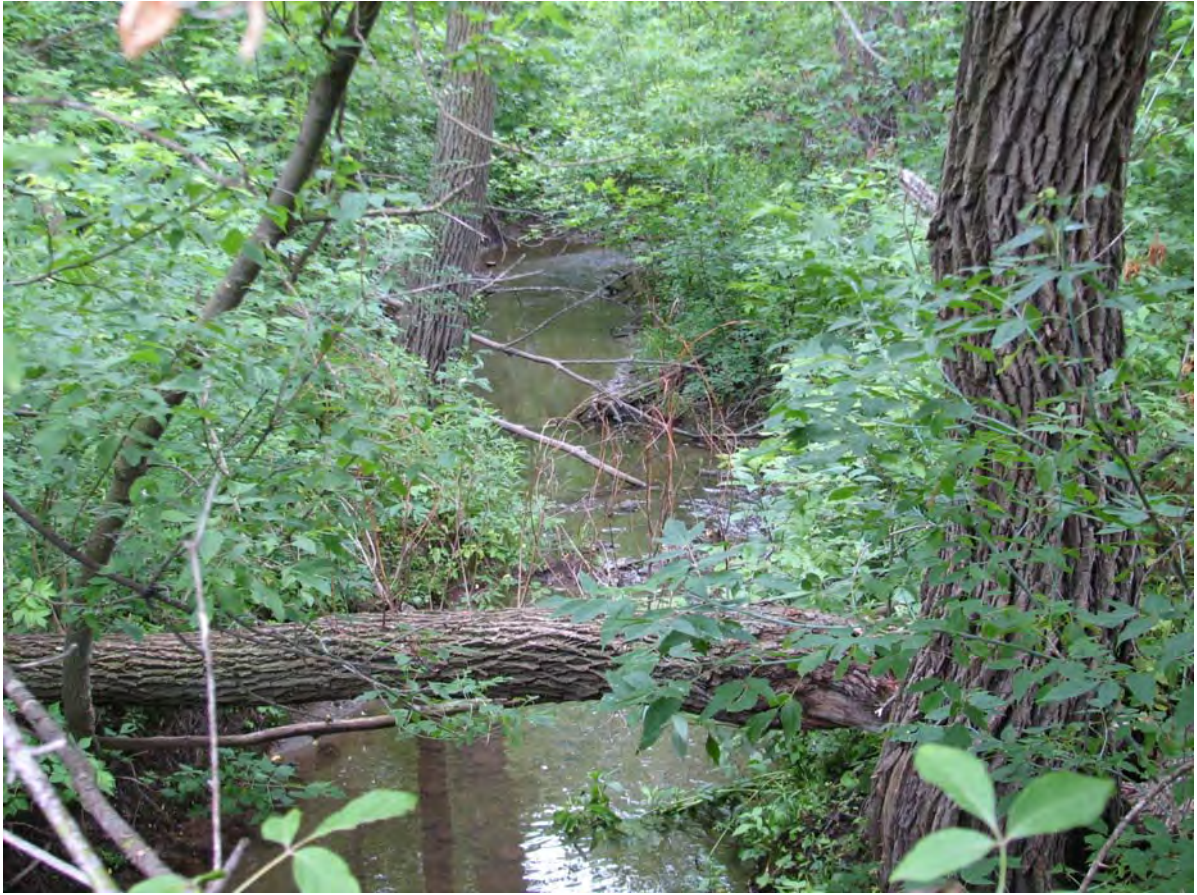
Photo 1: Upstream view to the west of Middle Sixteen Mile Creek Tributary at Station 1. At this location, above 6th Line, canopy cover is dense as the watercourse flows within a forested area.

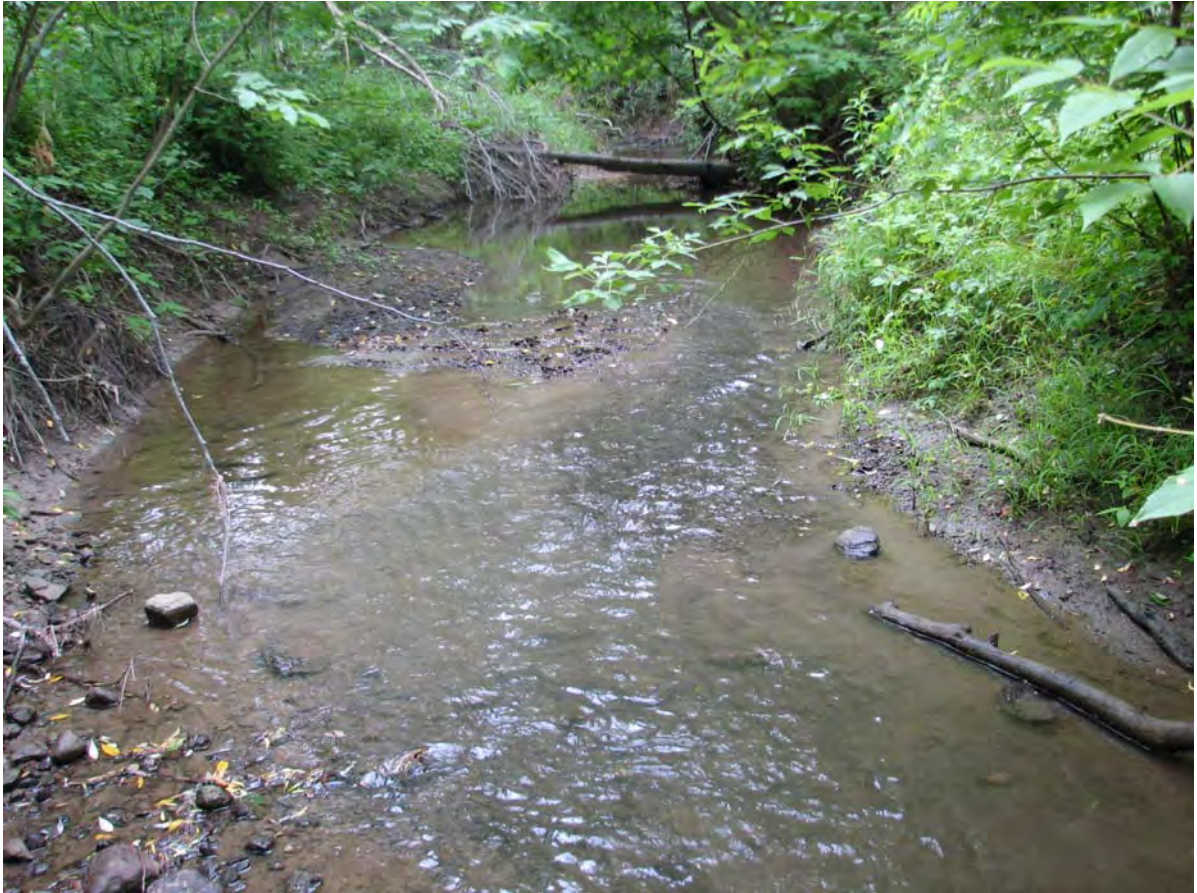
Photo 2: Upstream view to the west of Middle Sixteen Mile Creek Tributary at Station 1. The substrate is primarily gravel and sand and the stream banks show evidence of frequent high flows.

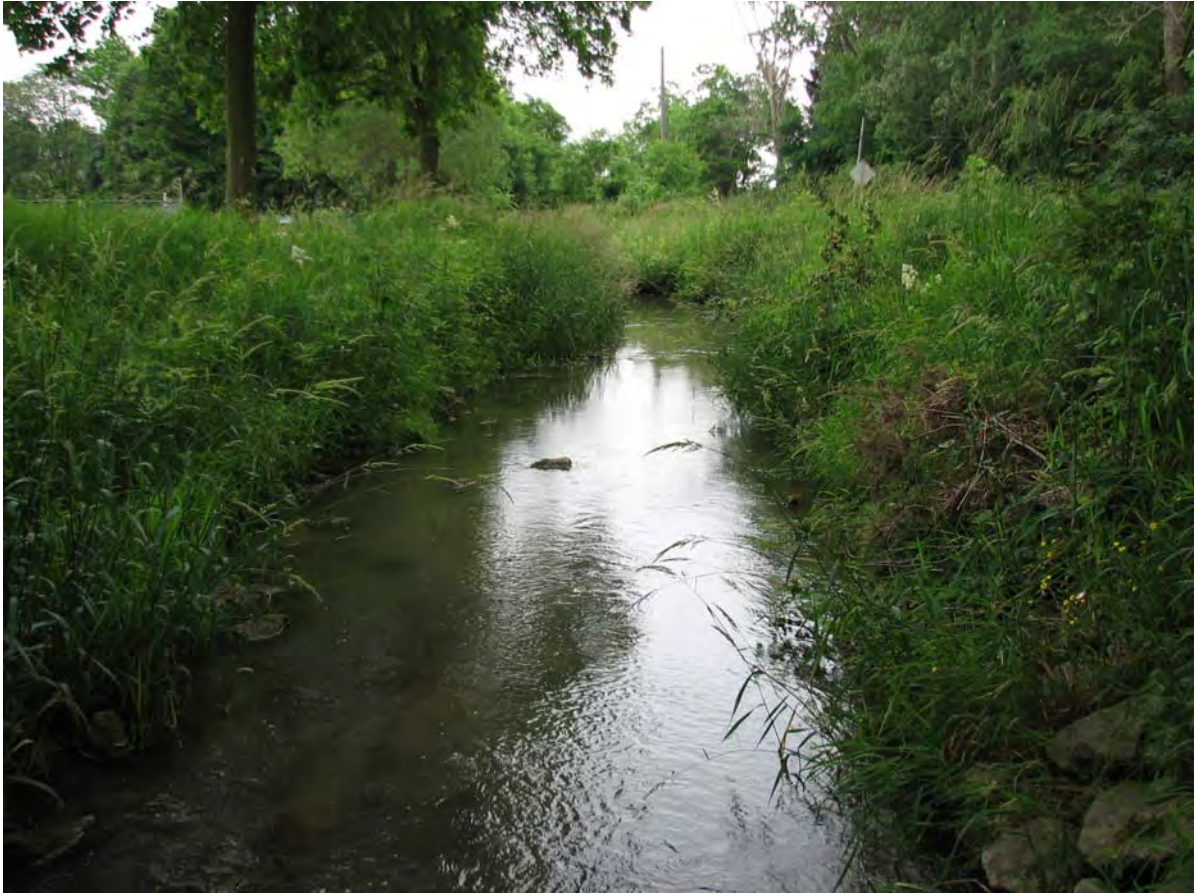
Photo 3: Downstream view to the south of Middle Sixteen Mile Creek Tributary at Station 2. At this location, adjacent to 6th line, the canopy is party open.

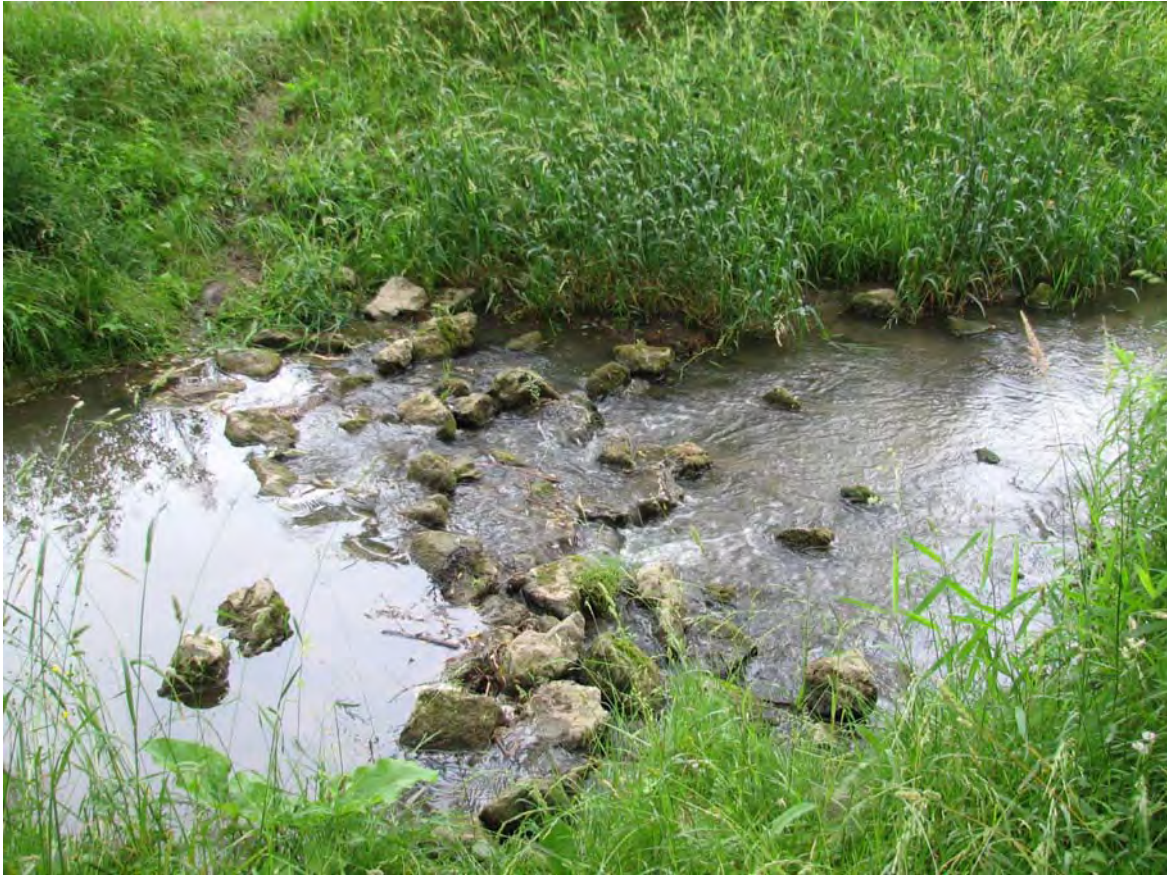
Photo 4: View of Middle Sixteen Mile Creek Tributary at Station 2. The adjacent landuse is parkland and this rock weir is man-made.

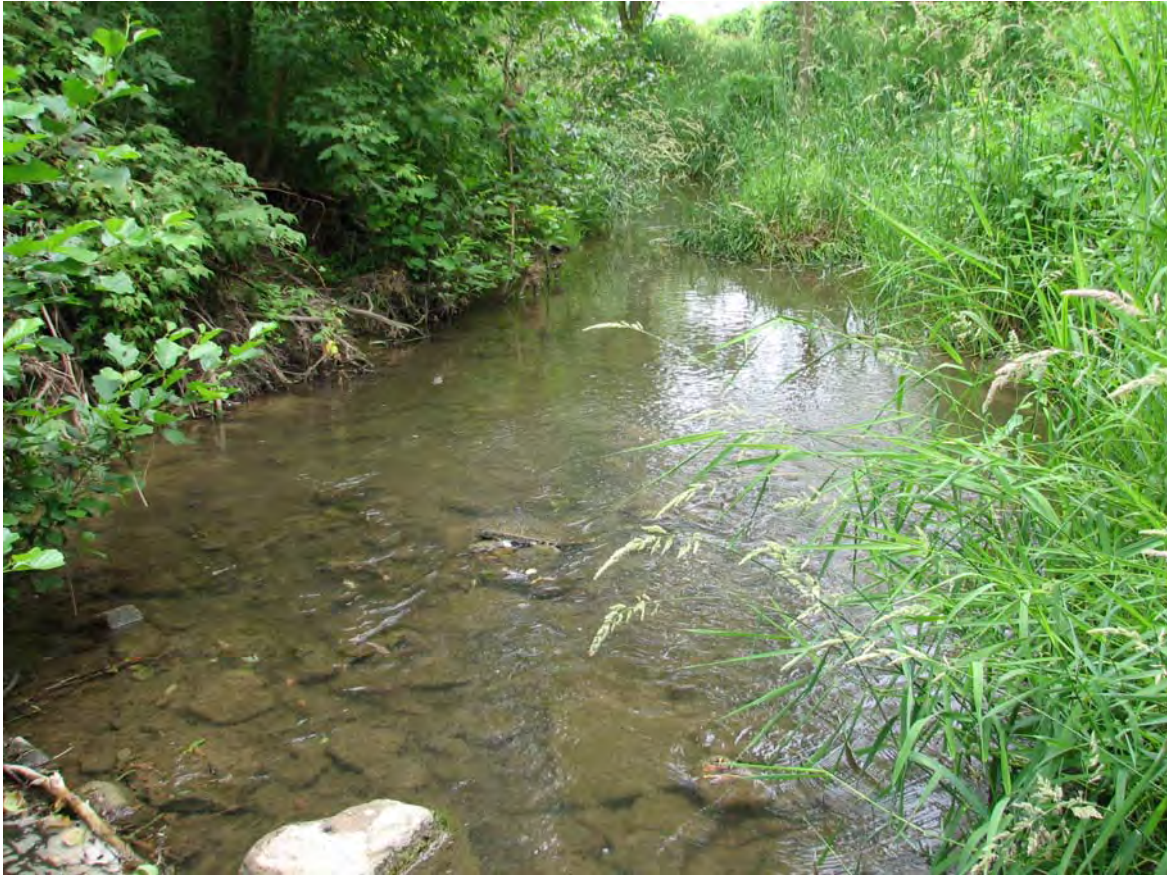
Photo 5: Downstream view to the south of Middle Sixteen Mile Creek Tributary at Station 3. At this location, upstream of the Highway 401 crossing, the canopy is partly open.

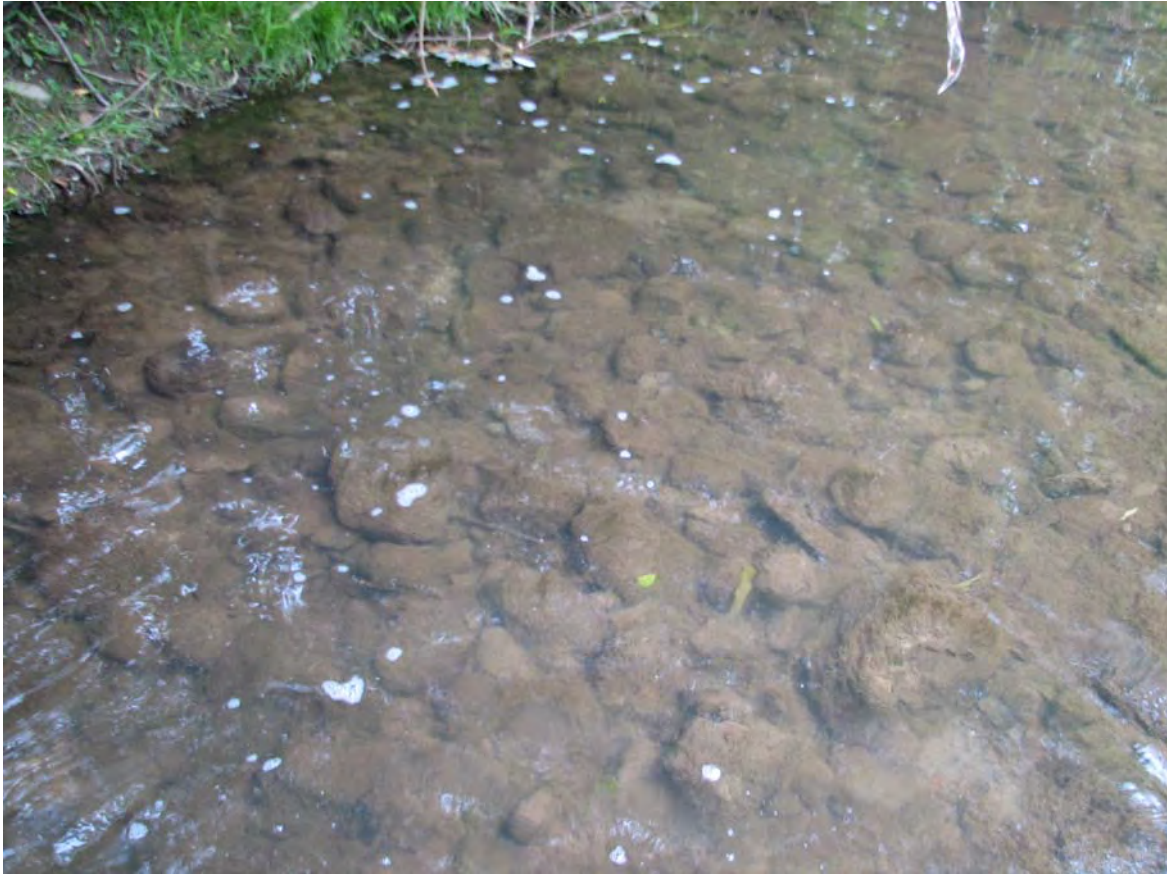
Photo 6: View of Middle Sixteen Mile Creek Tributary at Station 3. The substrate is primarily cobble with heavy algal growth and moderate sediment overlying.

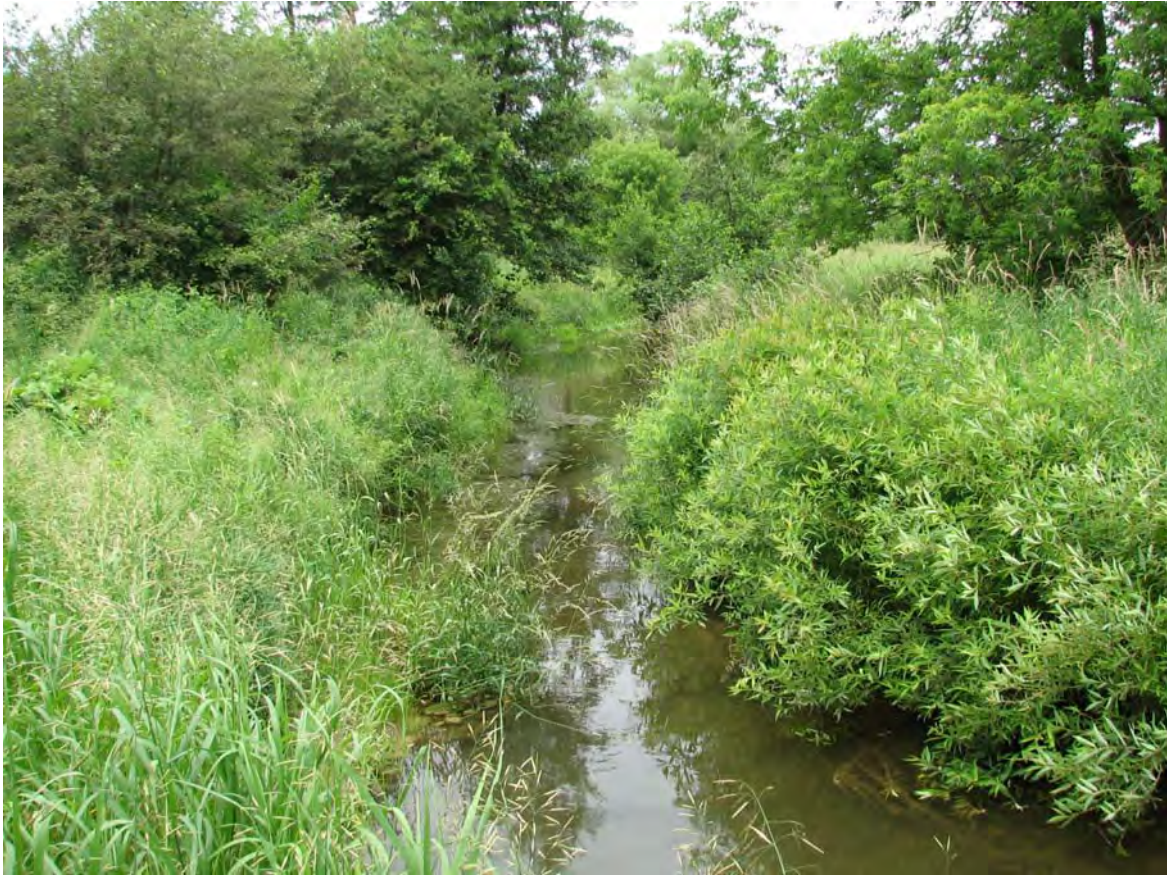
Photo 7: Upstream view to the north of Middle Sixteen Mile Creek Tributary at Station 4. At this location, upstream of the Canadian Pacific Railway crossing, canopy cover is mainly open and instream submergent aquatic macrophytes are abundant.

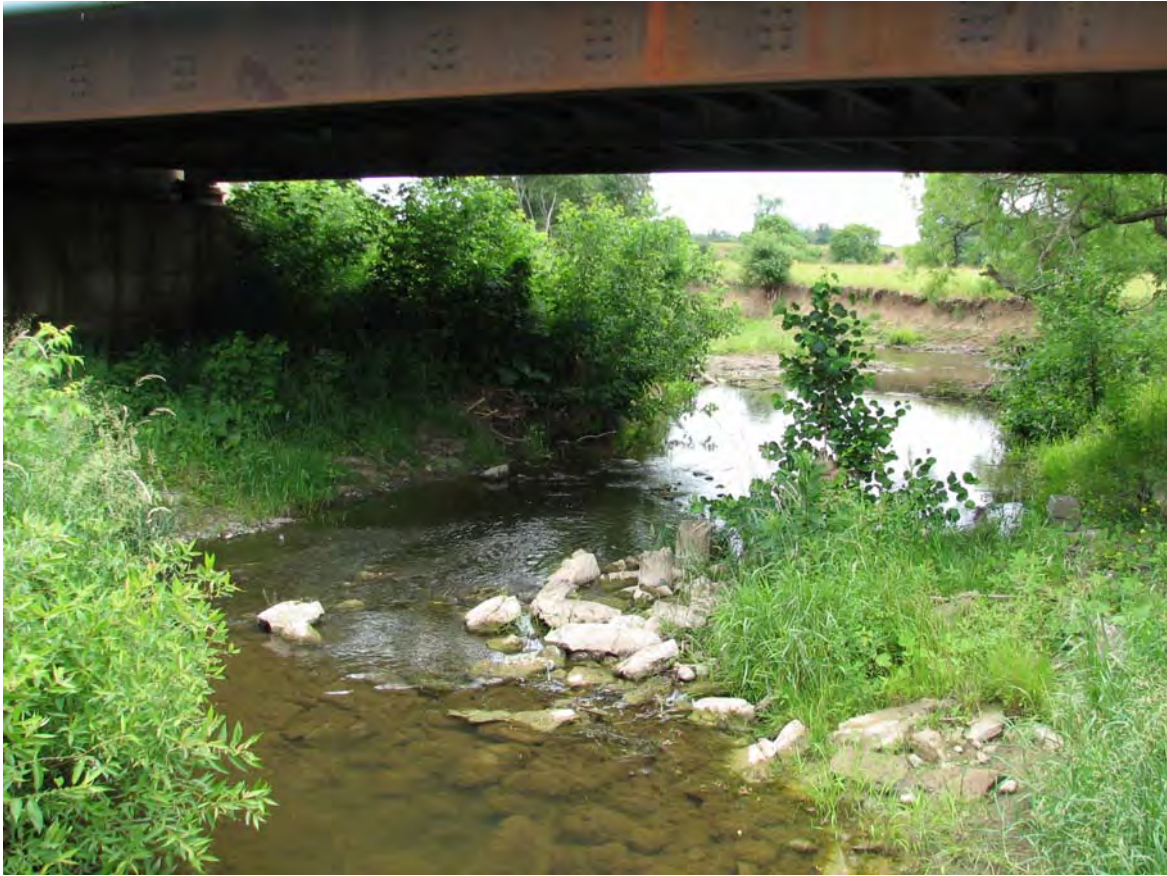
Photo 8: Downstream view to the south of Middle Sixteen Mile Creek Tributary at Station 4. The confluence with Middle Sixteen Mile Creek occurs almost immediately downstream of the railway crossing.

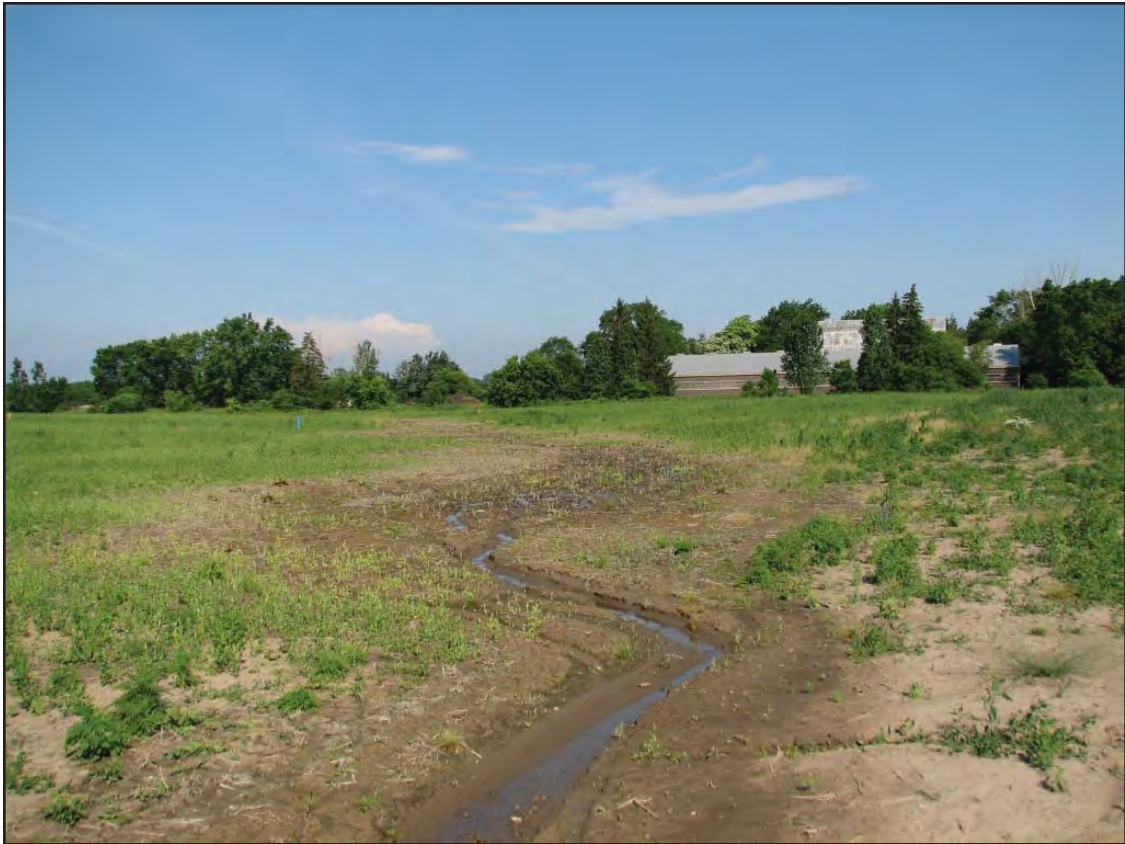
Swale 1 on 21 June 2007 (looking upstream); water in the channel due to groundwater discharge from Steeles Avenue construction activities.

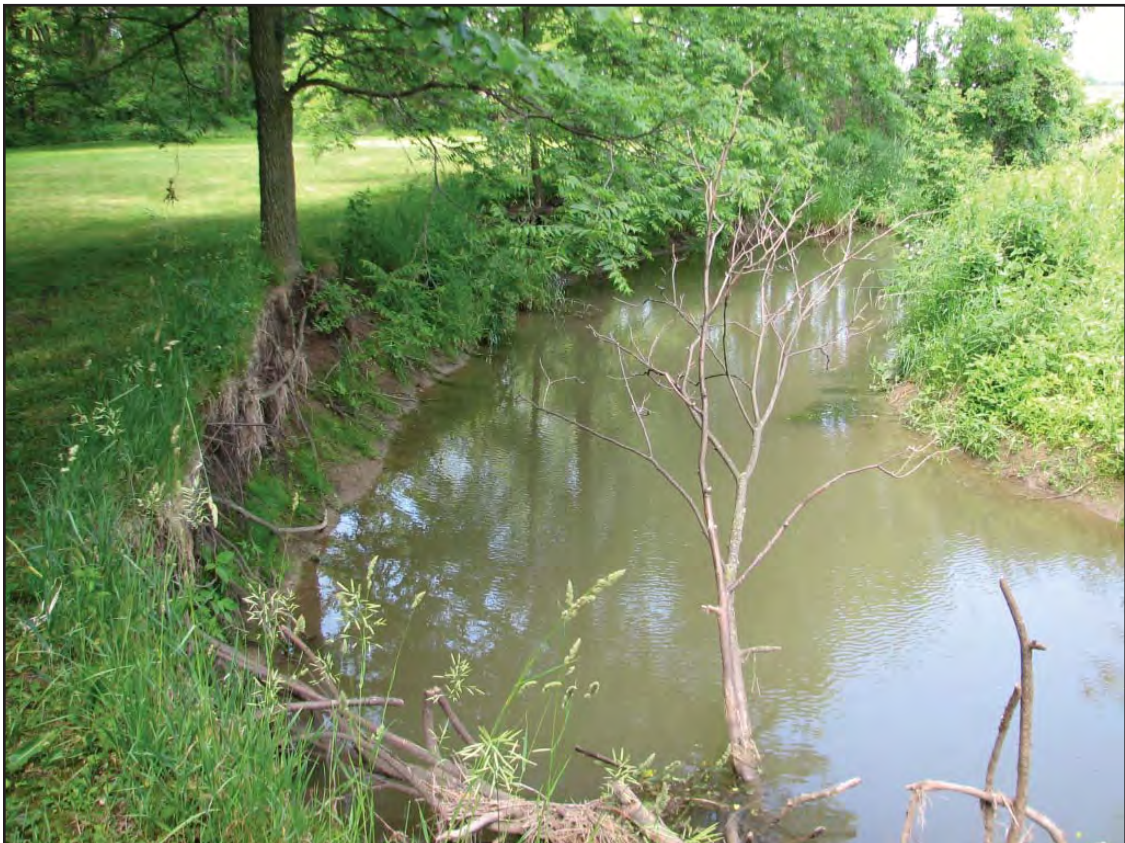
Main Eastern Tributary 13 (looking upstream); note turbidity.

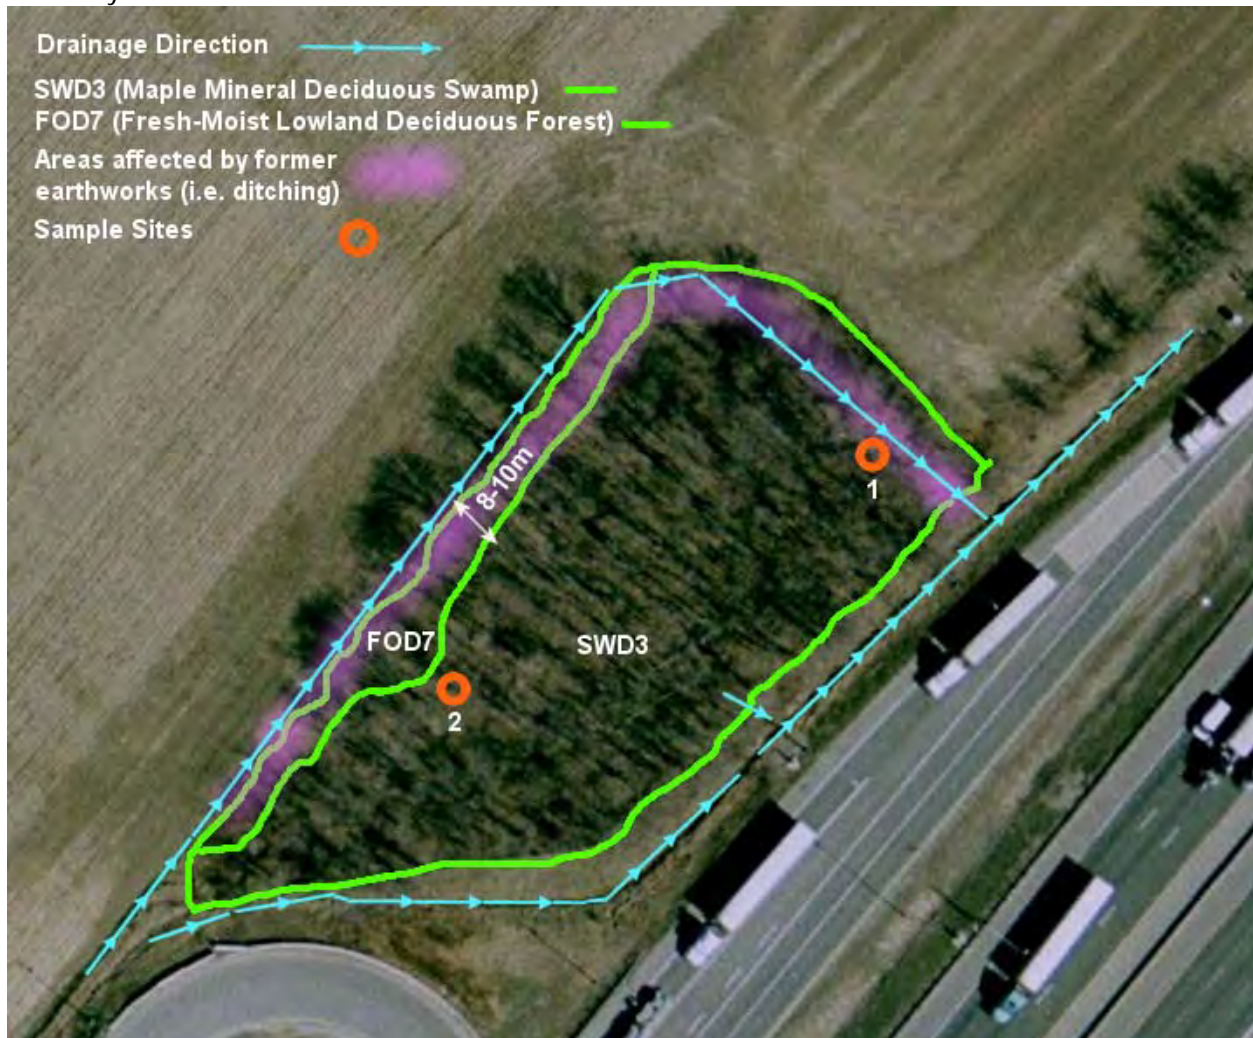
Figure 2 - Vegetation Map

Based on the vegetation and soils data collected, it is our opinion that 80% of the site (0.31 ha) should be classified as a Swamp Maple Mineral Deciduous Swamp (SWD3-3), while the remaining 20% (0.07 ha) corresponding with the northern edge should be categorized as a Fresh to Moist Lowland Deciduous Forest ecosite (FOD7) (see Figure 2). A complete set of ELC data cards have been completed for the primary vegetation unit (SWD3-3); the secondary unit has been treated as an inclusion due to its relatively small size.

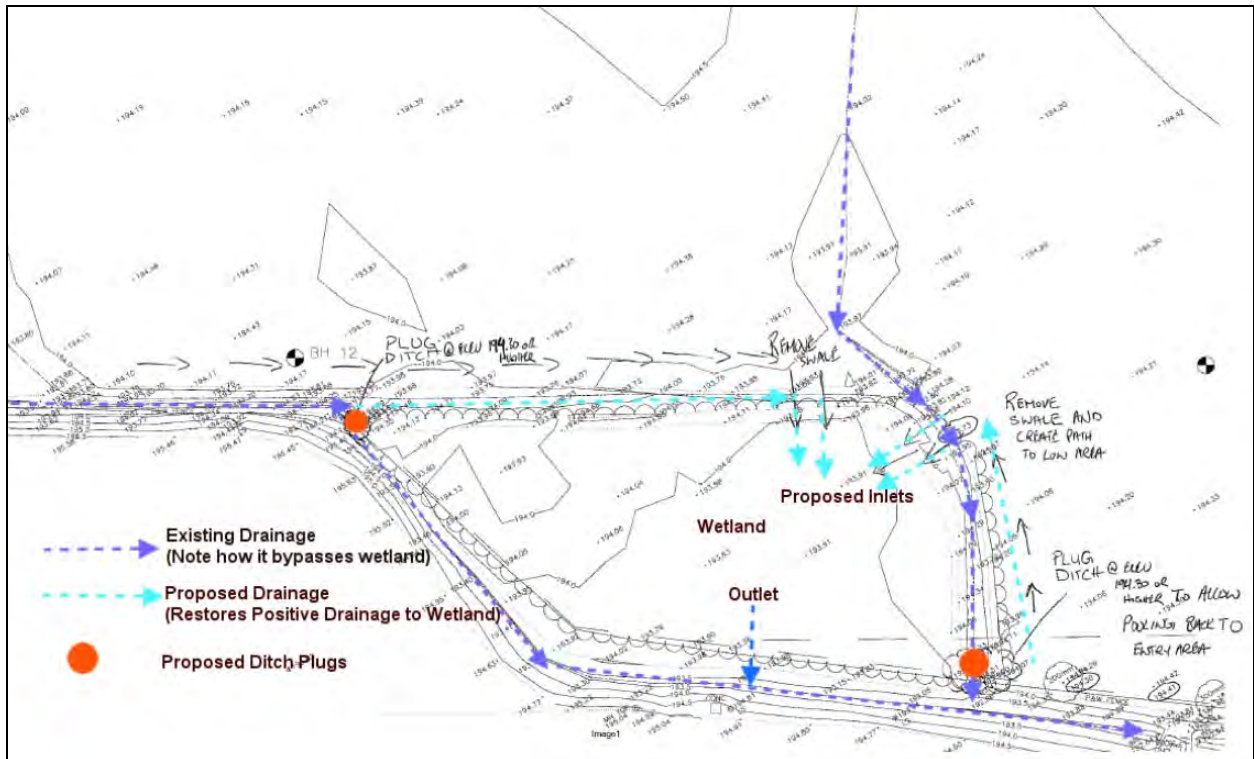
Figure 2. Sketch of proposed drainage modifications to restore wetland hydrology.

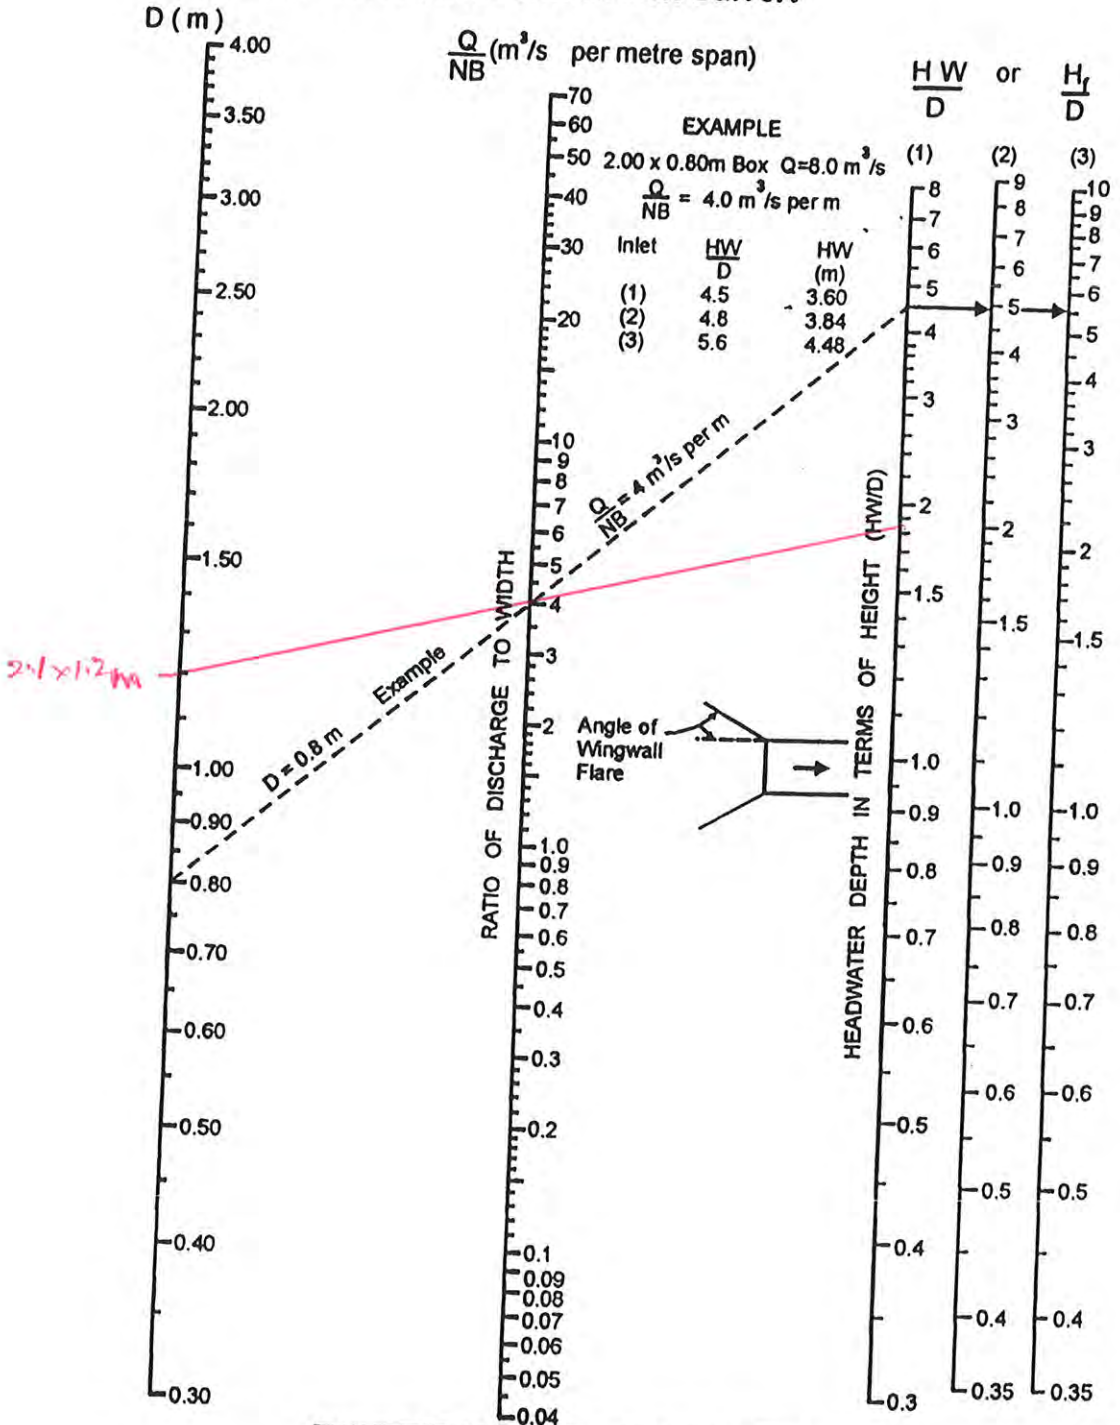
Design Chart 5.39: Inlet Control: Box Culvert

Wingwall Flare	Bevels	HW/D	Scale
30° - 75°	None	1	1*
30° - 75°	Top Bevel	1	1*
90° (headwall)	None	2	2
90° (headwall)	Top & sides	Use chart 5.40	
0° (parallel)	Top Bevel	2	2
0° (parallel)	None	3	3
