**SUBWATERSHED IMPACT STUDY
HALTON HILLS GENERATING STATION**

Prepared for:

TransCanada Energy Limited
In business to deliver

March 2008

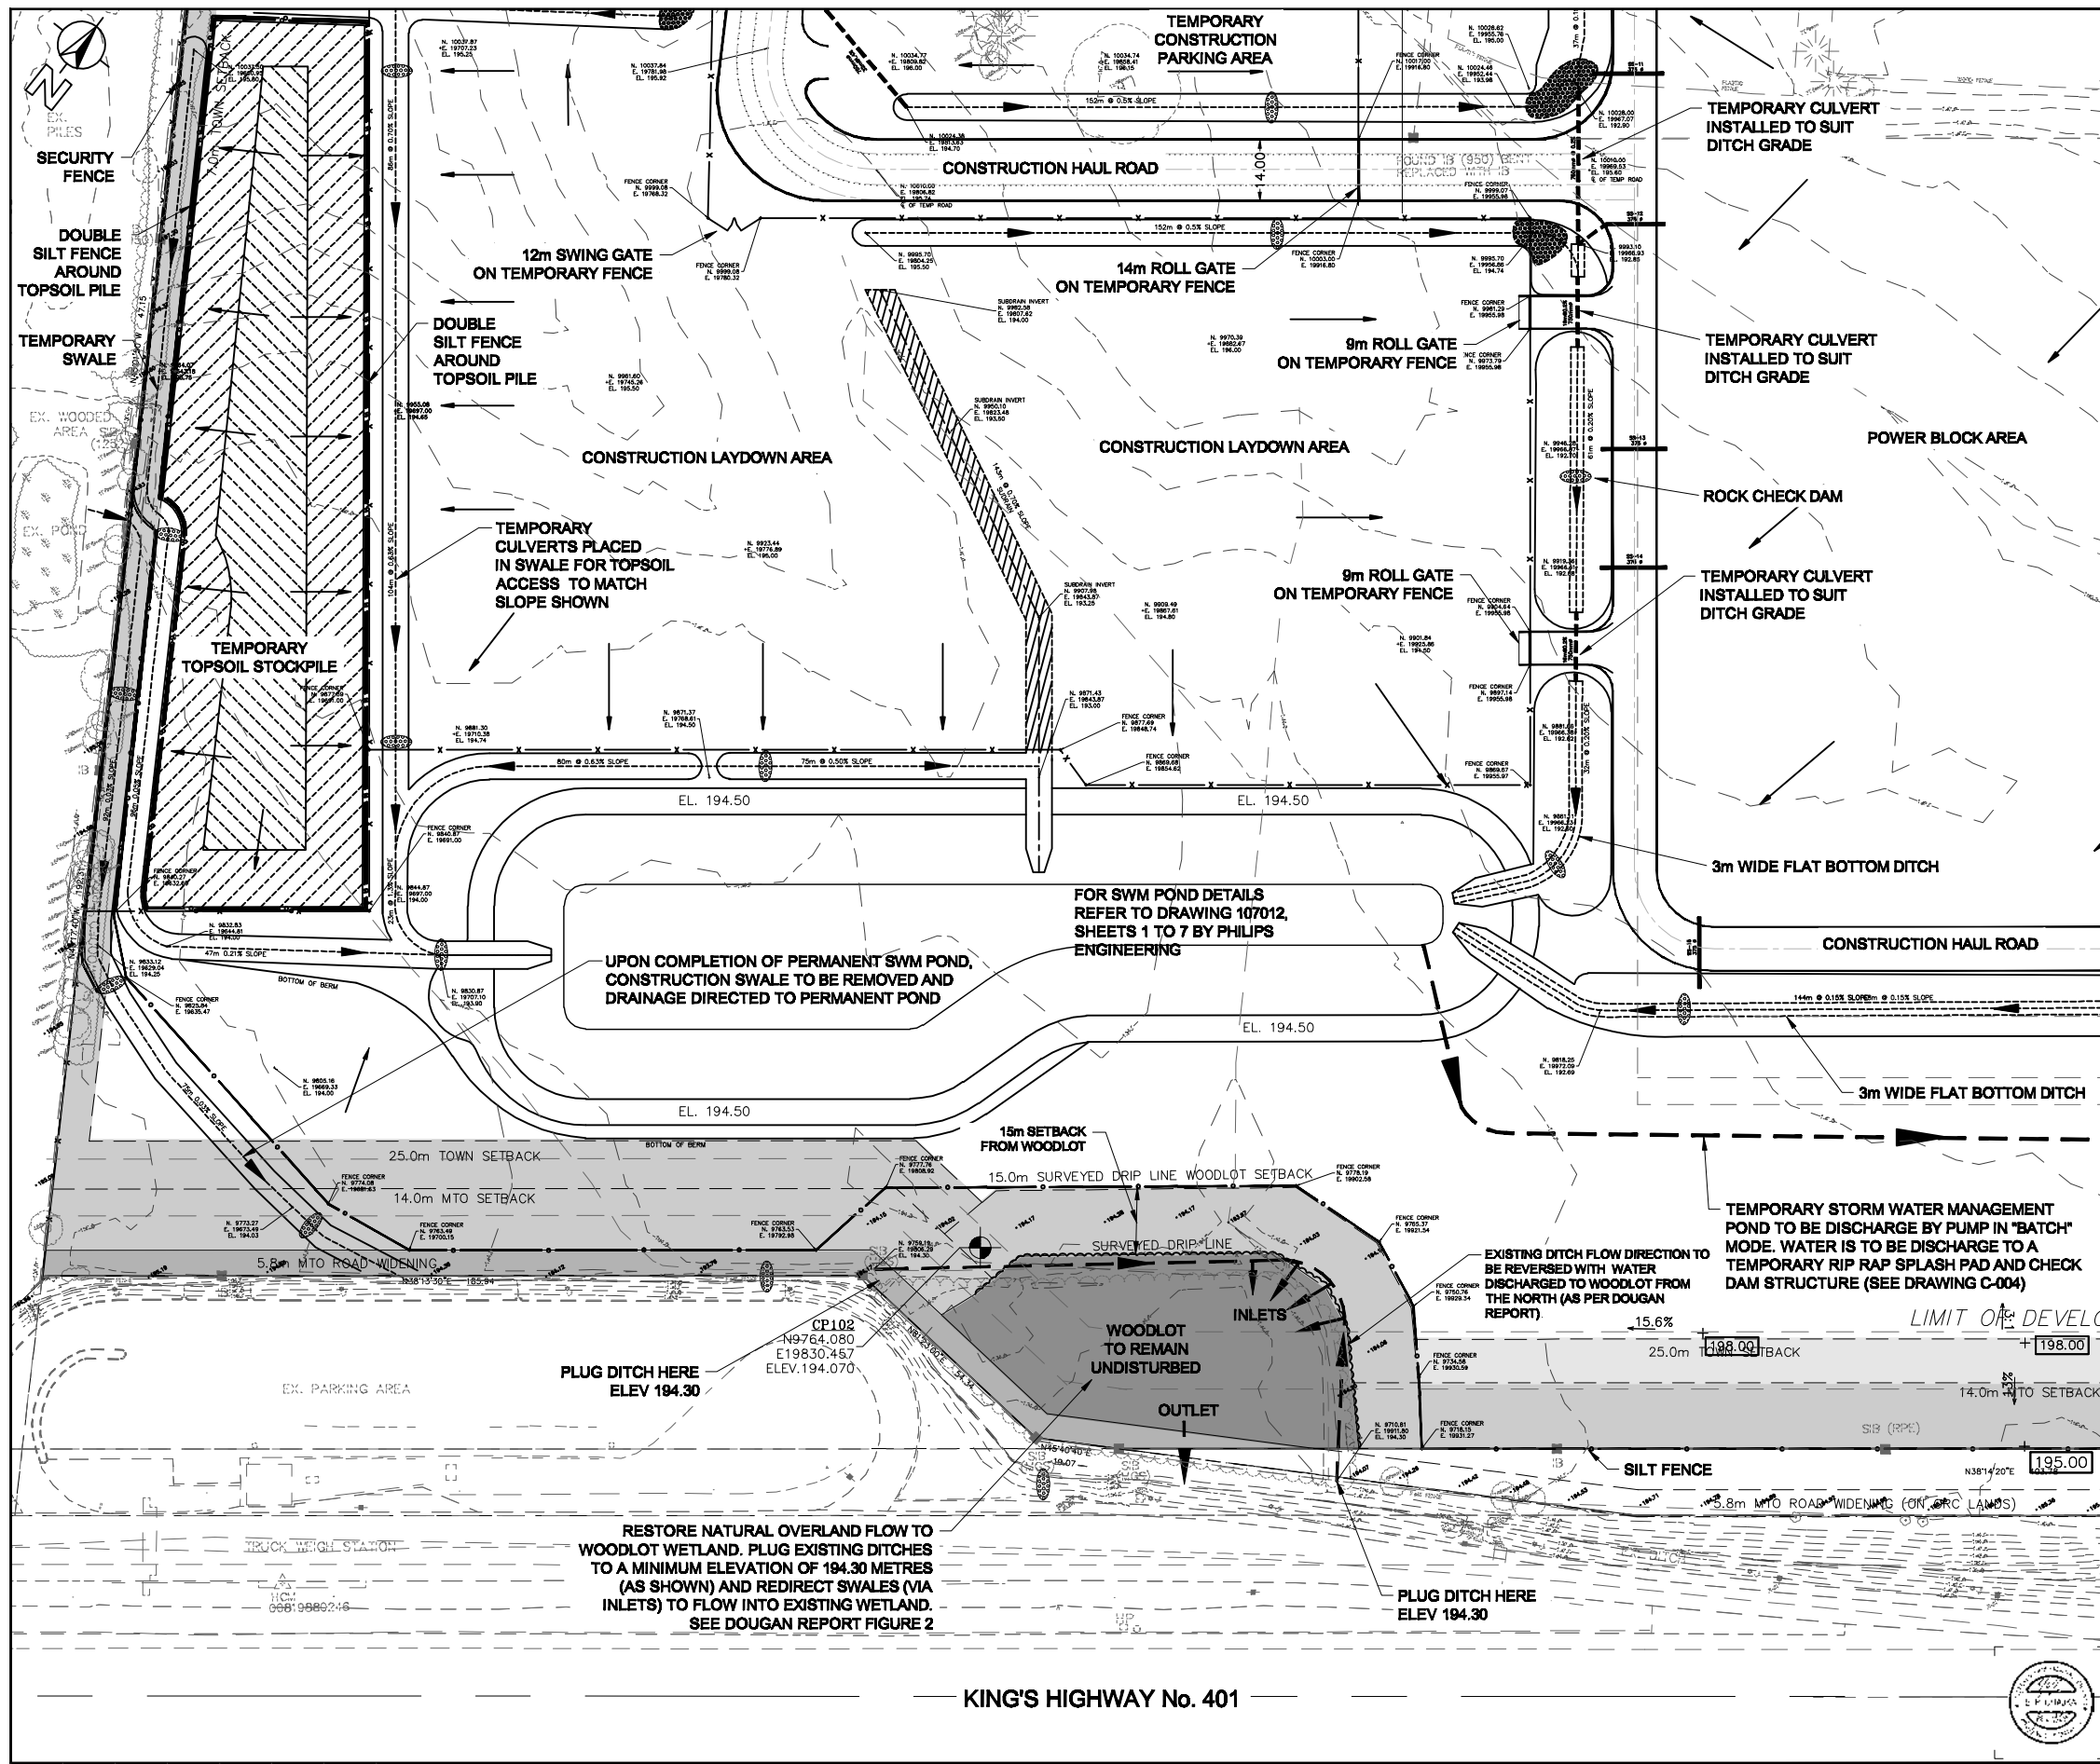
DRAWING No. 234438-C-002

- SEDIMENTATION AND EROSION CONTROL**
- INSTALL ROCK CHECK DAMS IN DITCHES AS PER OPSD 219-211.
 - INSTALL TEMPORARY SILT FENCE, AS PER OPSD 219.110 AROUND PERIMETER OF SITE, APPROX. 1m INSIDE SITE FENCING, AS SHOWN, OR AS DIRECTED BY THE ENGINEER.
 - INSTALL TEMPORARY SILT FENCE AROUND TOPSOIL/SOIL STOCKPILE AREA AS SHOWN.
 - REFER TO DWG. C-009 FOR EROSION CONTROL DETAILS.
 - PLAN (CONSTRUCTION) NORTH SHOWN ON DRAWINGS IS ROTATED 52.7° COUNTER CLOCKWISE FROM TRUE NORTH.
 - TOPSOIL SHALL BE STRIPPED TO INERT SOIL LAYER.
 - TOPSOIL WILL BE STOCKPILED ON SITE (LOCATION INDICATED ON DRAWING C-001).
 - REFER TO DRAWING C-009 FOR INVERTS OF CULVERT AND CATCHBASIN LEADS.
 - DURING CONSTRUCTION OF CONSTRUCTION ACCESS ROADS, INSTALL ALL CATCHBASIN LEADS, BUT NOT THE CATCHBASINS.
 - AREAS TO REMAIN DISTURBED >30 DAYS REQUIRE VEGETATIVE GROUND COVER.
