Town of Halton Hills

Southwest Georgetown Subwatershed Study
VISION GEORGETOWN
Subwatershed Strategy Report
FINAL REPORT

AECOM

May, 2017

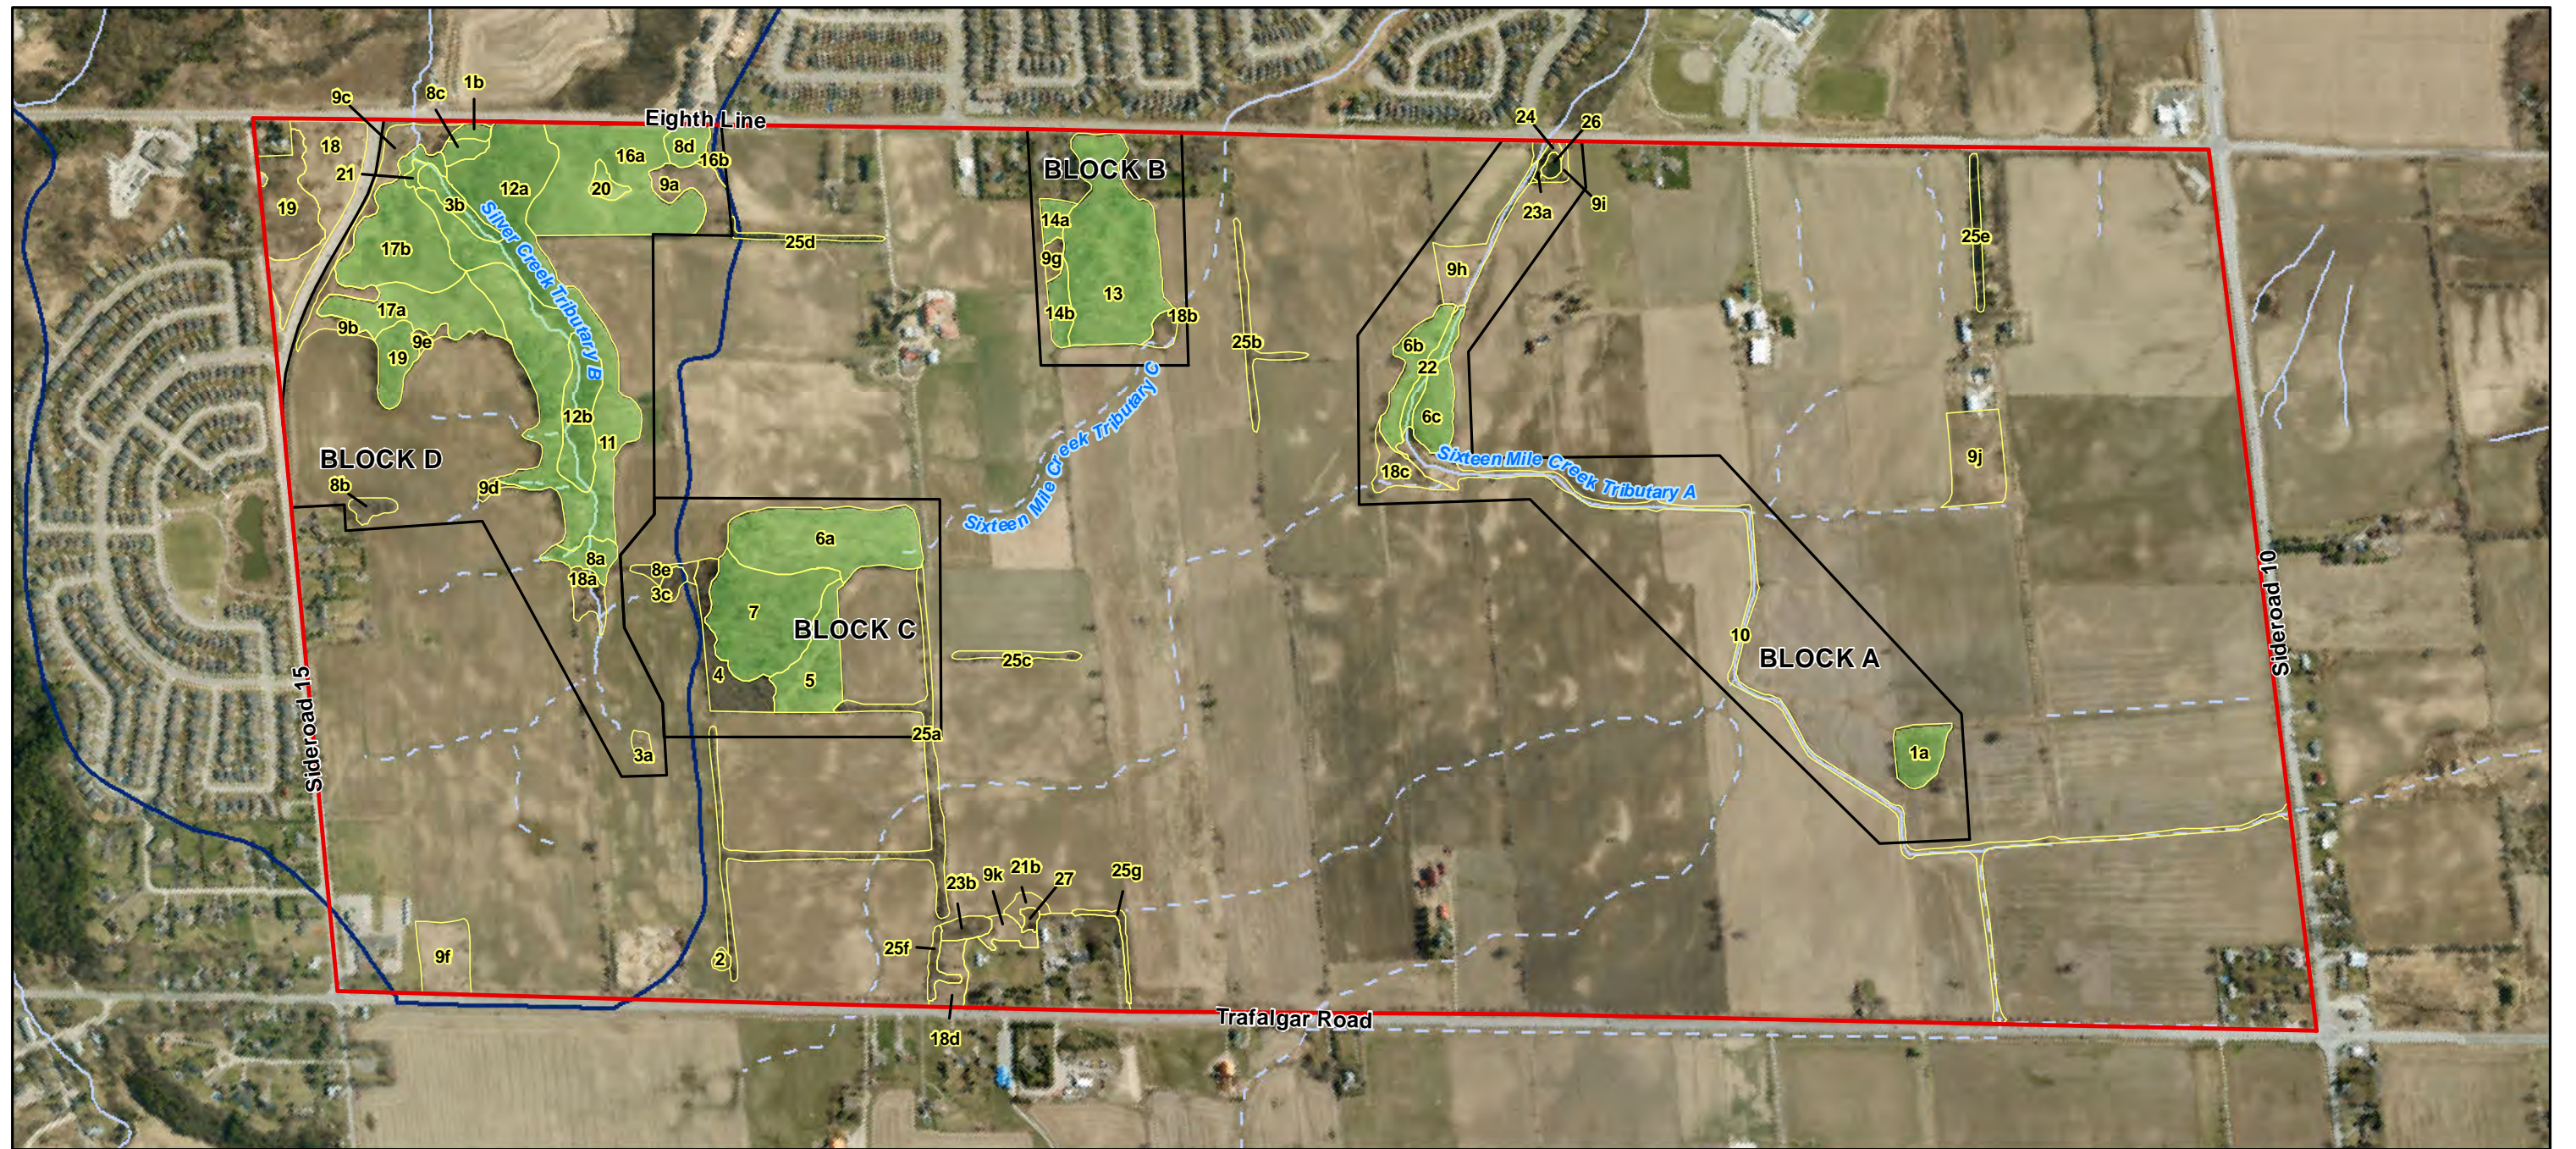
This block includes vegetation communities associated with Tributary A, which originates at the southern corner of the plan area by a small isolated woodland and extends north and east to Eighth Line. This block includes the following vegetation communities:

- Unit 1a: Fresh-Moist Lowland Deciduous Forest (FOD7)
- Units 6b and 6c: Dry-Fresh Sugar Maple-White Ash Deciduous Forest (FOD5-8)
- Units 9h and 9i: Dry-Moist Old Field Meadow
- Unit 10: Reed Canary Grass Mineral Meadow Marsh (MAM2-2)
- Unit 18c: Cultural Thicket (CUT1)
- Unit 22: Fresh-Moist Sugar Maple Deciduous Forest (FOD6)
- Unit 23: Cultural Woodland (CUW1)
- Unit 24: Fresh-Moist Lowland Deciduous Forest (FOD7)
- Unit 26: Open Water Aquatic (OAO)

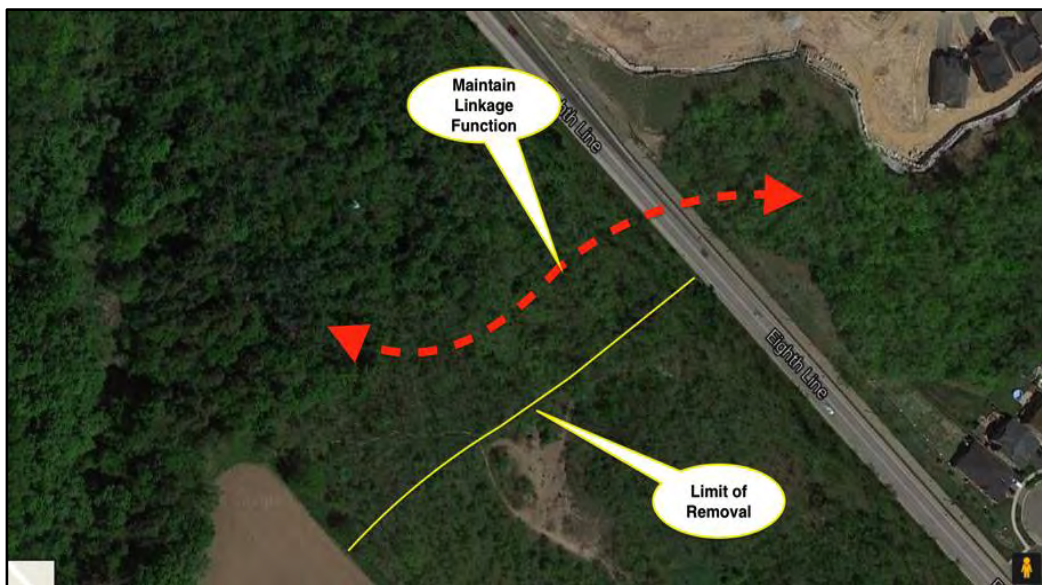
Air Photo D View of maintained linkage function through northern part of Black Locust woodland (Google Earth, 2005)

The significant wetland and hydrological features found in the main Block D are associated with the riparian zone and discharge areas of the valley bottom. The hydrological setting and soils in the Black Locust woodland preclude the development of wetlands, groundwater discharge zones, breeding amphibian habitat, or a watercourse. With the exception of the northern limit the Black Locust woodland (which is proposed to be retained) the area does not provide surface drainage to the watercourse as the lands slopes away from the valleyland. The woodland is dominated by edge habitat and therefore does not support forest interior (>100 m from woodland edge).

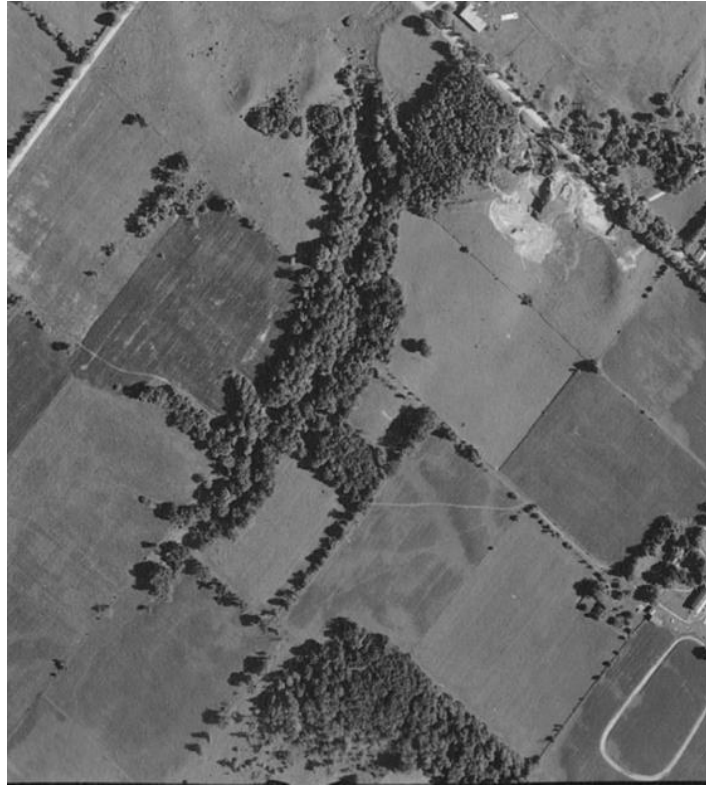
Air Photo E 1965 view of area between Block C and D

A series of historic and current air photos have been compiled to review the extent and types of changes in woodland cover and agricultural uses in the area between the Block C and D woodlands. This spans a time frame of over 50 years from 1965 to 2016 (see **Air Photos E to H**) and provides important context to reviewing past and current ecological linkage functions between the two woodlands. From the 1965 and 1972 air photos it is evident that within at least the past 50 years there hasn't been a woodland area that directly connects Block C and D. Rather, there was an extension of woodland along the southeast side of Block D approximately 150 m from the linkage area. Additionally, there were two hedgerows located between the two Blocks (see **Air Photo E, F and G**). Based on the air photo review, the woodland extension and hedgerows were present up to at least 2004. Agricultural practices have been ongoing within the majority of the area between Block C and D from at least 1965 to present day. The enhancement between Block C and D as proposed in the subwatershed study is therefore a substantial improvement compared to the historic and existing conditions identified through the subwatershed study.
