Phase I Environmental Site Assessment 130 Mountainview Road North, Georgetown, Ontario

Project No. 0082-002.01

February 28, 2022

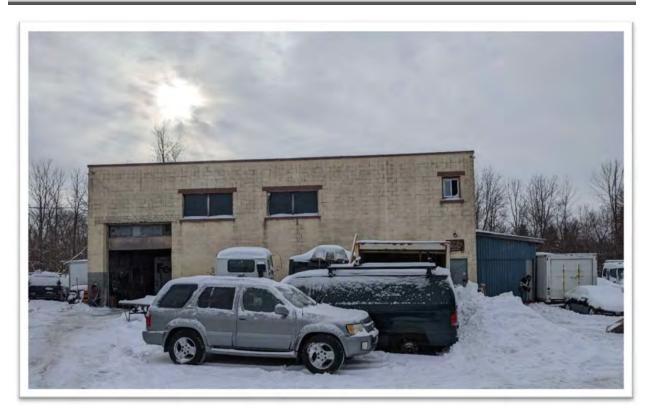
Photo 1: The Site exterior, facing south, front of the building.

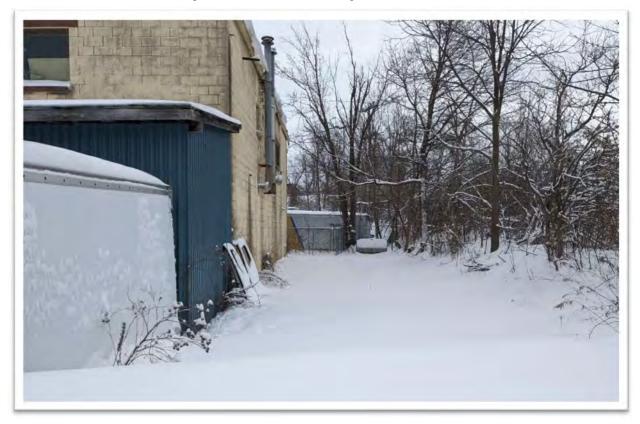
Photo 2: The Site exterior, south side of the building, aboveground storage tank located behind the building.

Aboveground storage tanks / fill and vent pipes	Based on the interview conducted, petroleum products were historically stored on-site in ASTs.
	A 200 L disused metal storage tank located on the south side of the building.
Belowground storage tanks / fill and vent pipes	None observed or reported by the Site Representative.

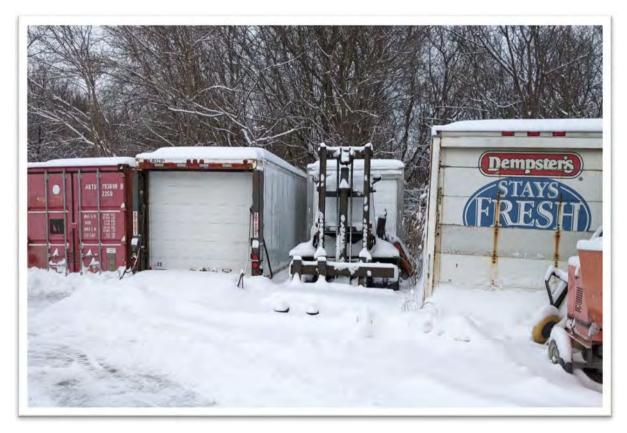
Photo 3: The Site exterior, facing west, shipping crate and truck storage that is rented out.

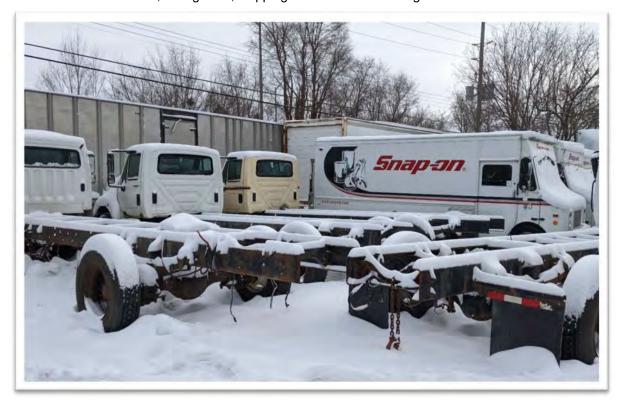
Photo 4: The Site exterior, east side of the property, truck storage and parking.

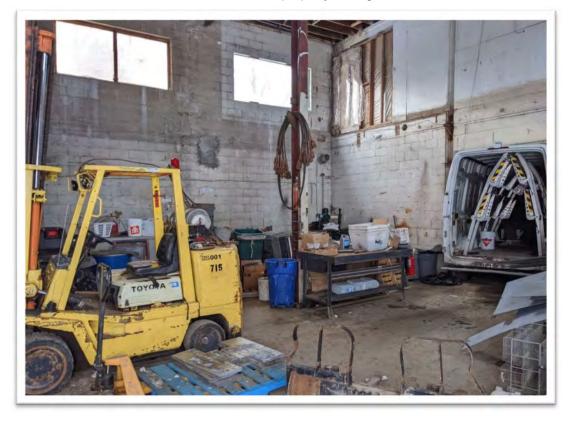
Photos 6: The Site interior, oily staining on cement flooring inside the bay door of the building.

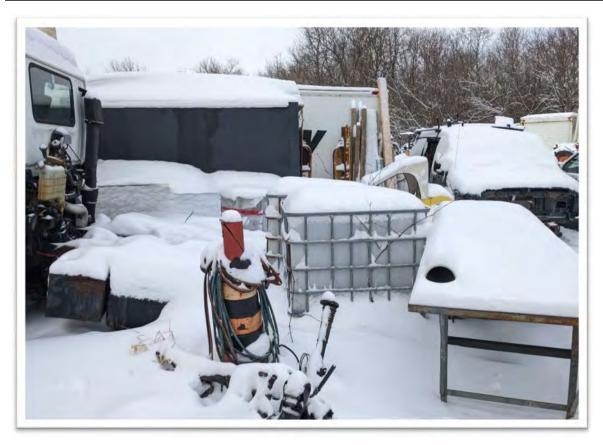
Photo 7: The Site exterior, north side of the building facing west; storage area with four 1000 L totes.

Chemicals and hazardous materials	None observed or reported by the Site Representative.
Unidentified substances	None observed or reported by the Site Representative.
Hazardous wastes	None observed or reported by the Site Representative.
Non-hazardous wastes	None observed or reported by the Site Representative.
Drums, totes and/or pails	$4 \times 1000 L$ empty totes located on the north side of the building and $3 \times 205 L$ empty lidless drums located on southwest side of parking area; the use of the totes and drums are not known.

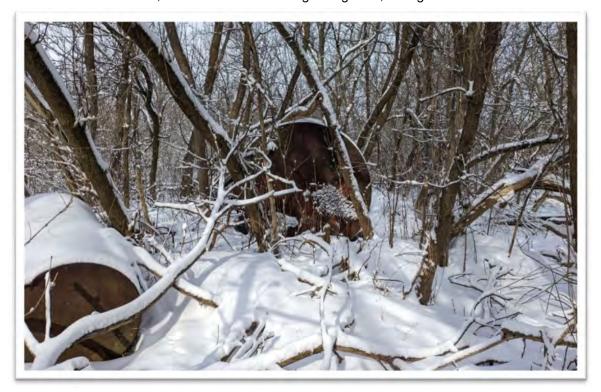
Photo 8: The Site exterior, center of the wooded area facing northwest; two discarded vessels/tanks.

- 5. Fill material and debris: A berm of fill material and fill piles were observed during the Site visit along the railway tracks near the south property boundary and in the southwestern portion of the of the property, respectively; metal debris consisting of a former storage vessel and storage tank discarded in the south central area of the Site.

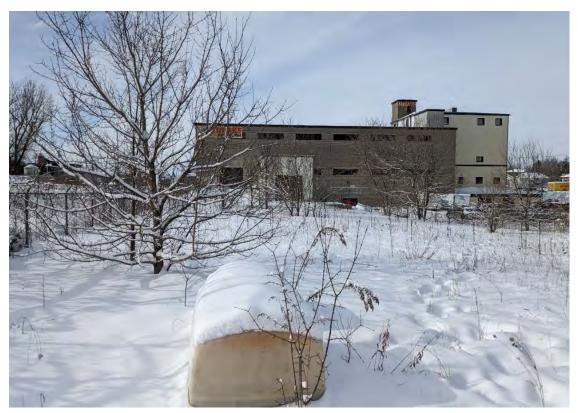
Photo 9: The Site exterior, southwest corner of the property; Adjacent property to the west, A-Plus Canada Inc. Self Storage, in the background and two 200 L plastic storage tanks located in the foreground.

Fill material and debris	Berm of fill material located along the railway tracks on the south side of the property and further fill piles in the southwest area of the Site.
	The following debris was noted:
	2 x 200 L plastic storage tanks located on the southwest side of the property along the railway tracks.
	1 x approx. 30,000 L scrap metal vessel discarded in the wooded area in the south central part of the Site.
	1 x approx. 3,000 L scap metal storage tank discarded in the wooded area in the south central part of the Site in proximity of the above vessel.
Pits and lagoons	None observed.
	Historical aerial photographs and interviews indicate former industrial lagoons were present in the now wooded area; evidence of historical lagoons were not observed.
Water courses, ditches or standing water	Low-lying areas within the wooded area were present.
Parking facilities	Surface parking for cars and trucks located around the south and west of the building.
