**Final**  
**HYDROGEOLOGICAL INVESTIGATION REPORT**  
**PROPOSED DEVELOPMENT AT 159 CONFEDERATION STREET,**  
**TOWN OF HALTON HILLS, ONTARIO**

Project: SP23-01265-00  
August 26, 2024

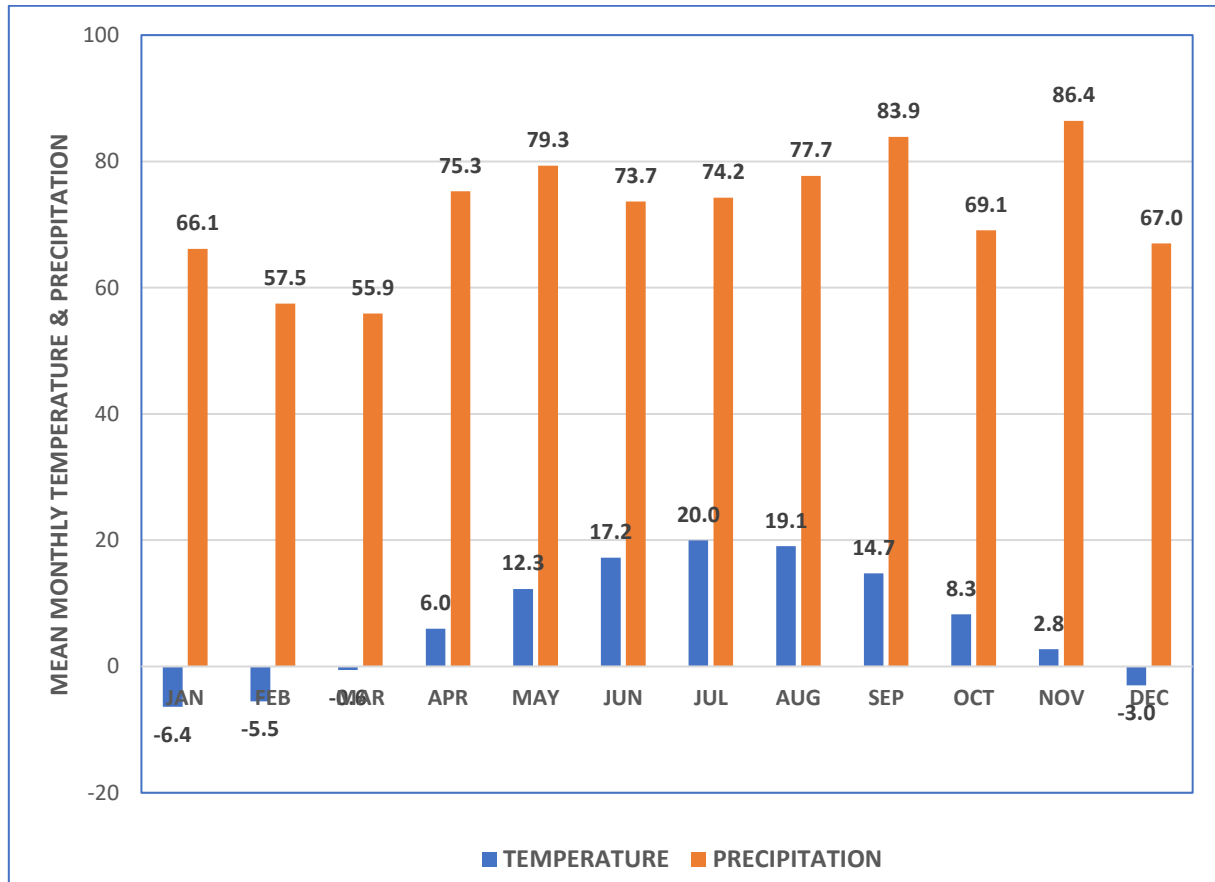
**Figure 11-5: Mean Monthly Average Temperature and Precipitation at the Site**

Average monthly variations of both temperature and precipitation were calculated for the period from 1979 to 2006 (27 years) and is presented below in Figure 11-5. The highest average temperature was recorded in the month of July, while the highest precipitation was in the month of November.

Based on the data for the precipitation and temperature, actual evapotranspiration was estimated to be about 529 mm/annum using the USGS Thornthwaite Monthly Water Balance software (Appendix F), and the average annual precipitation was recorded to be 898 mm/annum.

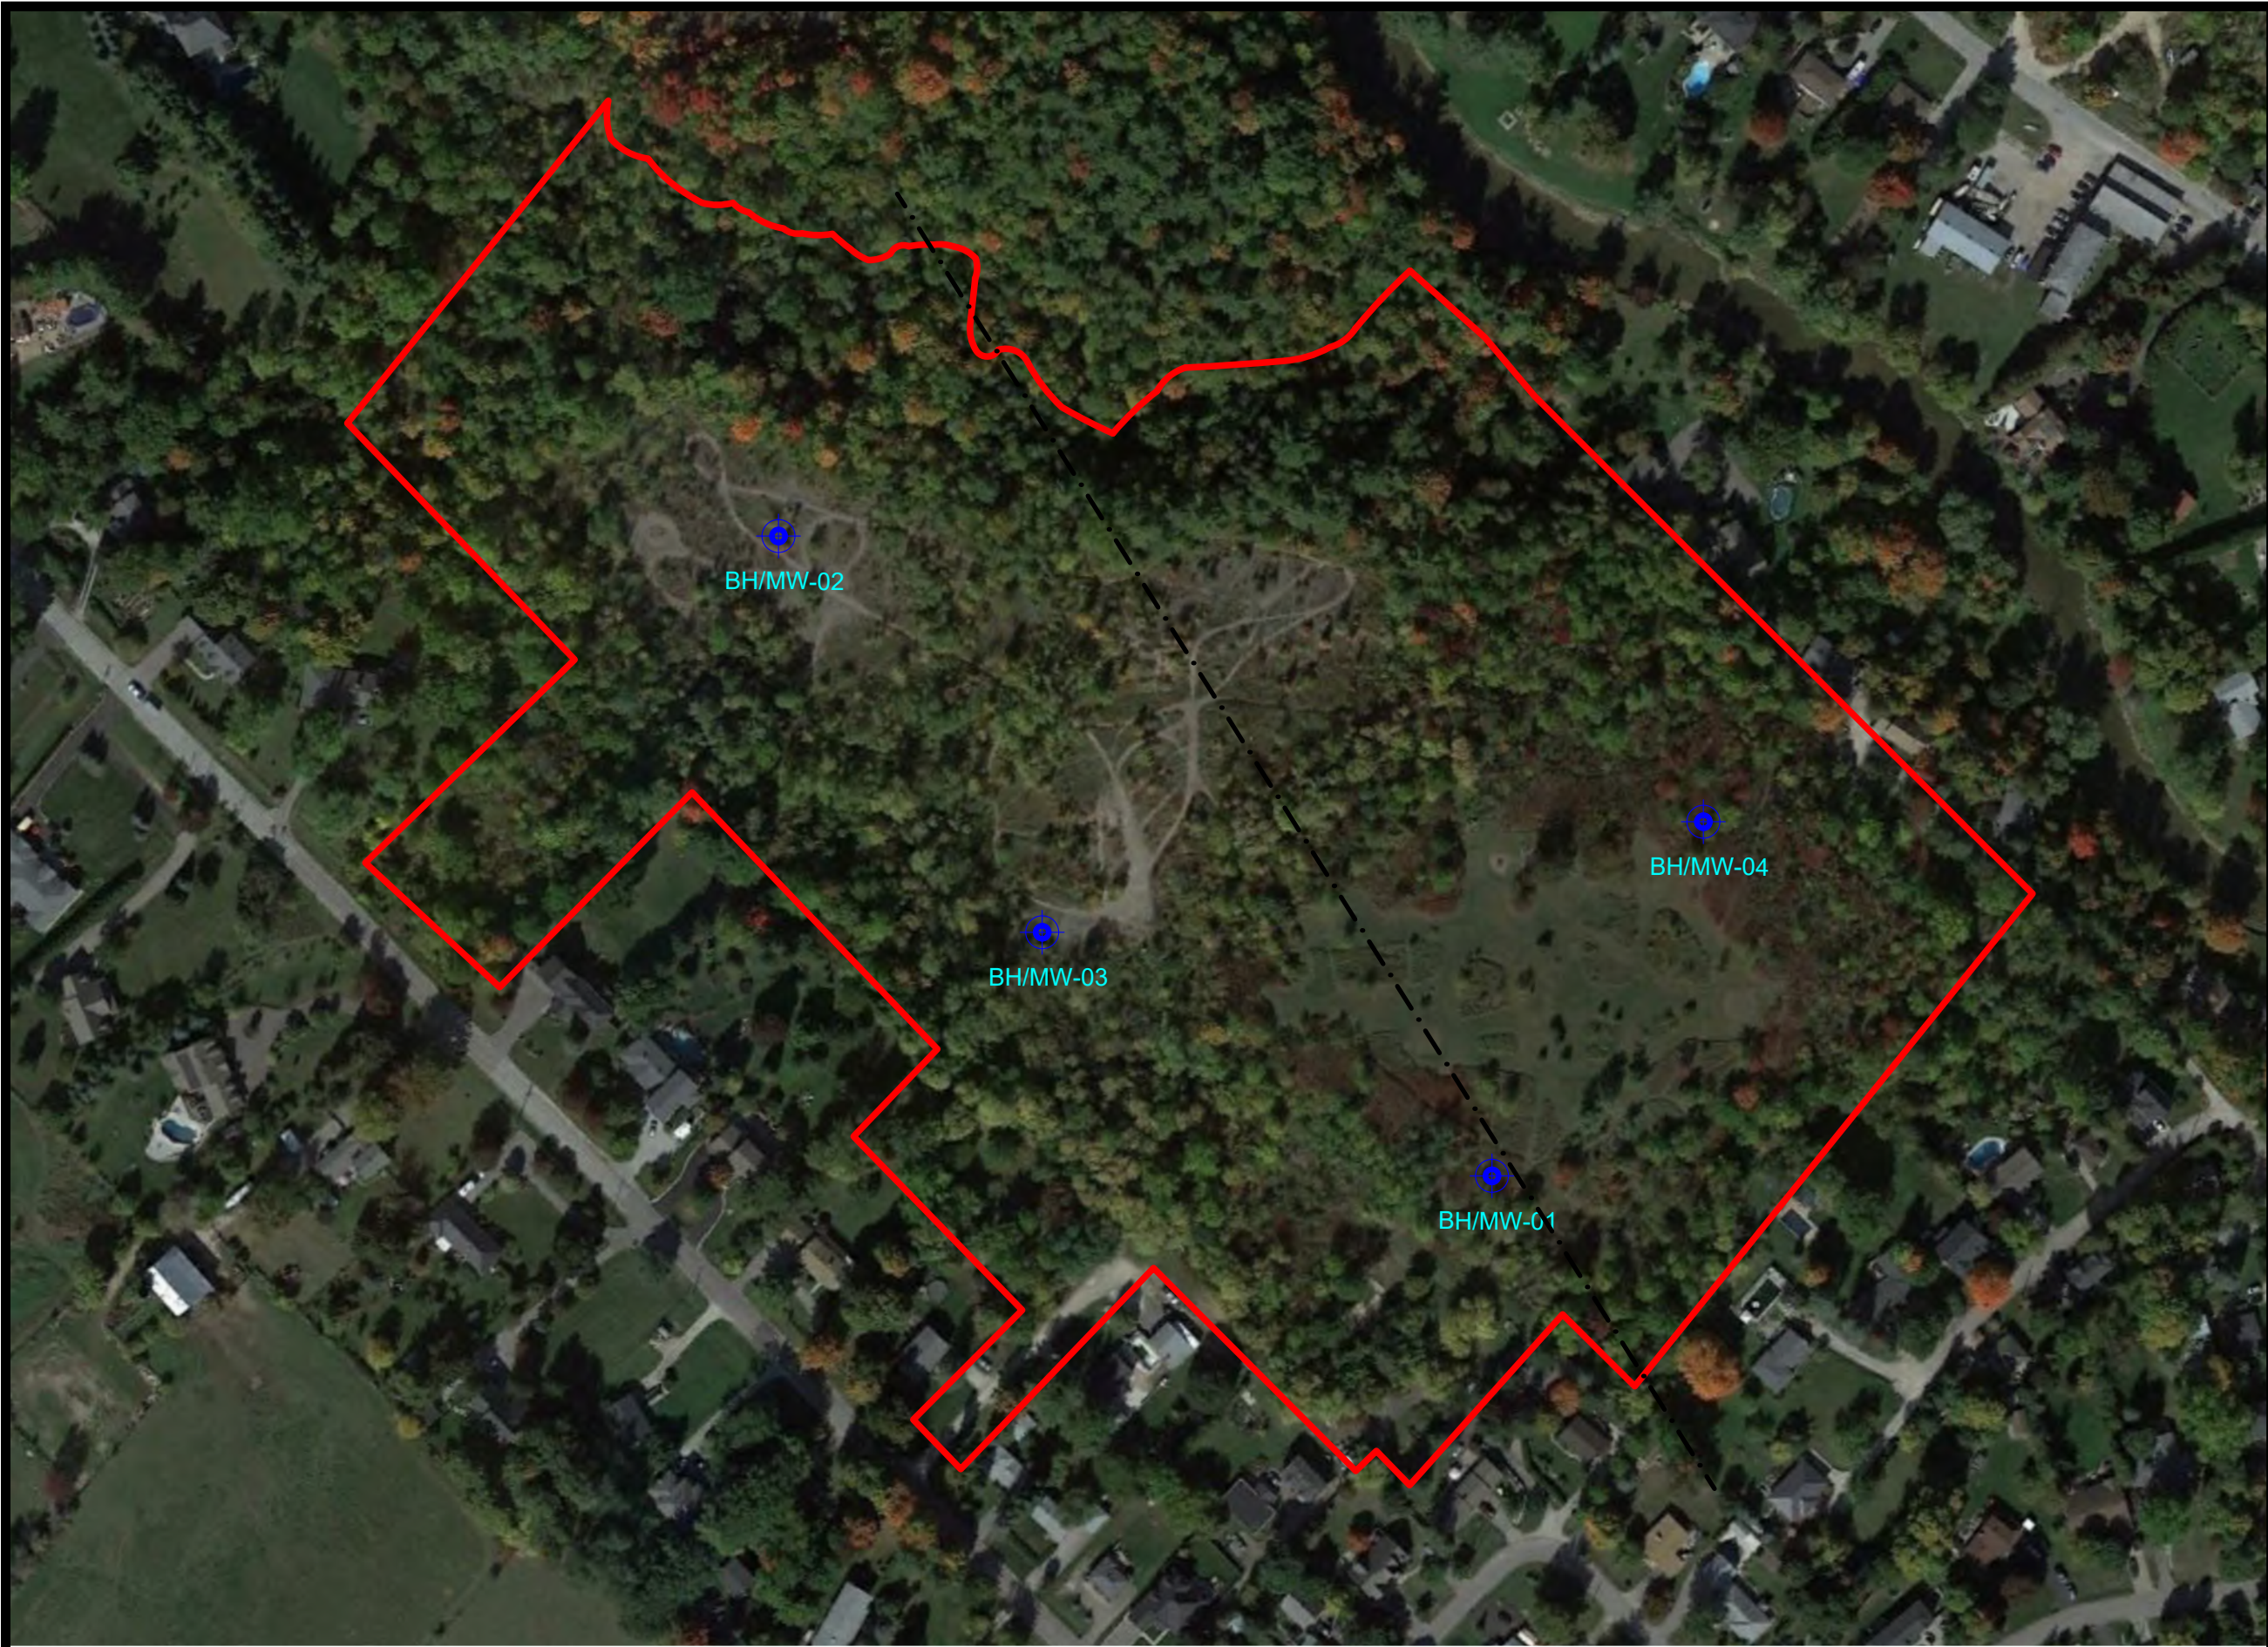
<b>Date:</b> February, 2024	<b>Figure Number:</b> 2
--------------------------------	----------------------------

Figure 2 – Borehole/Monitoring Well and Cross Section Location Plan

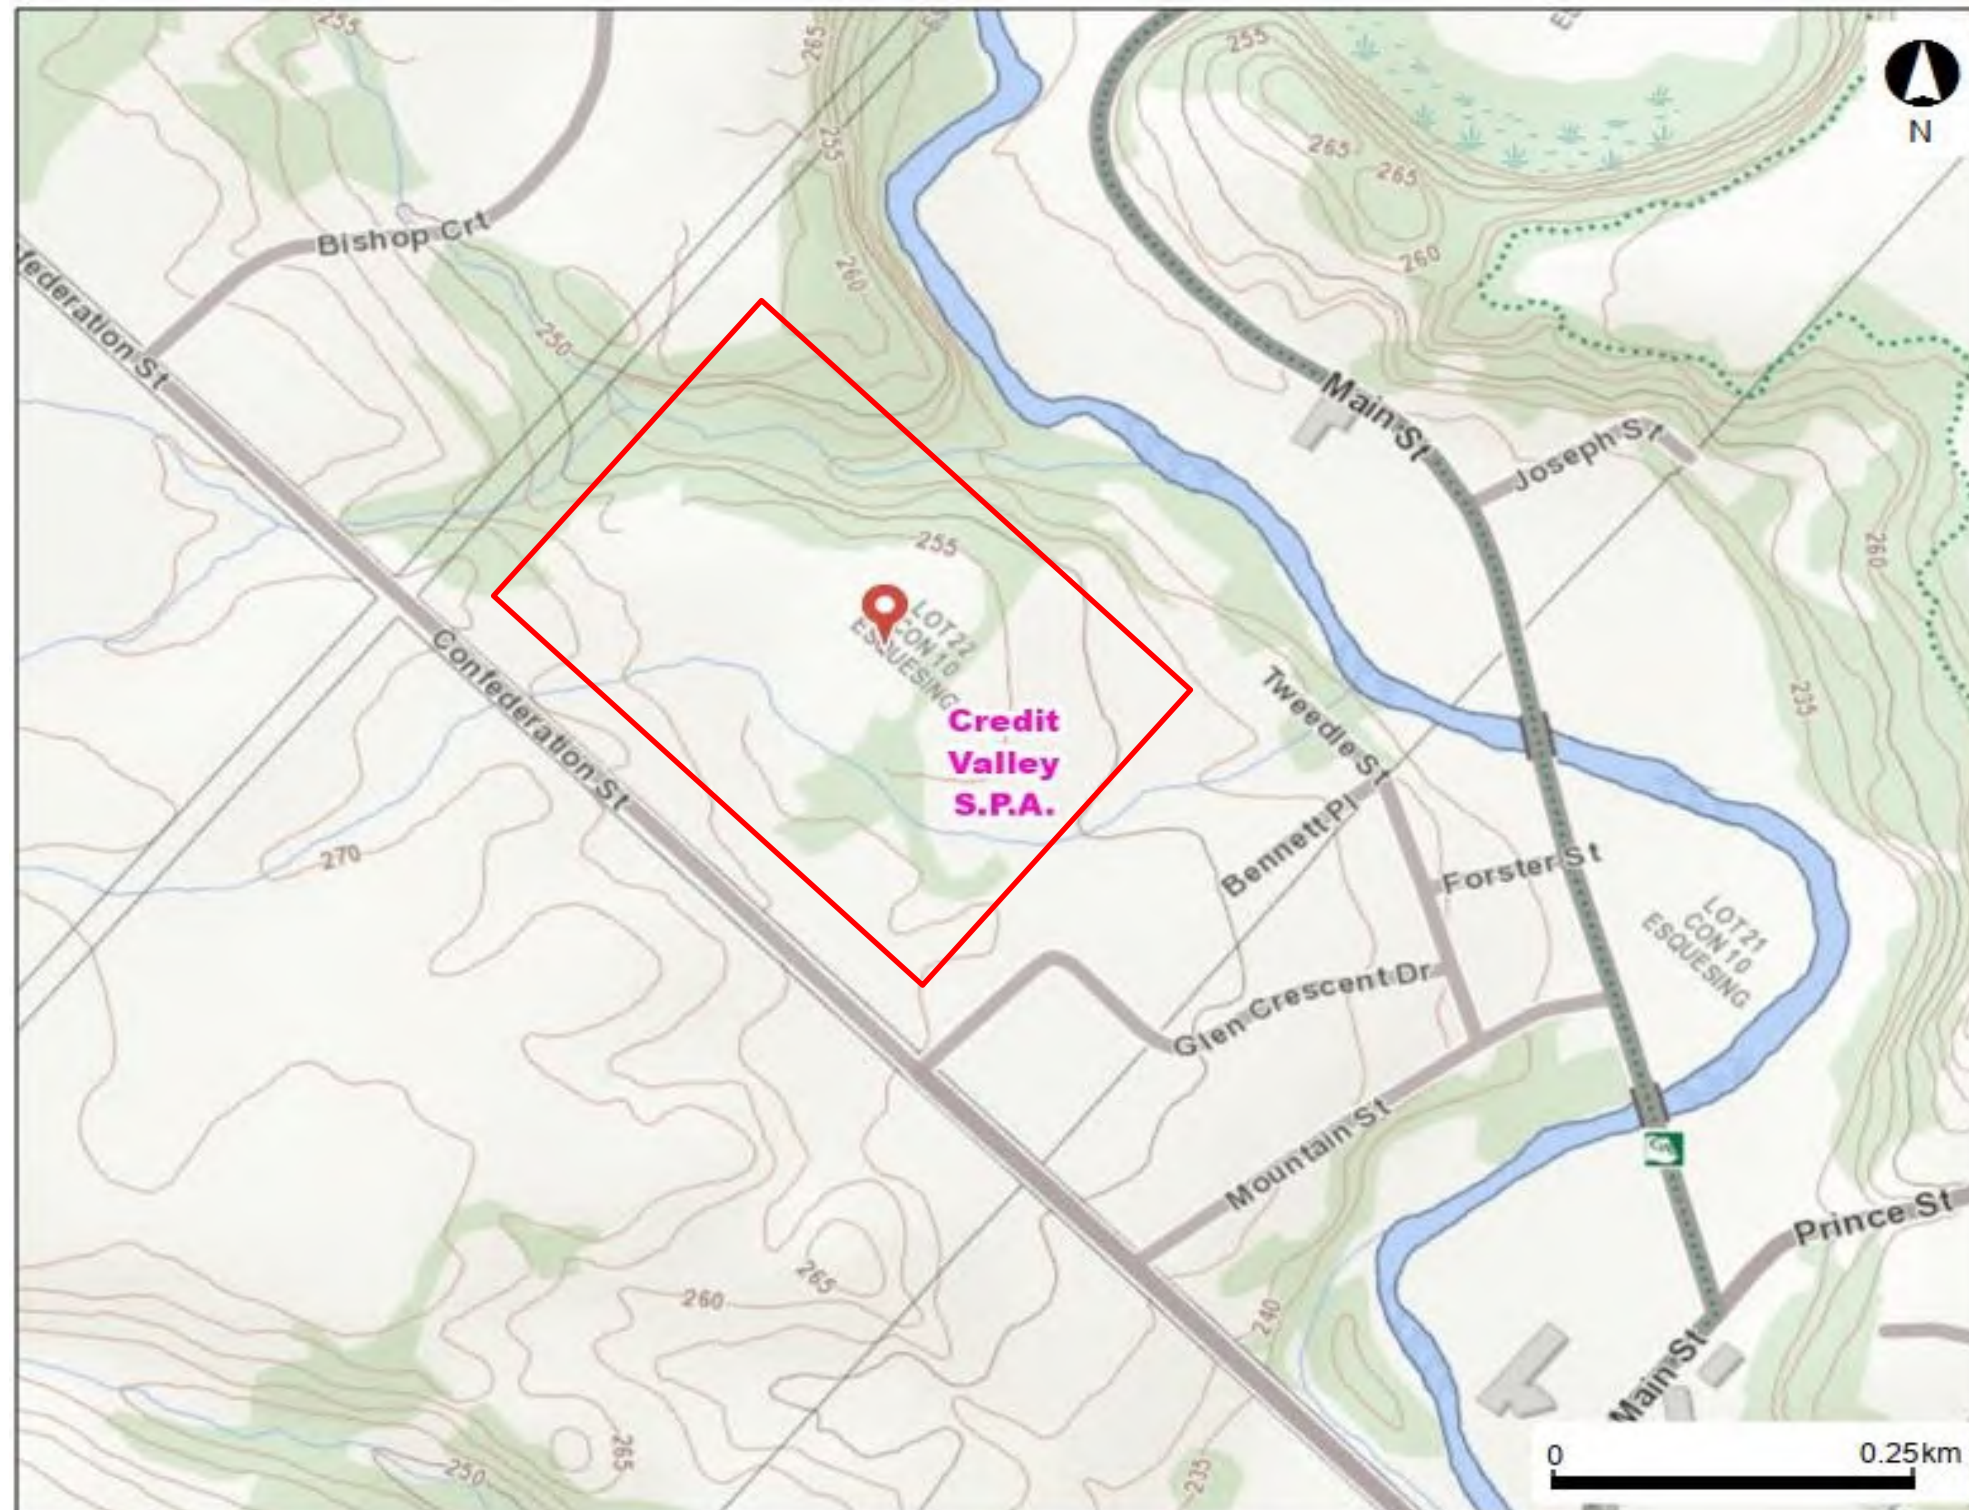
Legend

-   Issue Contributing Areas
-   WHPA-E
- Wellhead Protection Area
-   A
-   B
-   C
-   C1
-   D
-   F
-   Intake Protection Zone 1
-   Event Based Areas
-   Intake Protection Zone 2
-   Source Protection Areas

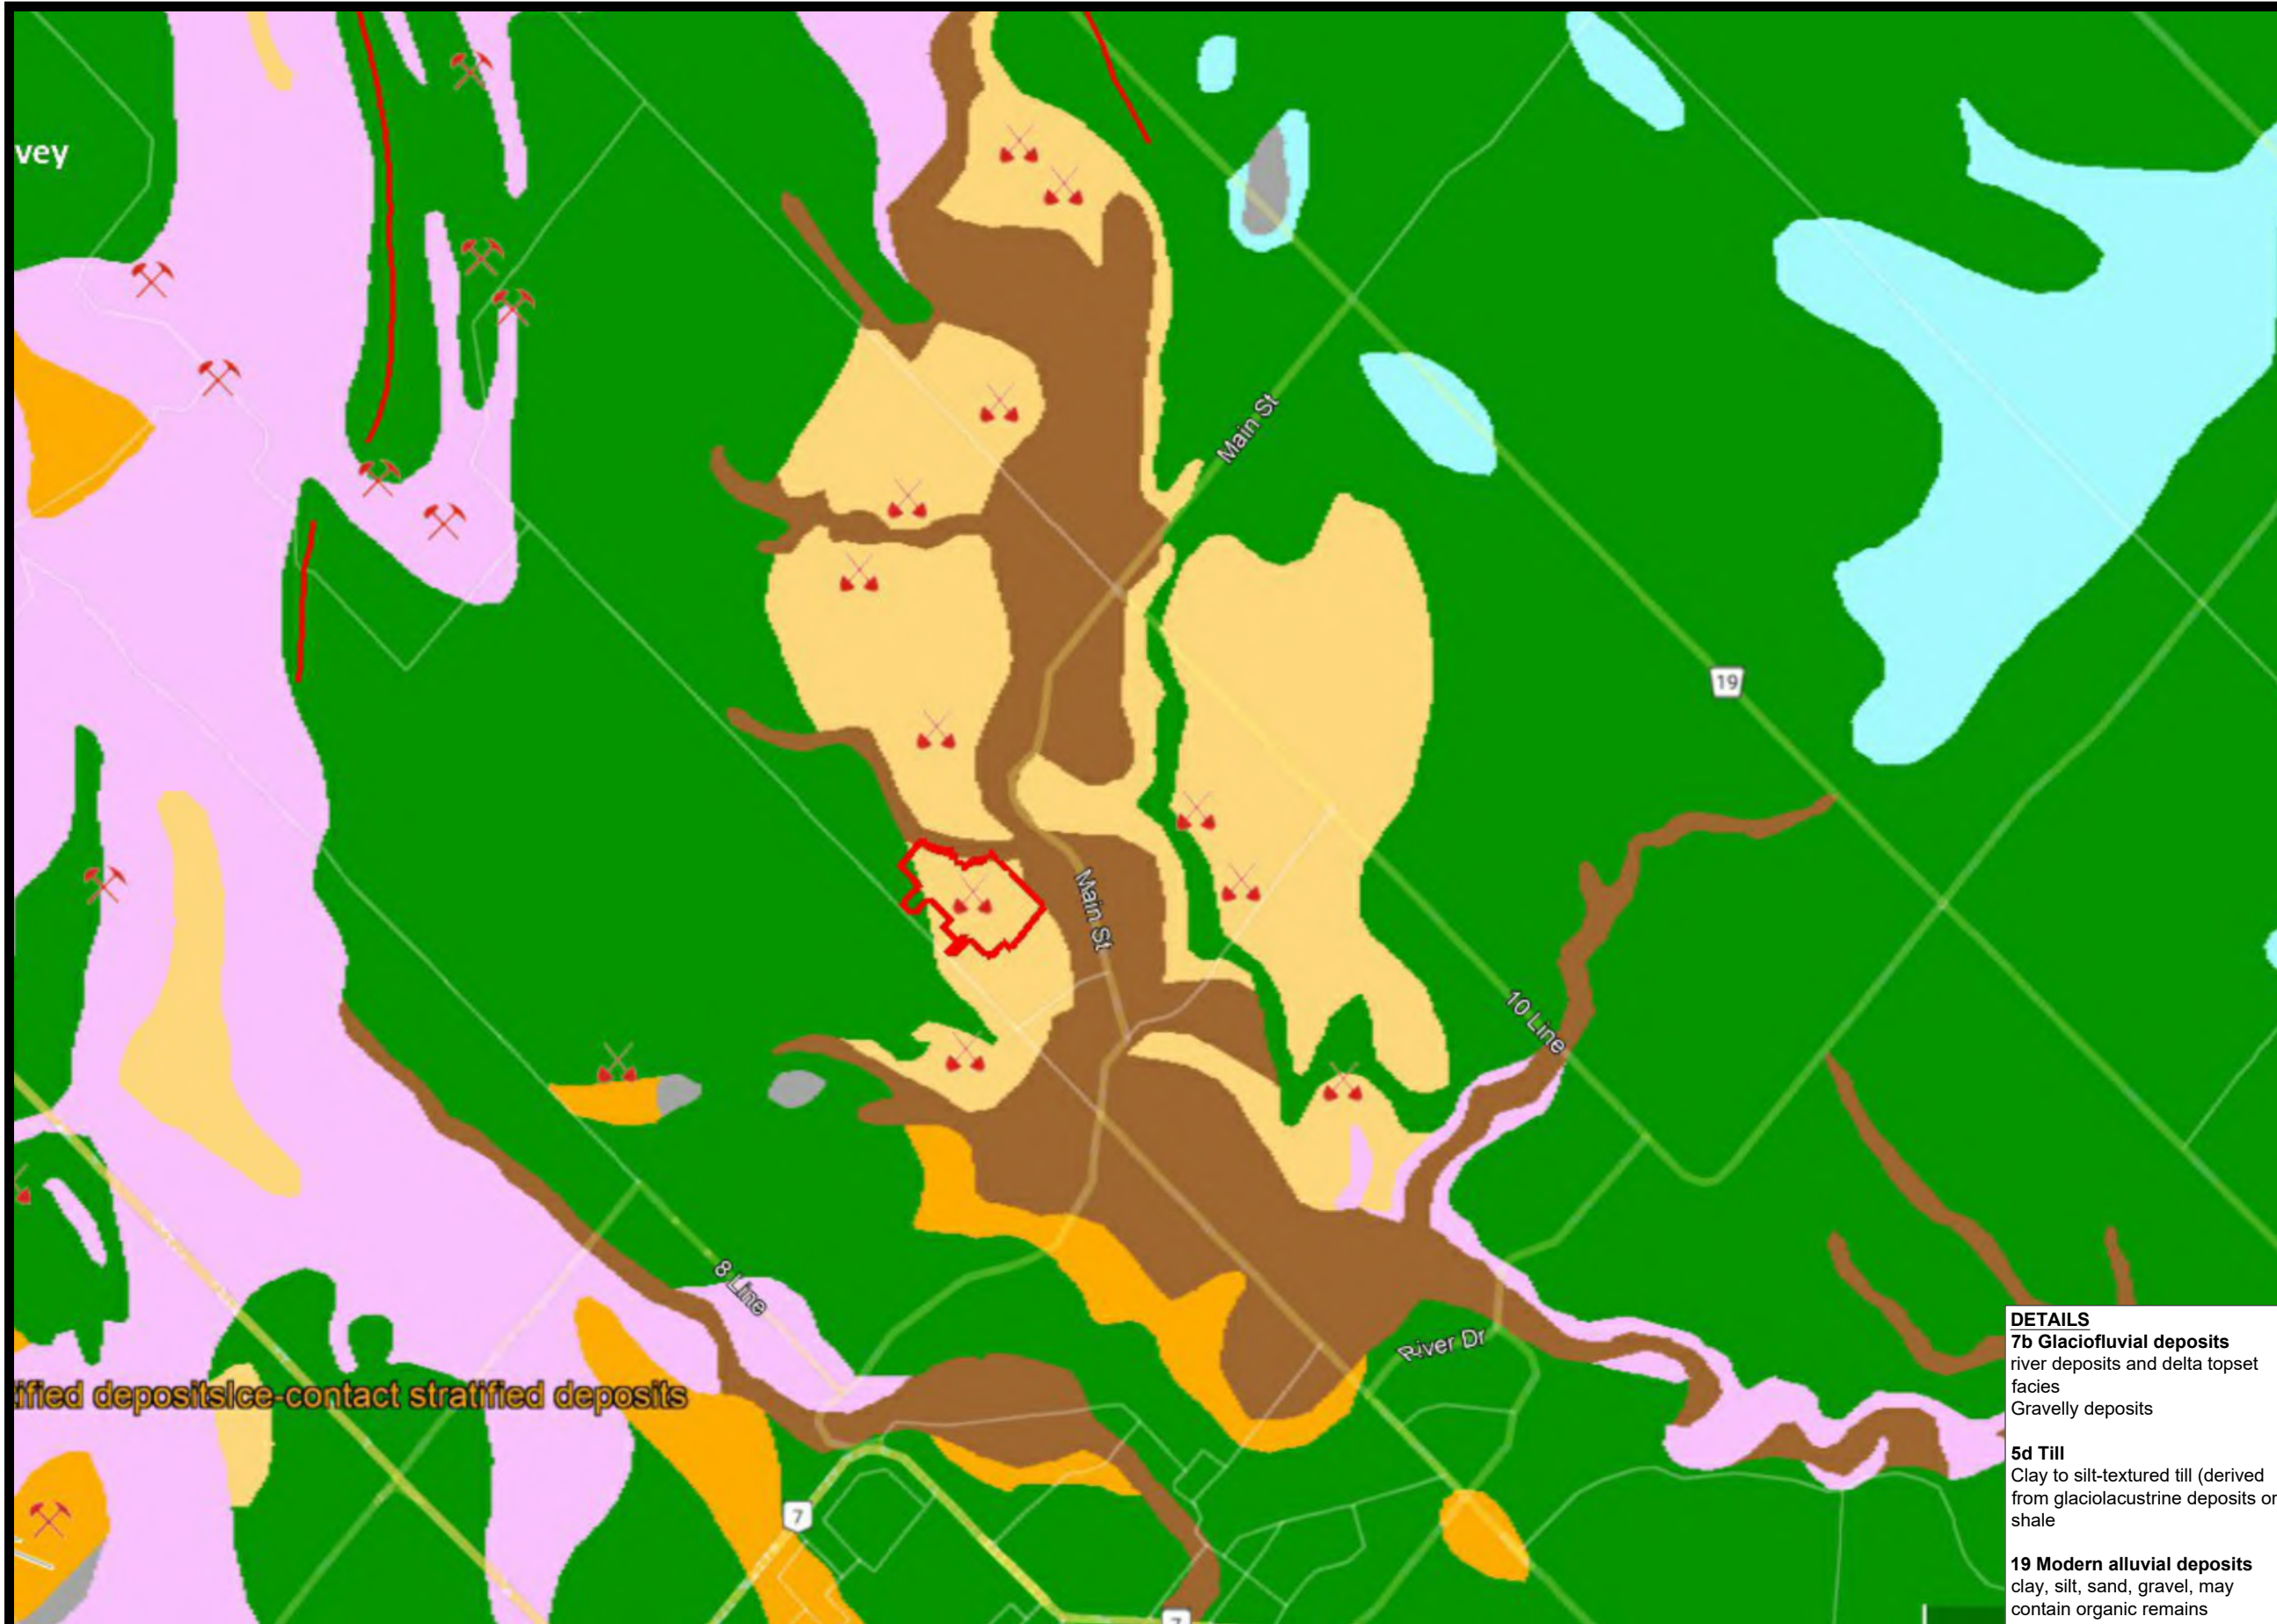
- Legend:**
- Approximate Property Boundary
  - 7** Glaciofluvial deposits: river deposits and delta topset facies  
 7a Sandy deposits  
 7b Gravelly deposits

- 6** Ice-contact stratified deposits: sand and gravel, minor silt, clay and till  
 6a In moraines, eskers, kames and crevasse fills  
 6b In subaquatic fans
