Town of Halton Hills Heritage Conservation Award

Owner and Restorer, 36 Edith Street

1 - Goal and Purpose

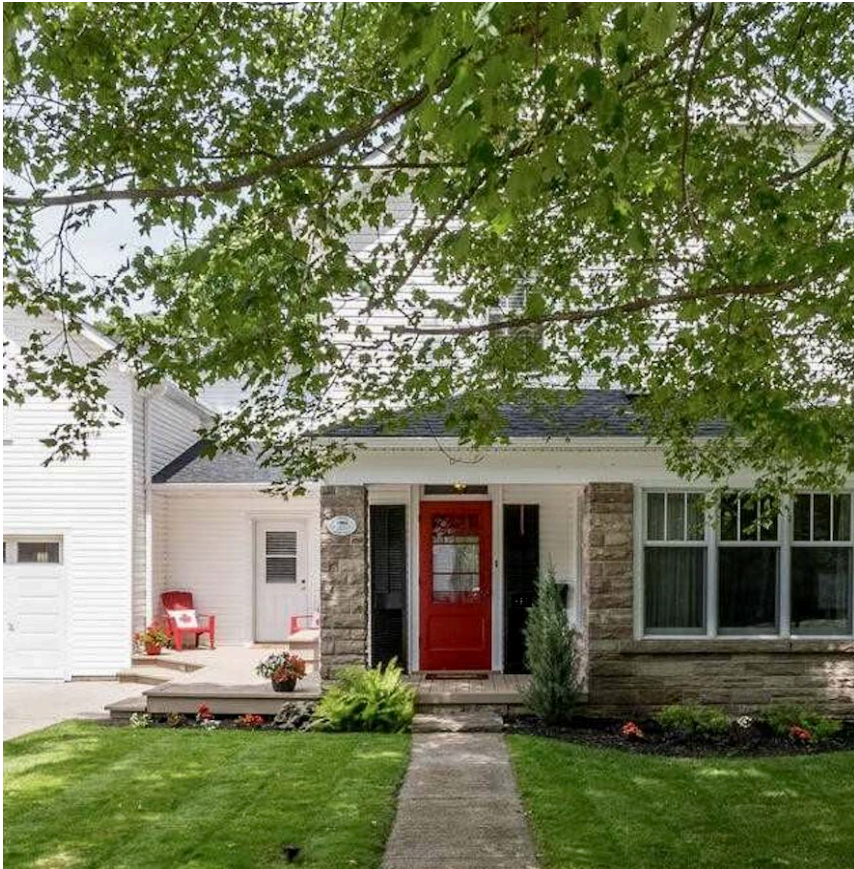
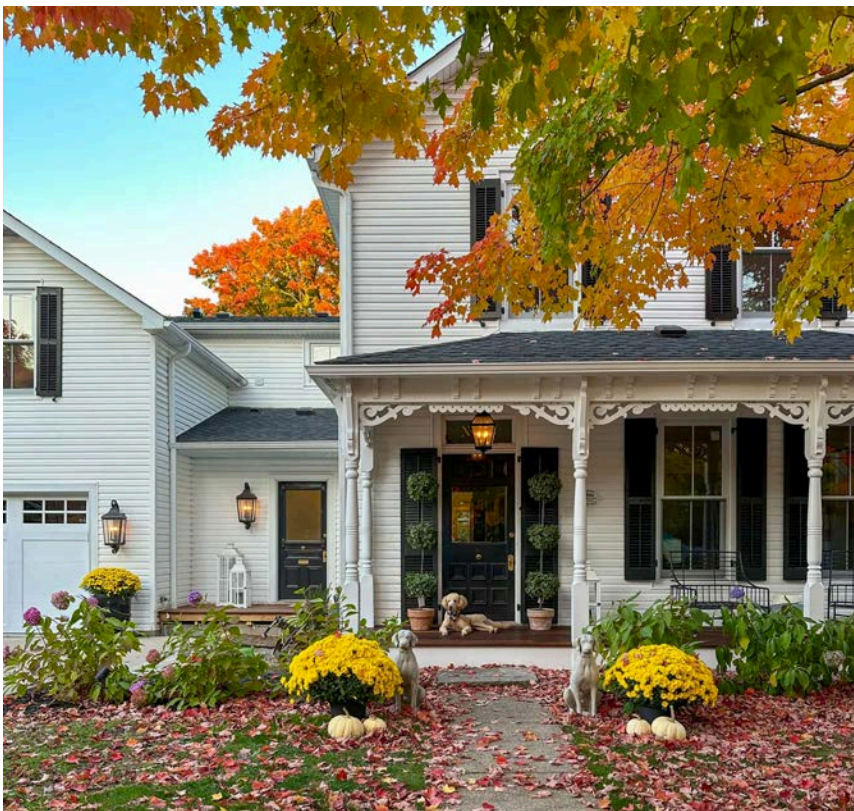
I. Before and after the restoration, as seen standing on Edith Street looking East toward 36 Edith Street

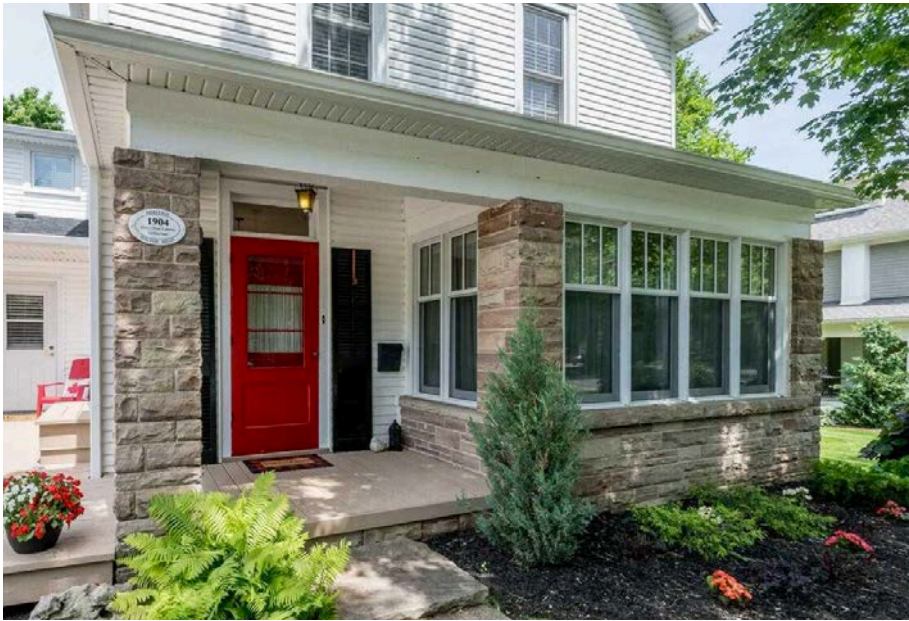
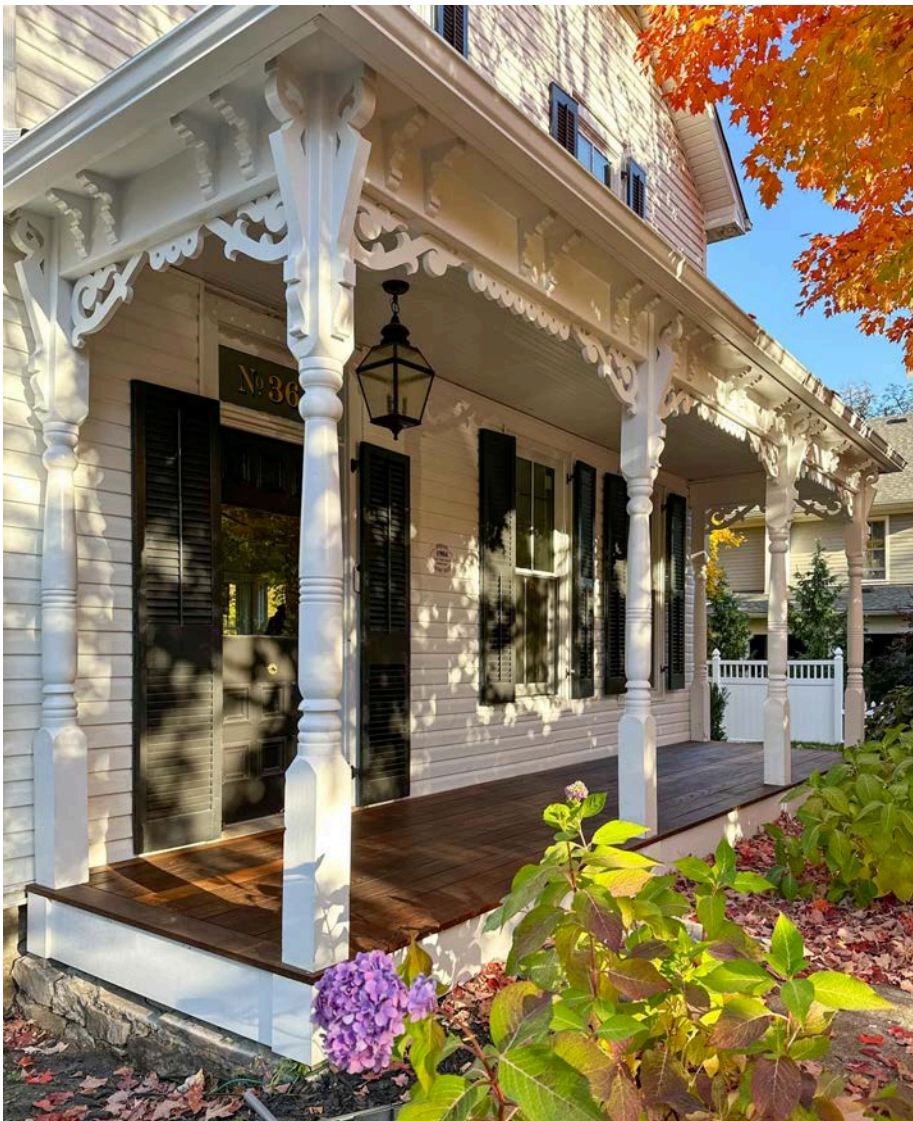
II. Before and after the restoration, as seen standing on Edith Street looking East toward 36 Edith Street, showing corbel, fretwork, brackets, posts, ceiling, door, and shutter details.

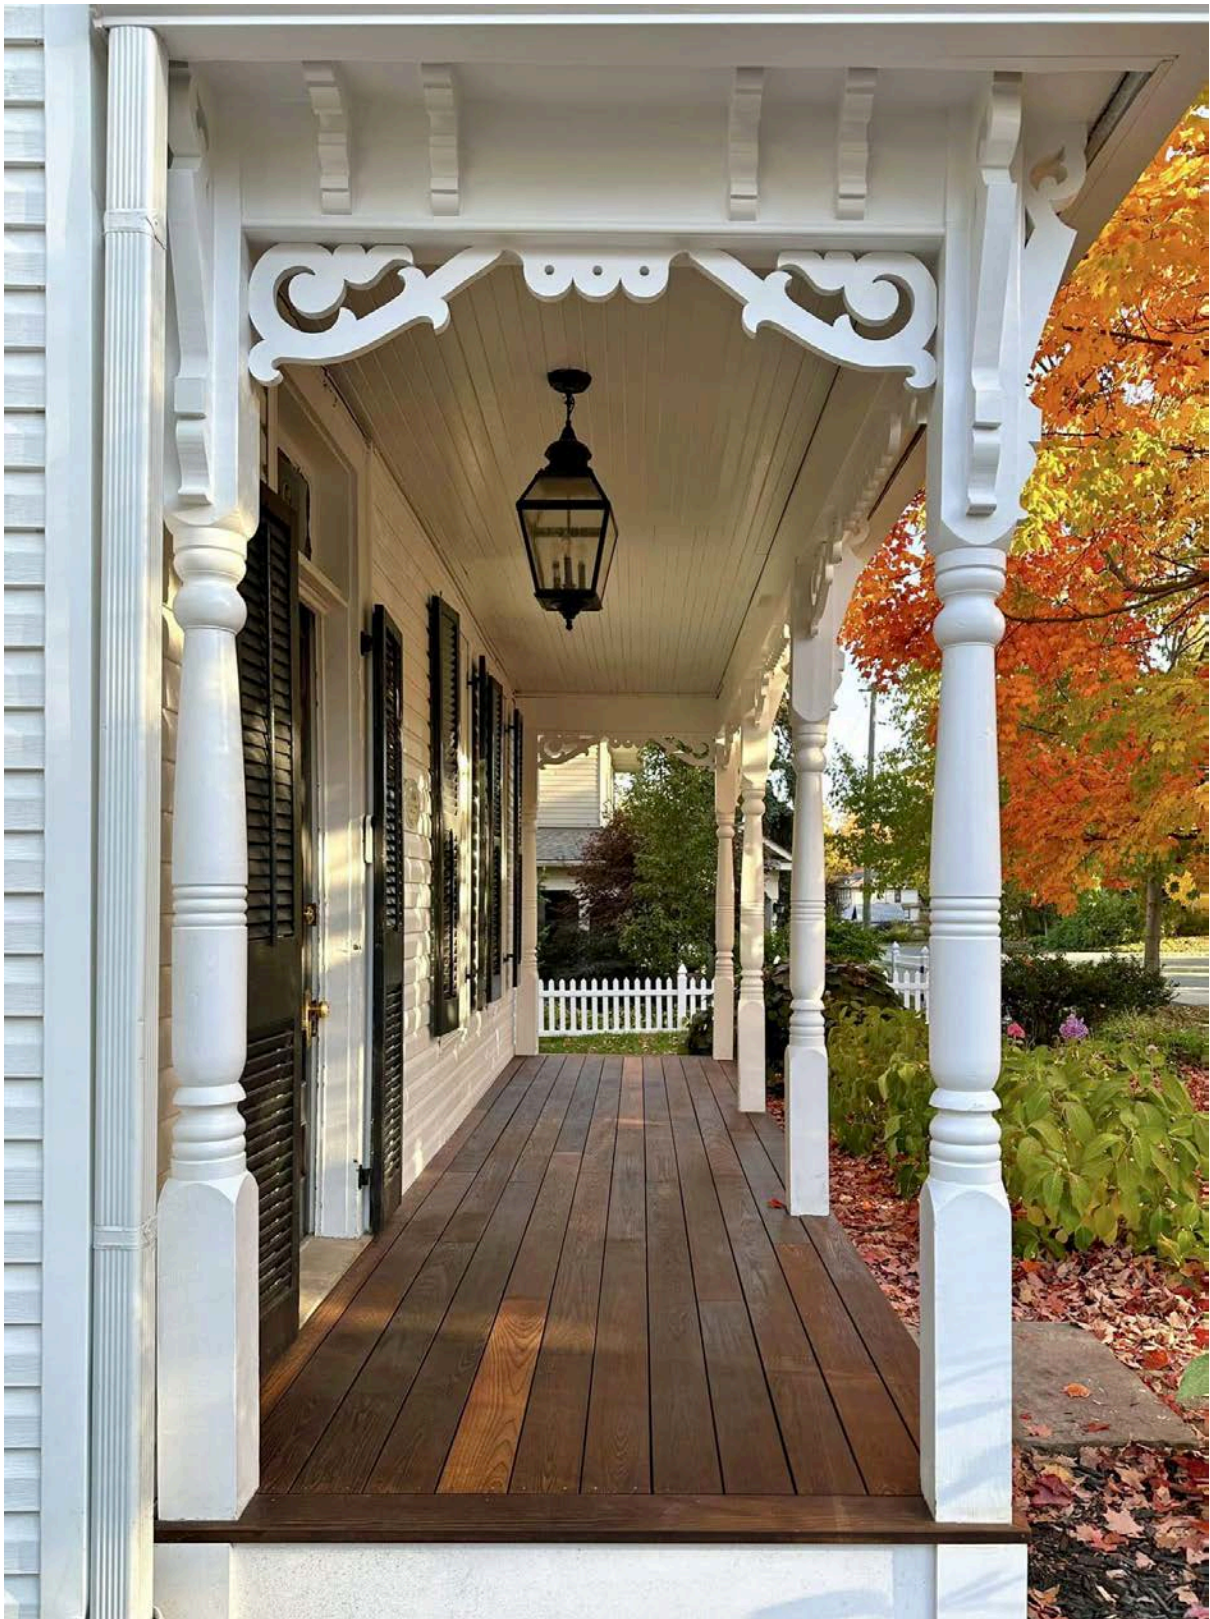
III. Porch through-view, standing in the driveway looking South at the verandah

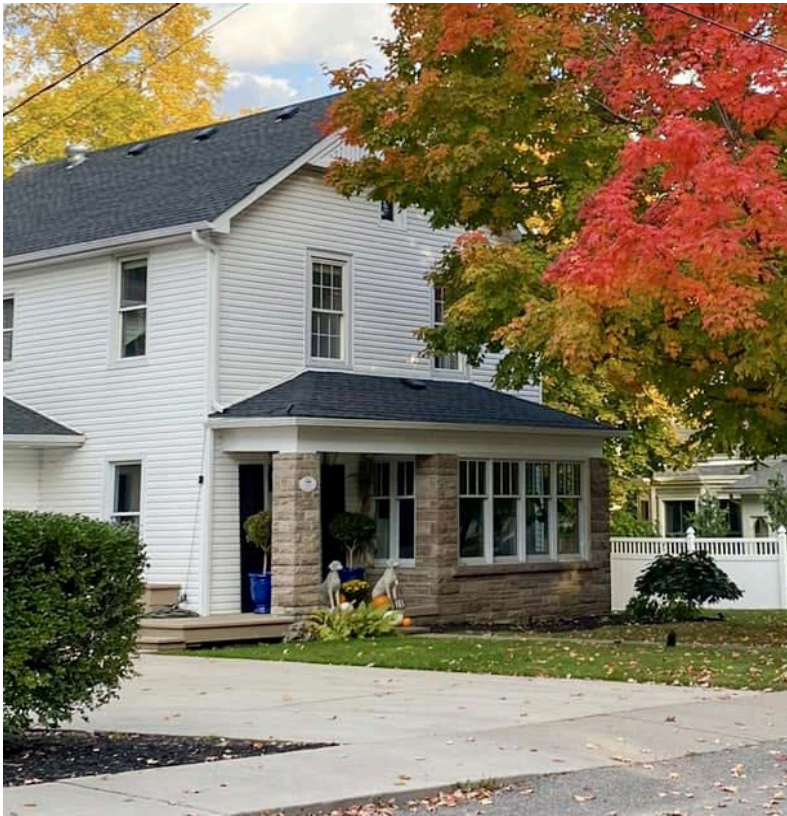
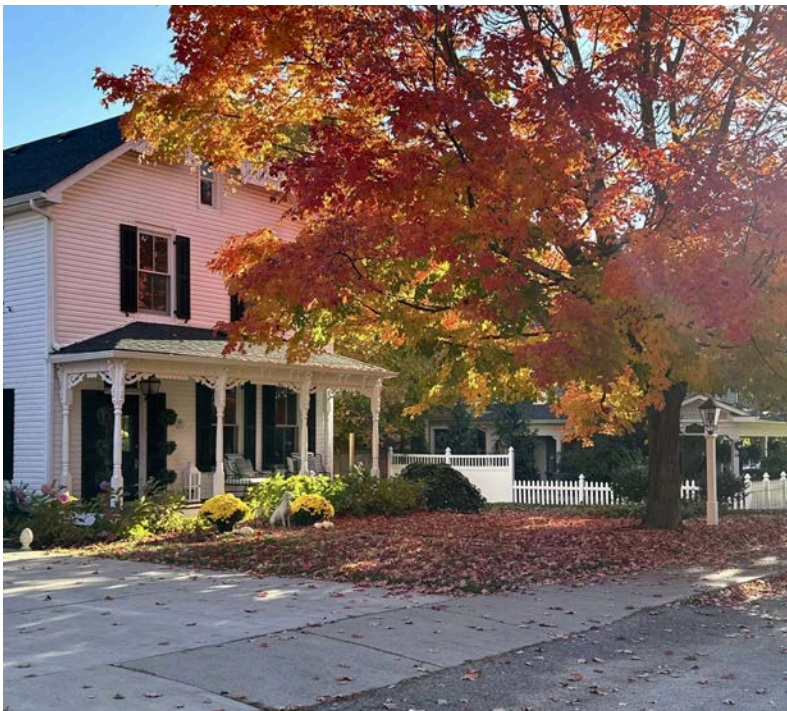
IV. Before-and-after standing on Edith Street looking South-East at the property

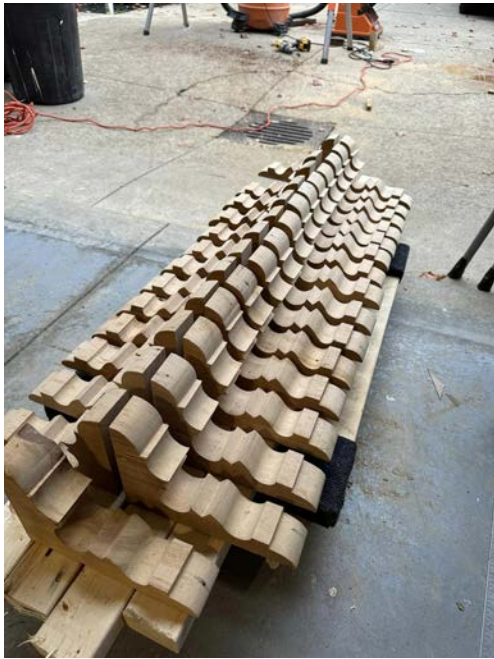
Top Left: corbels created using measurements found in original paint marks, using old-growth lumber from the property

Sustainability was a priority, and we aimed to minimize carbon emissions and avoid toxic materials. We reused old-growth pine timbers from a previous interior renovation, crafting 44 porch corbels from this reclaimed wood. This reduced material waste and aligned with the historical materials used in the porch's original construction.

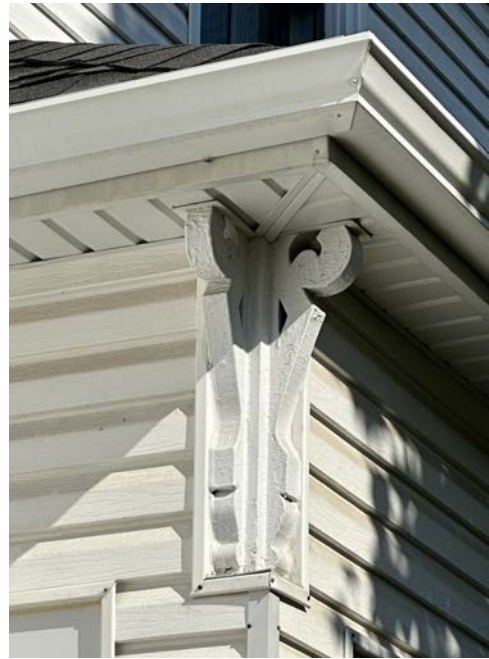
Top Right: original corbels remaining on the property (South Elevation dining room bay), combined with eave corbel spacing paint impressions, led us to identify 126 Main St South as having a near-identical porch kit. The corbels were verified to have been featured prominently on many HP Lawson homes.

On-site, we discovered "ghost marks" indicating the locations of original porch posts, eave corbels, and the porch's footprint. These findings corresponded with existing architectural elements, such as the dining room bay window corbels on our home that escaped demolition over the years. To further refine our design, we studied other local Lawson-built homes, particularly a designated heritage building at 126 Main Street South. This home had identical corbels and placements, which reinforced our findings.

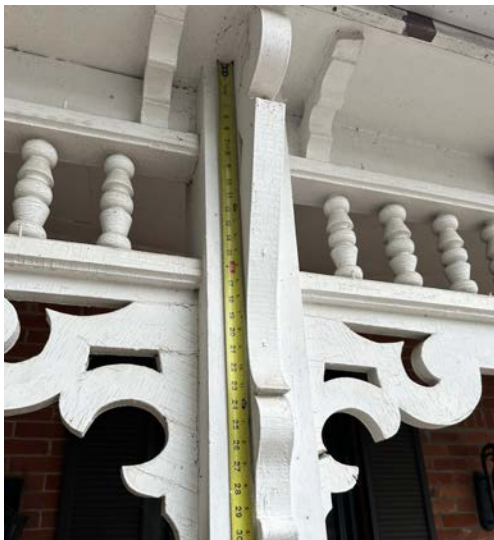
Bottom Left: with collaboration from Helen Lu of 126 Main St South, all measurements were taken from their preserved verandah to apply to the property at 36 Edith St

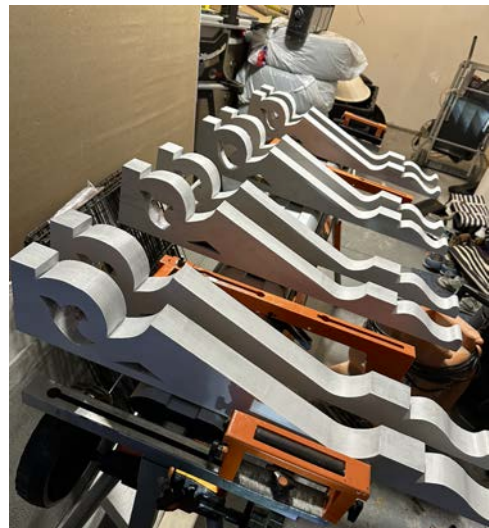
Bottom Right: reproduced corbels primed and painted for installation, matching the exact dimensions, proportions, scale, and style and those found on the South Elevation of 36 Edith St and on the porch at 126 Main St South.
