CULTURAL HERITAGE IMPACT ASSESSMENT

**PROPOSED MCGIBBON CONDOMINIUM PROJECT
69 MAIN STREET SOUTH, 71-77 MAIN STREET SOUTH, 79 MAIN STREET SOUTH, AND 94-96 MILL STREET,
FORMER ESQUESING TOWNSHIP, HALTON COUNTY
COMMUNITY OF GEORGETOWN, TOWN OF HALTON HILLS, ONTARIO**

ASI File: 15TS-266

February 2016

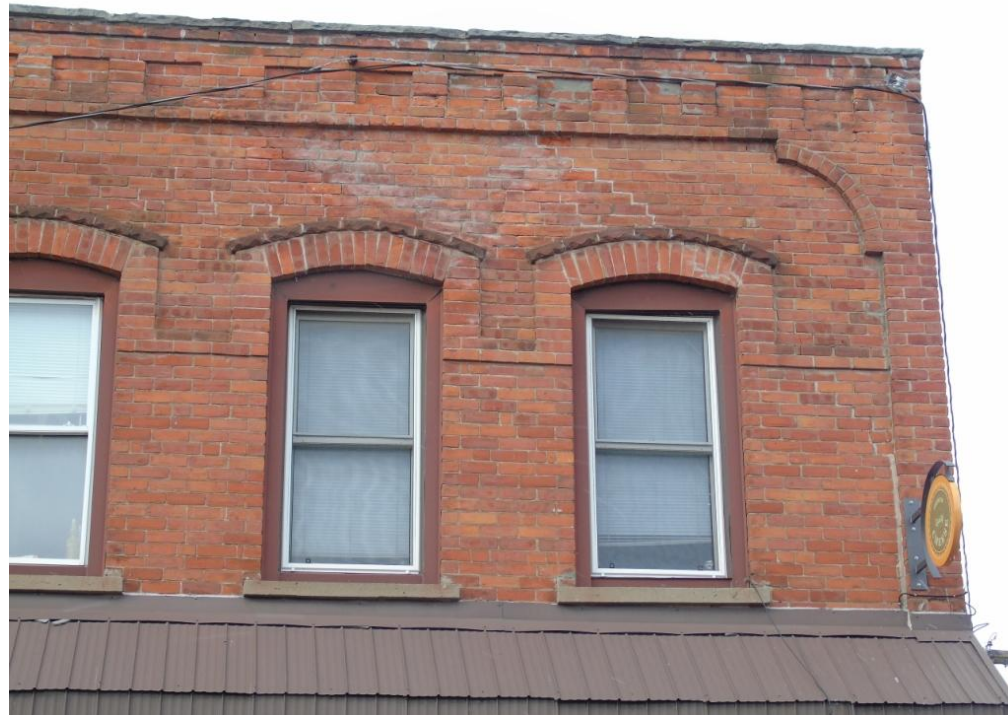
Plate 18: Details of the second floor fenestration and decorative brickwork on the south elevation of the structure at 94-96 Mill Street, looking north.

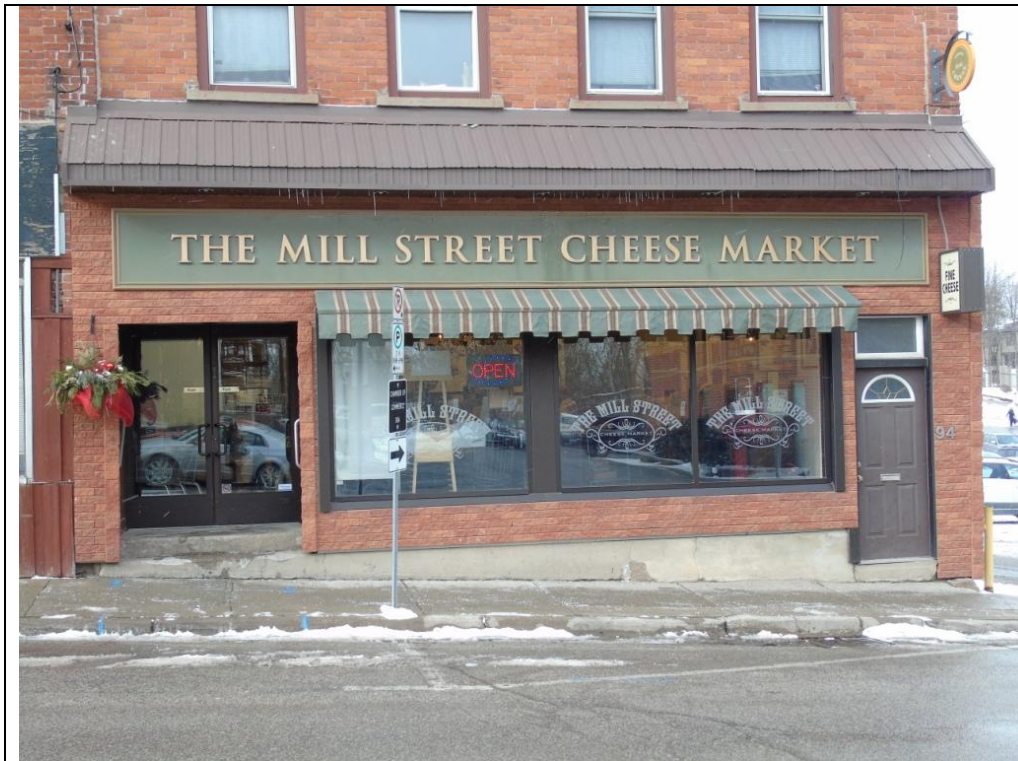
Plate 19: Detail of the brick work and large windows on the first floor of the south elevation of the structure at 94-96 Mill Street, looking north.

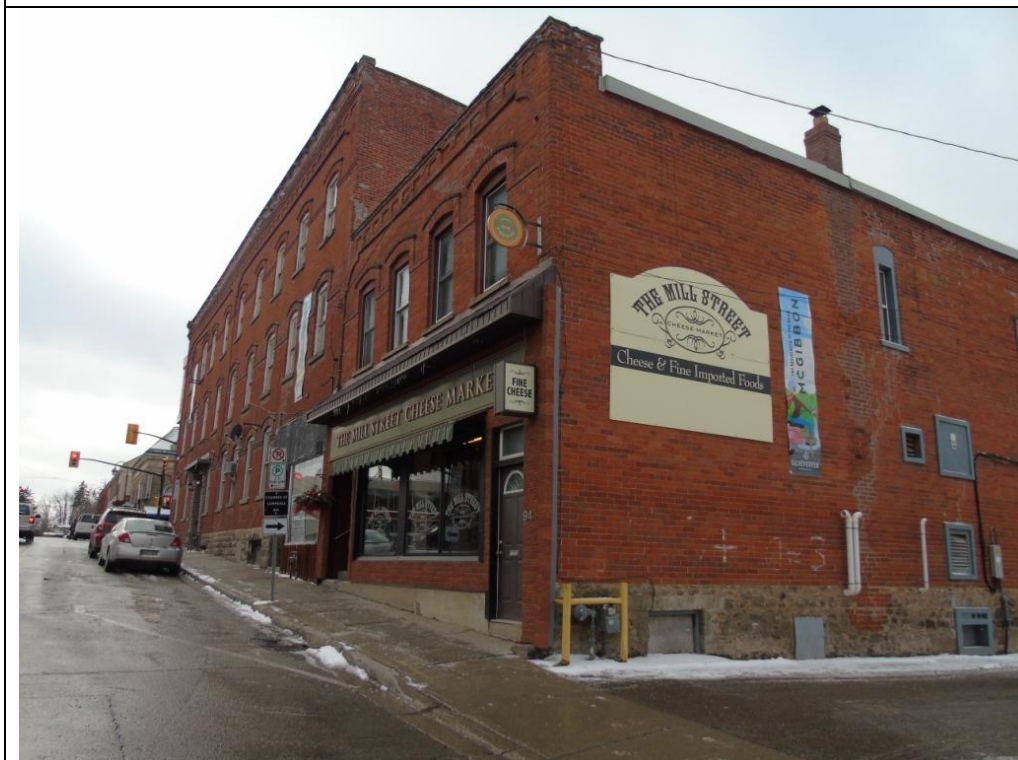
Plate 20: South and east elevations of the structure at 94-96 Mill Street, looking northwest.

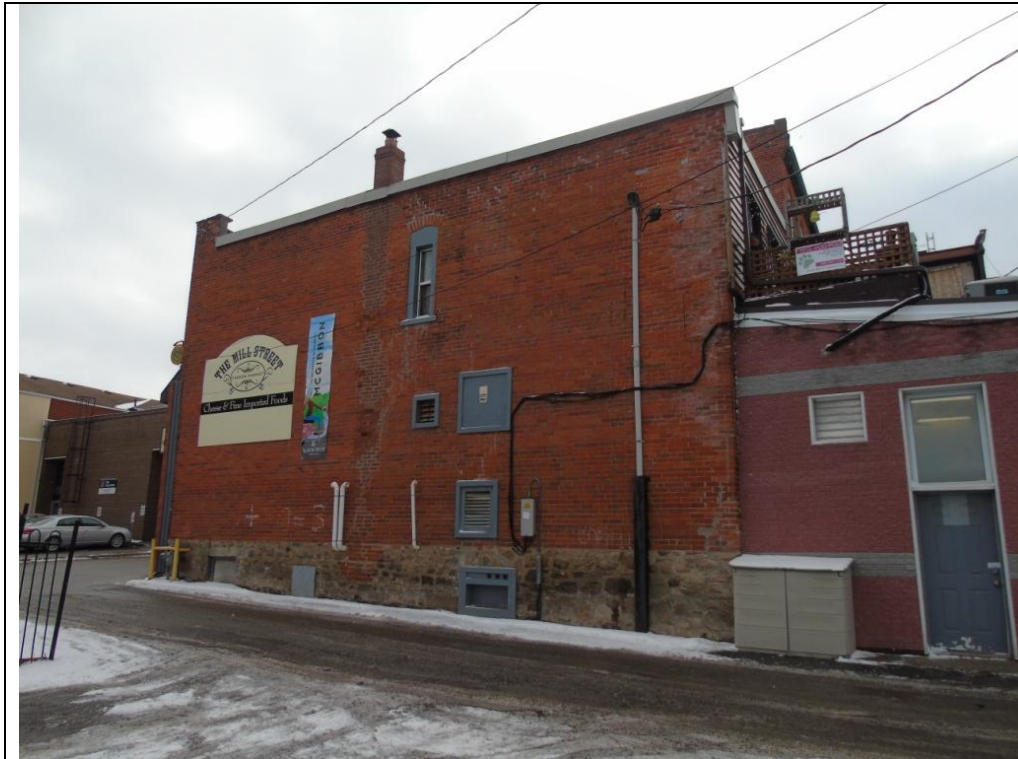
Plate 21: East elevation of the structure at 94-96 Mill Street, looking southwest.

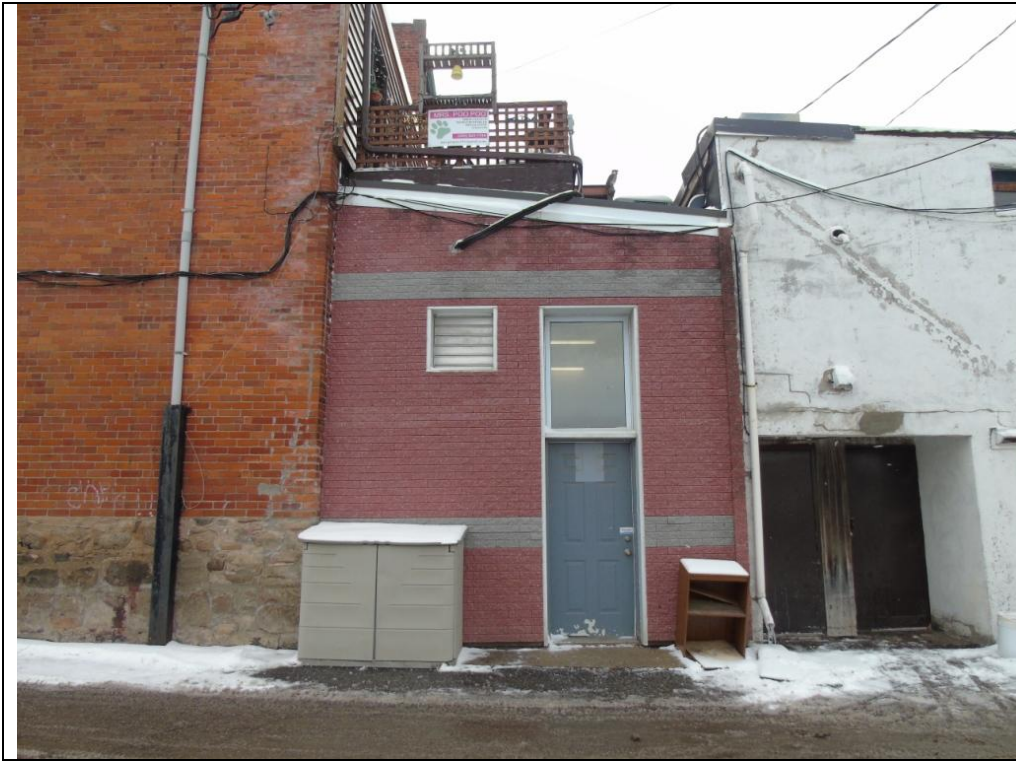
Plate 23: Detail of the east elevation of the northern addition and second floor patio at 94-96 Mill Street, looking west

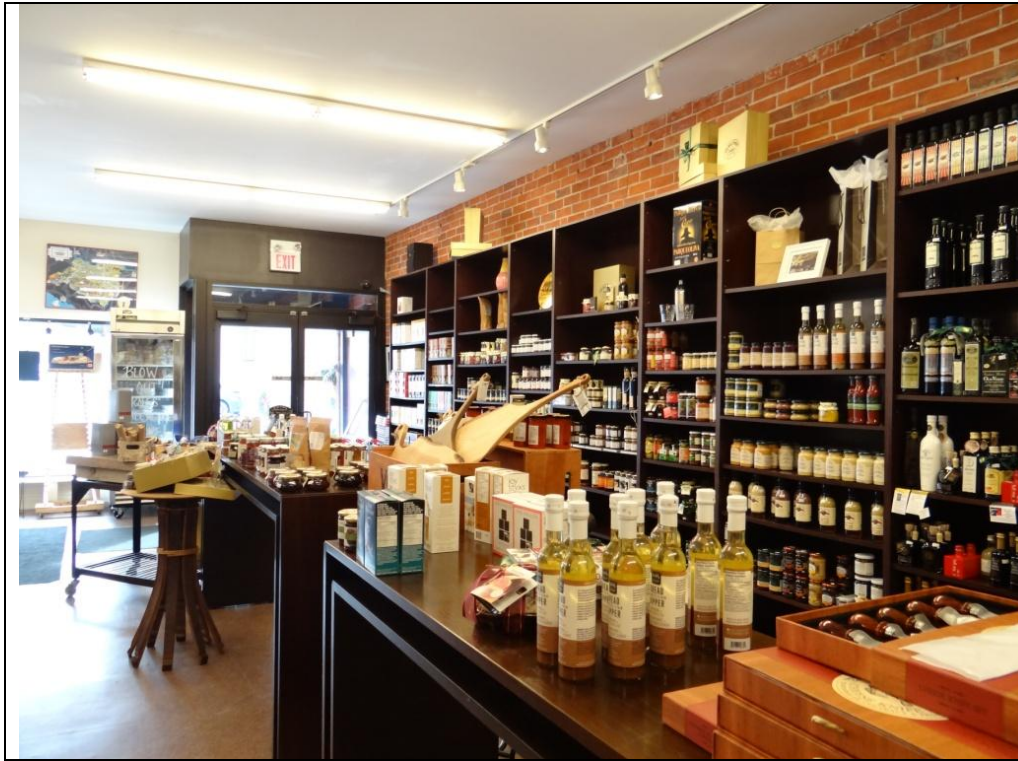
Plate 25: View of the main floor interior of 94-96 Mill Street, looking southwest.

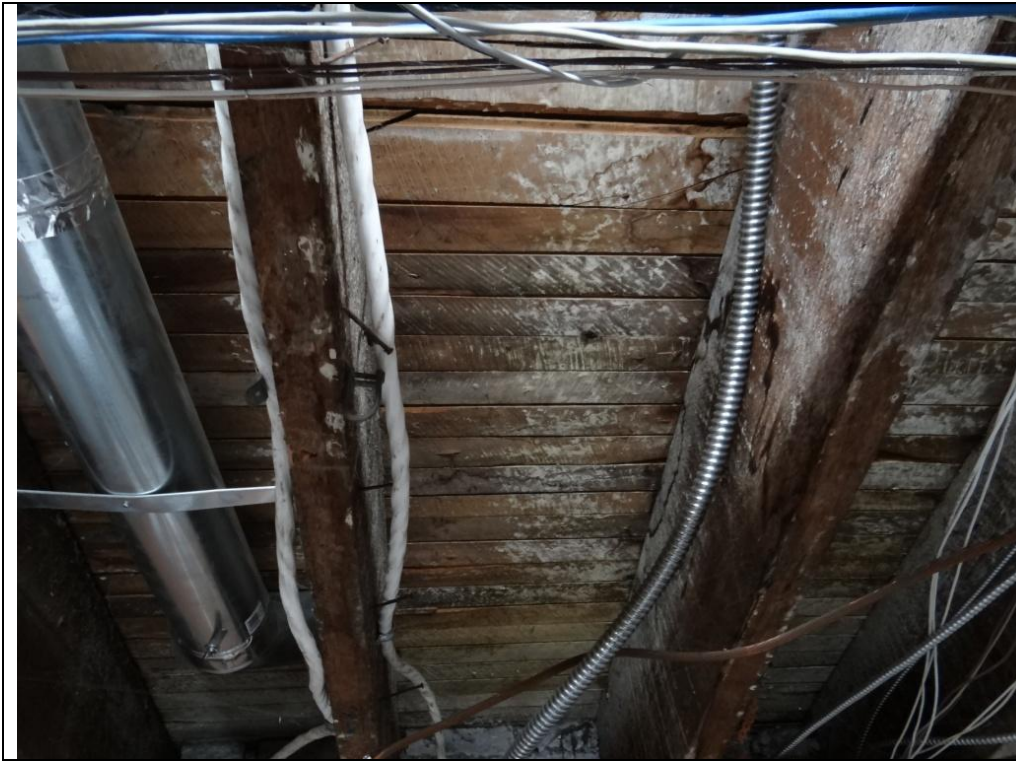
Plate 27: Detail of the sawn floor joists and softwood floor boards from the basement at 94-96 Mill Street.

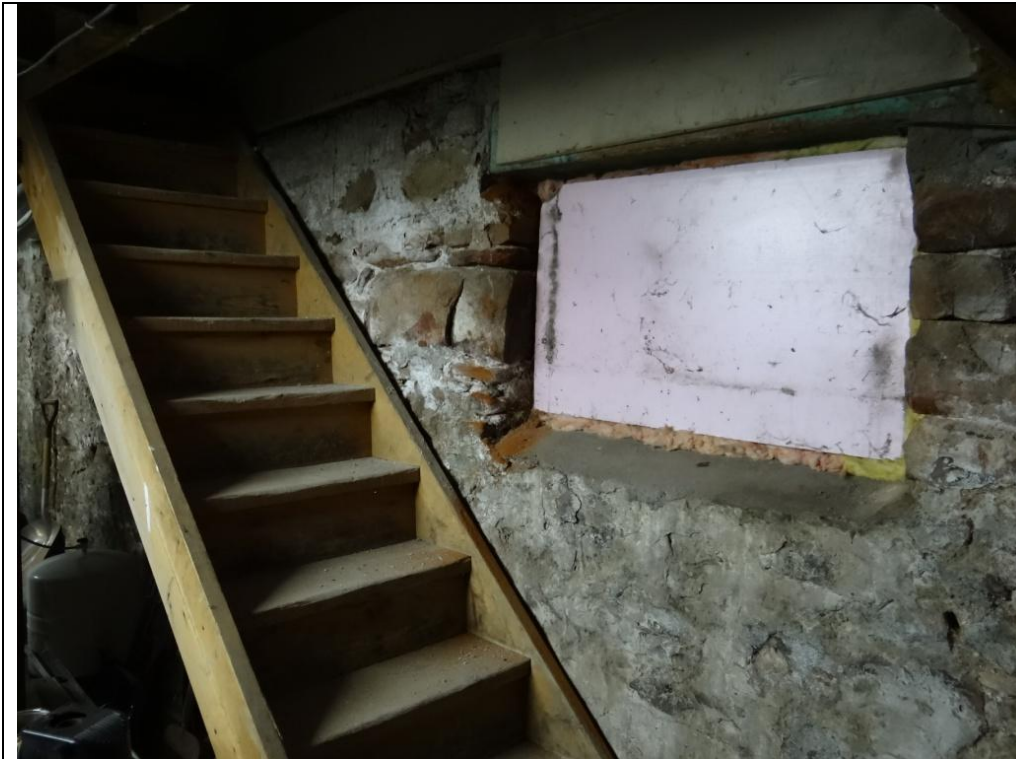
Plate 29: Detail of foundations, blocked windows, and un-used stairs in the basement at 94-96 Mill Street.

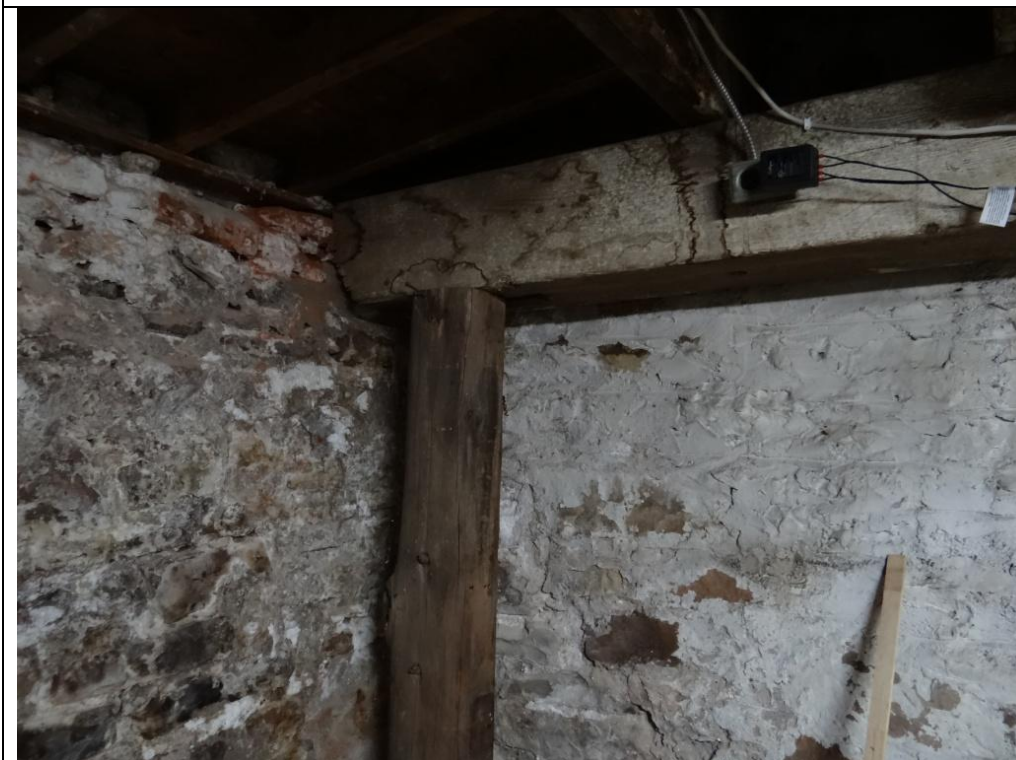
Plate 30: Detail of the foundation and large support beams in the basement at 94-96 Mill Street.

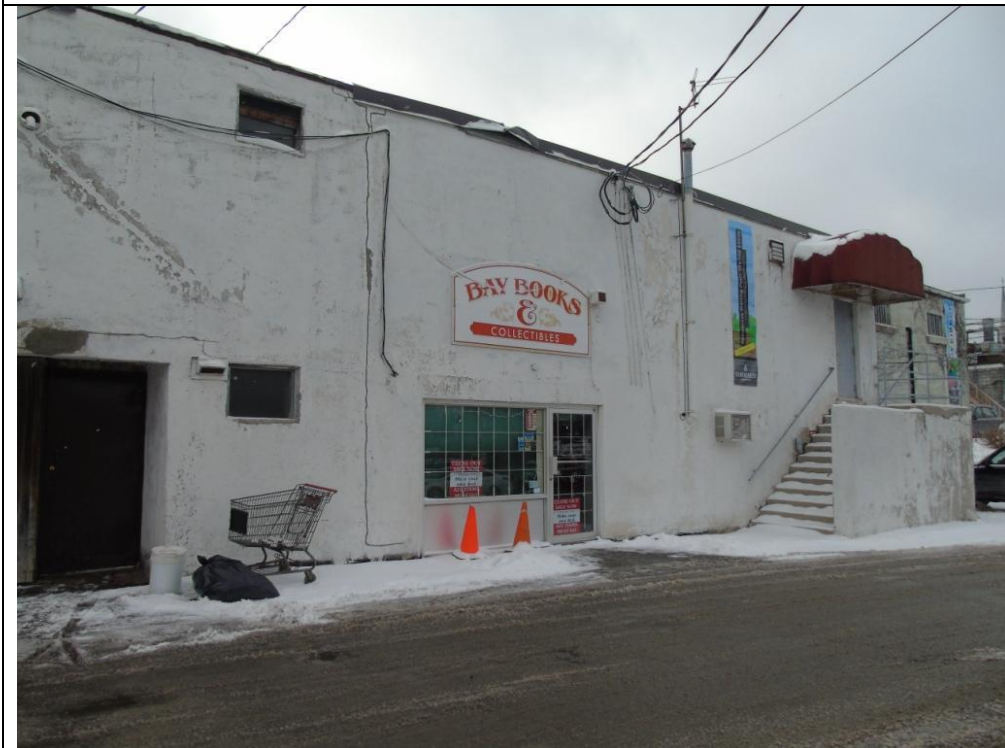
The east elevation of the 1960s addition, which fronts on a municipal parking lot, is the lower level of the structure. The east elevation of the addition features a walk-up entranceway on the north end, a ground-level entranceway and fixed rectangular window at center, and a double doorway at ground level on the south end. Two very small fixed rectangular windows are present on the south side, with one on the first and one on the second floor. The entire east elevation of the 1960s addition is very utilitarian and clad in off-white painted concrete (Plate 36).

Plate 36: East elevation of the eastern addition of 71-77 Main Street South fronting on parking lot, looking northwest.

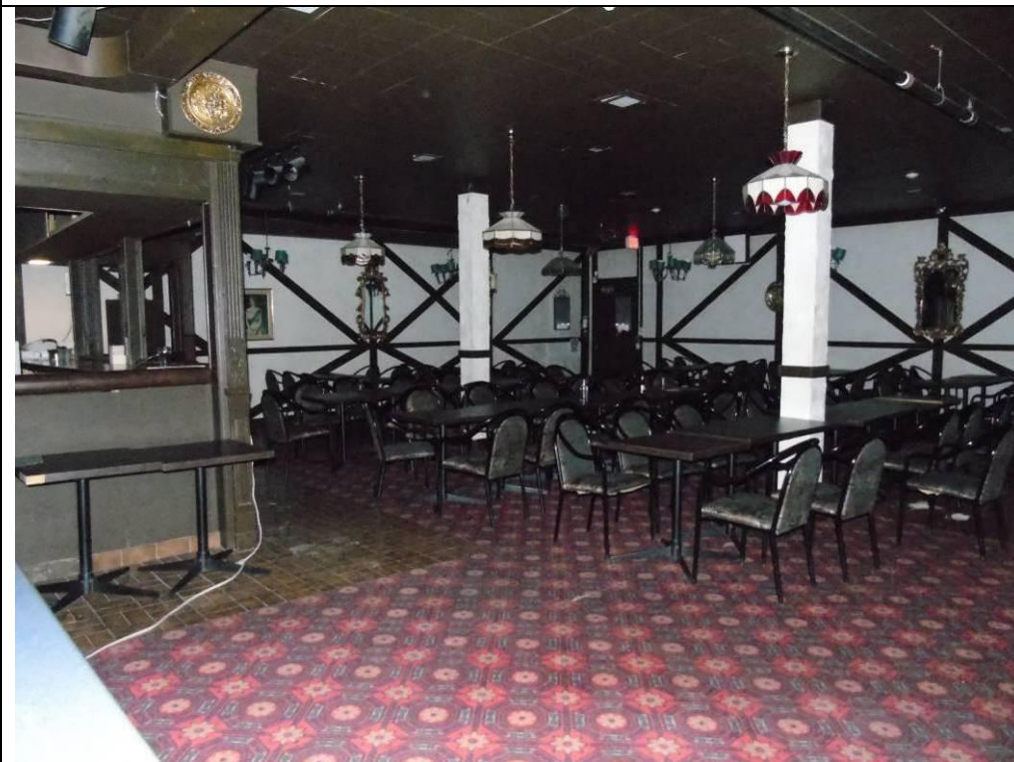
featuring a bar, dance floor, and a large seating area. The walls are clad in stucco and half-timbering, the floor is primarily carpeting with ceramic tile around the bar area and vinyl tile on the dance floor, and gypsum tiles on the ceiling (Plate 40).

Plate 40: Banquet Hall area in the rear 1960s addition to 71-77 Main Street South.

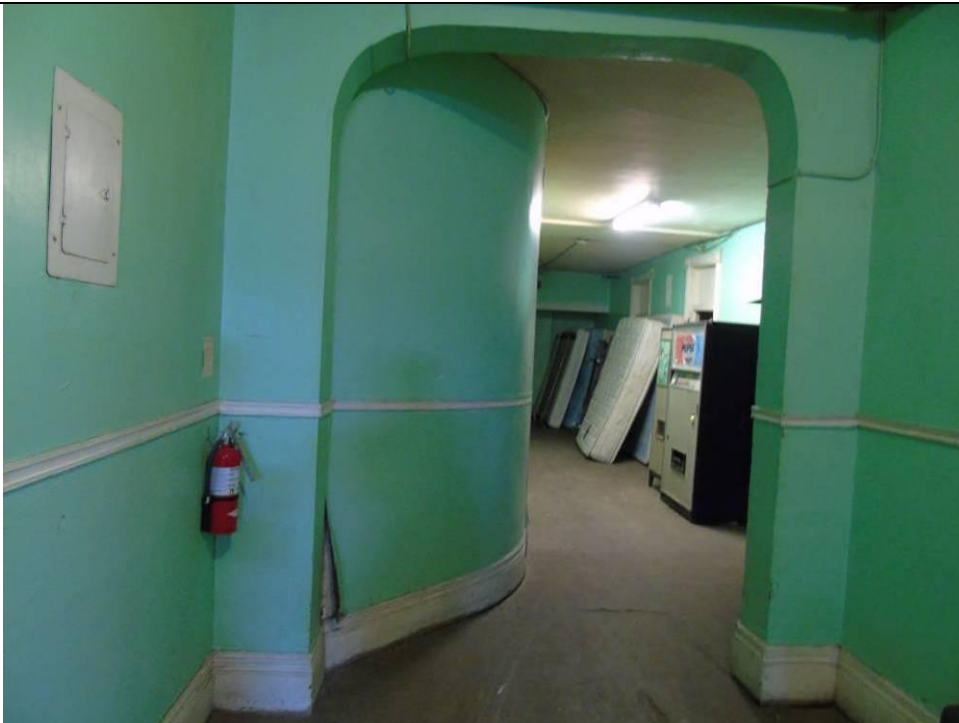
Plate 56: View of the main hallway on the second floor, looking east. Note that the hallway jogs to the south.

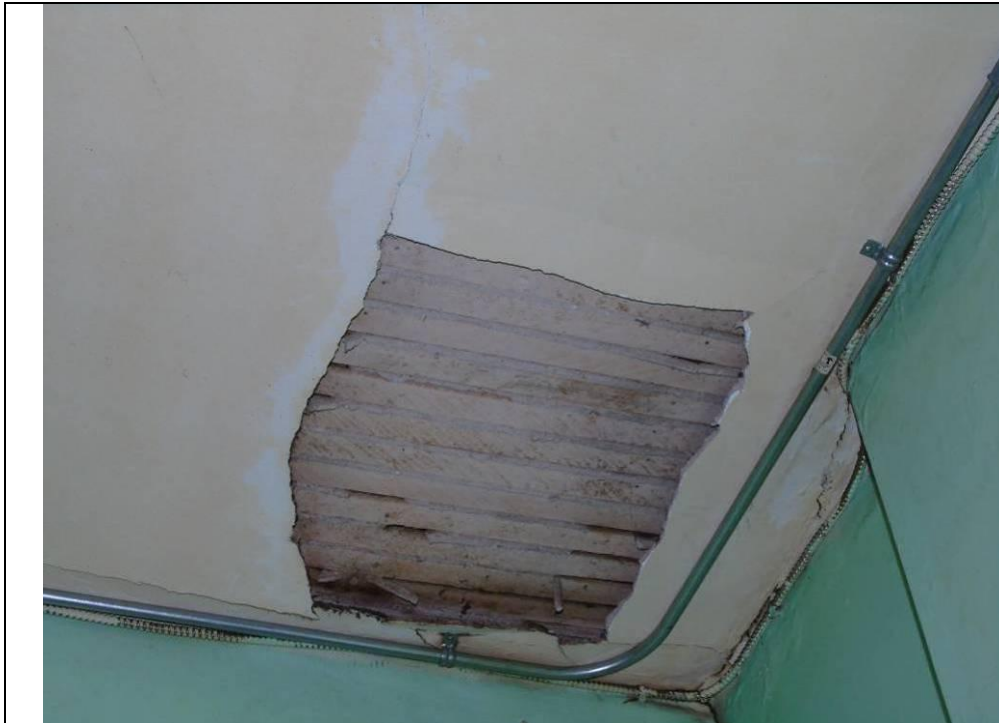
Plate 57: Original
lathe-and-plaster
was found
throughout.

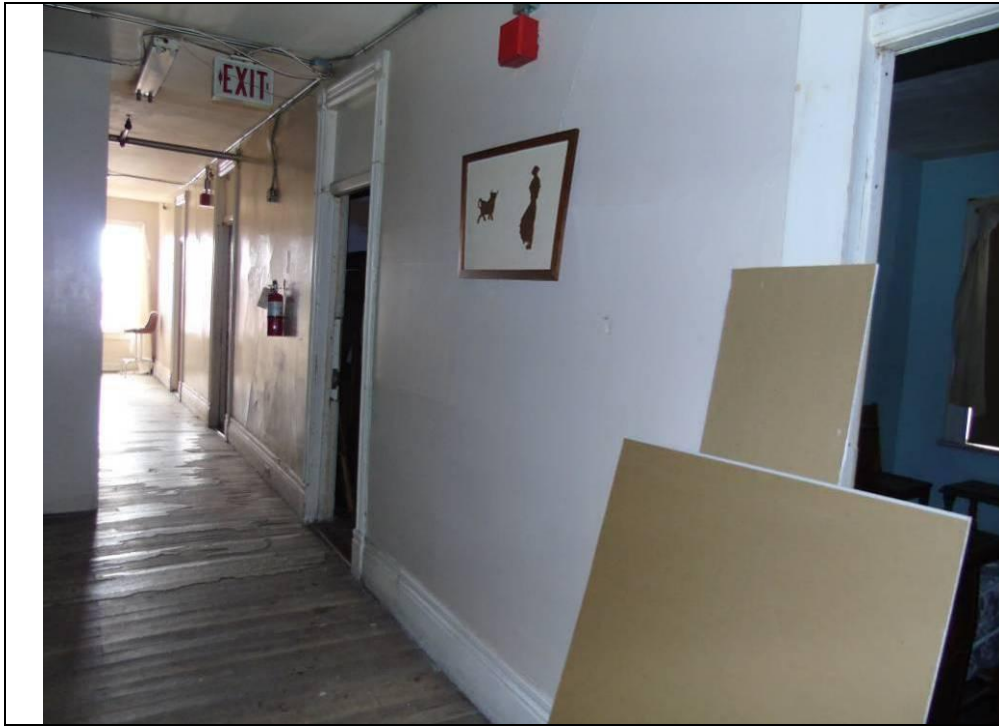
Plate 63: View of the north-south hallway towards the front of the hotel on the third floor.

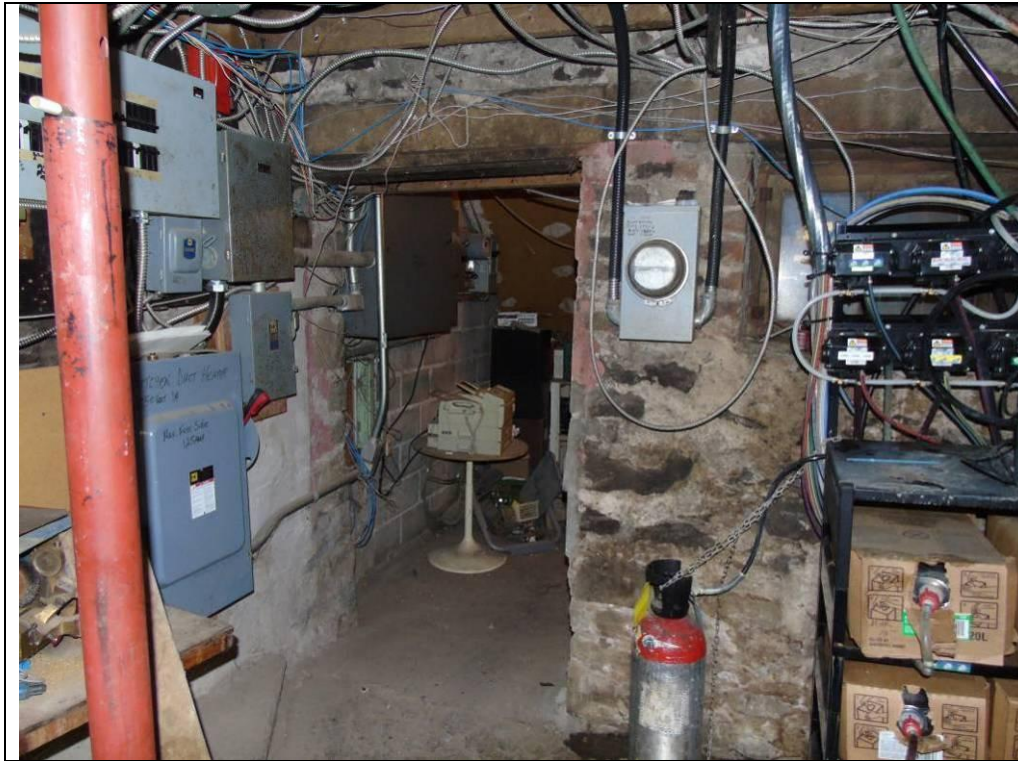
Plate 65:
Basement of 79
Main Street
South, showing
stone
foundations,
hewn beams,
and modern
electrical panels.

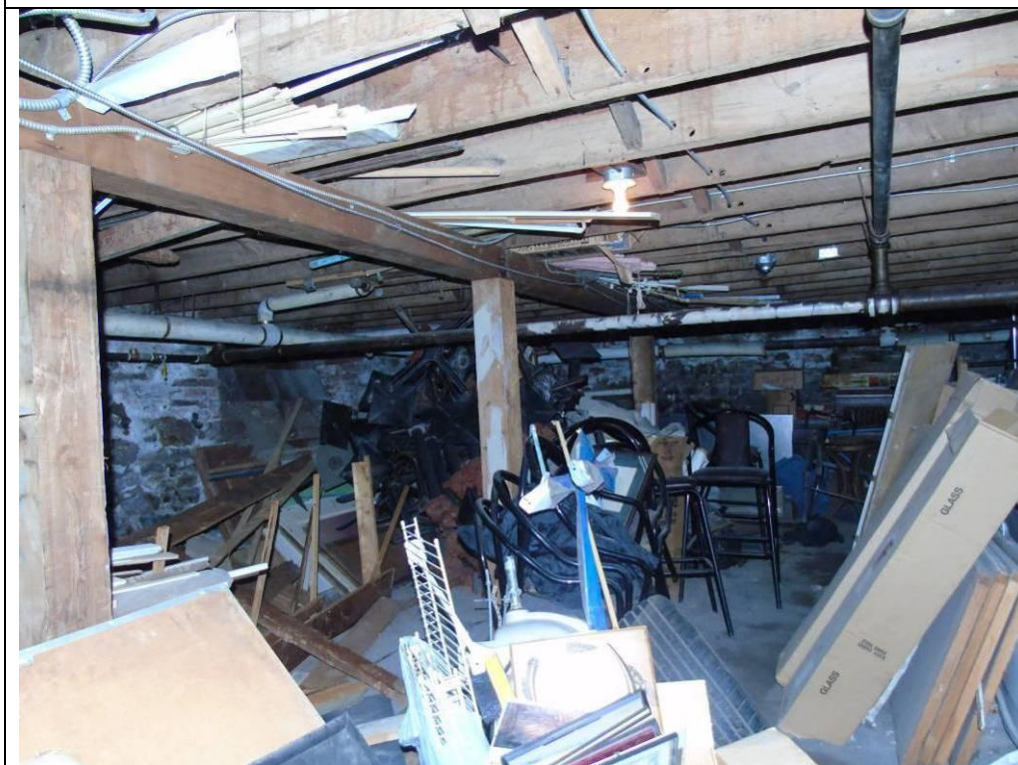
Plate 66:
Basement of 71-
77 and 79 Main
Street South,
showing stone
foundations,
sawn beams,
and modern
dimensional
lumber floor
joists.

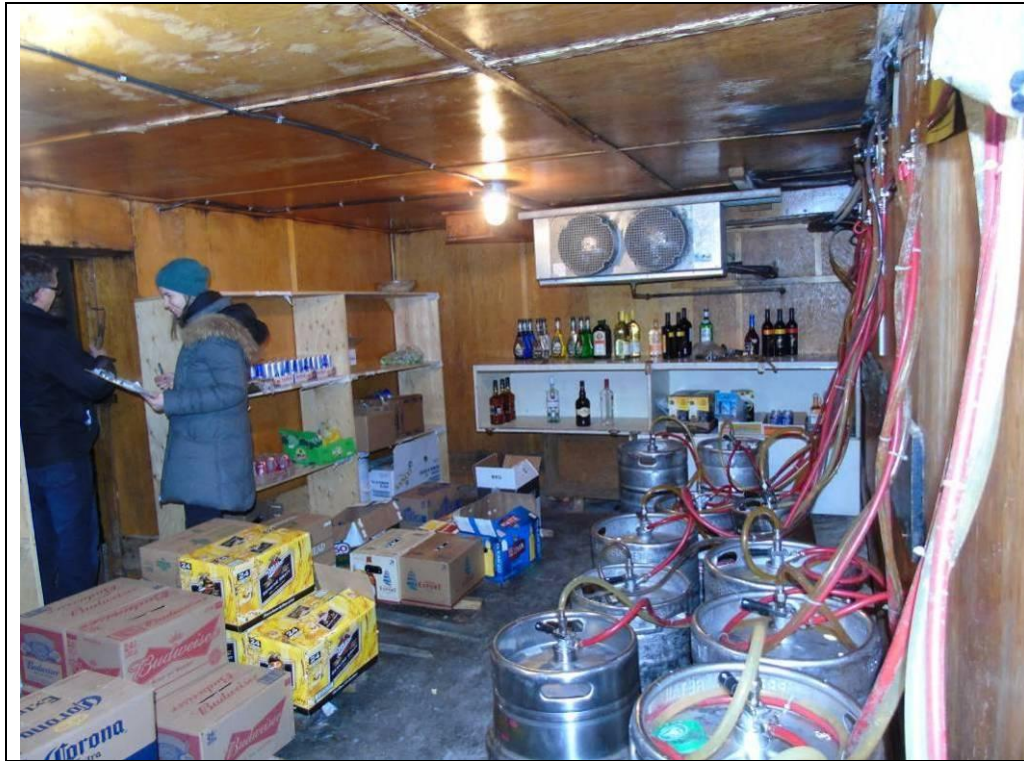
Plate 67:
Basement of 71-
77 and 79 Main
Street South,
showing modern
refrigeration
facilities for the
restaurant and
bar.

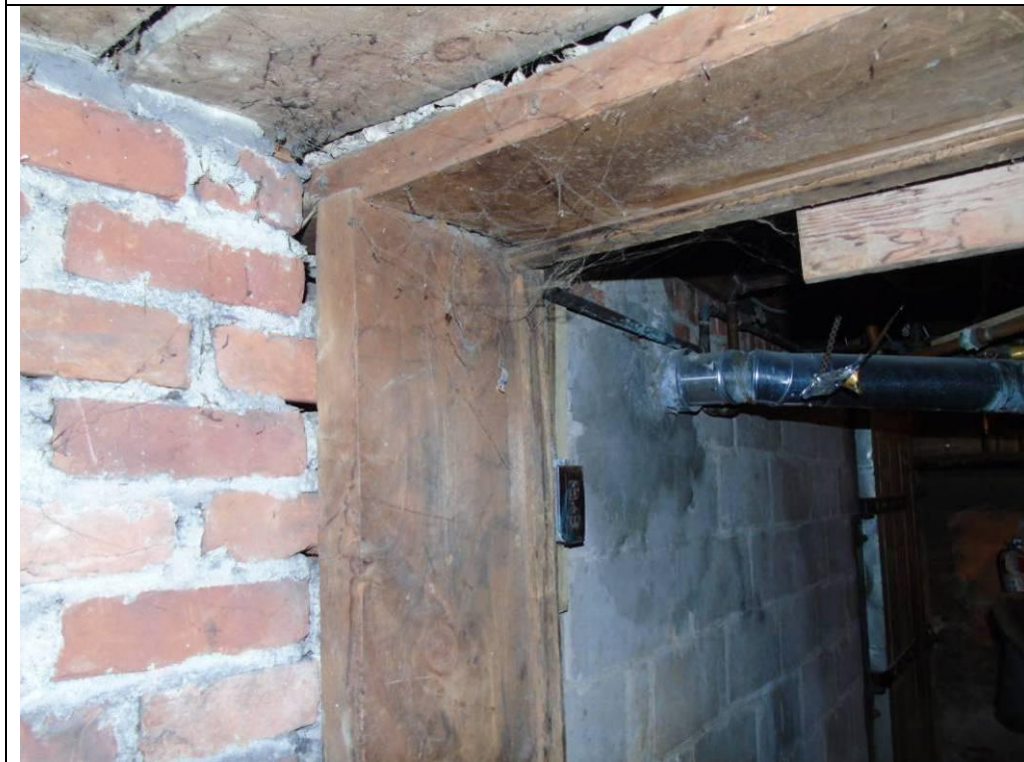
Plate 70:
Basement of 71-
77 and 79 Main
Street South,
showing red
brick and cinder
block
foundations,
softwood
floorboards, and
modern
dimensional
lumber door
framing.

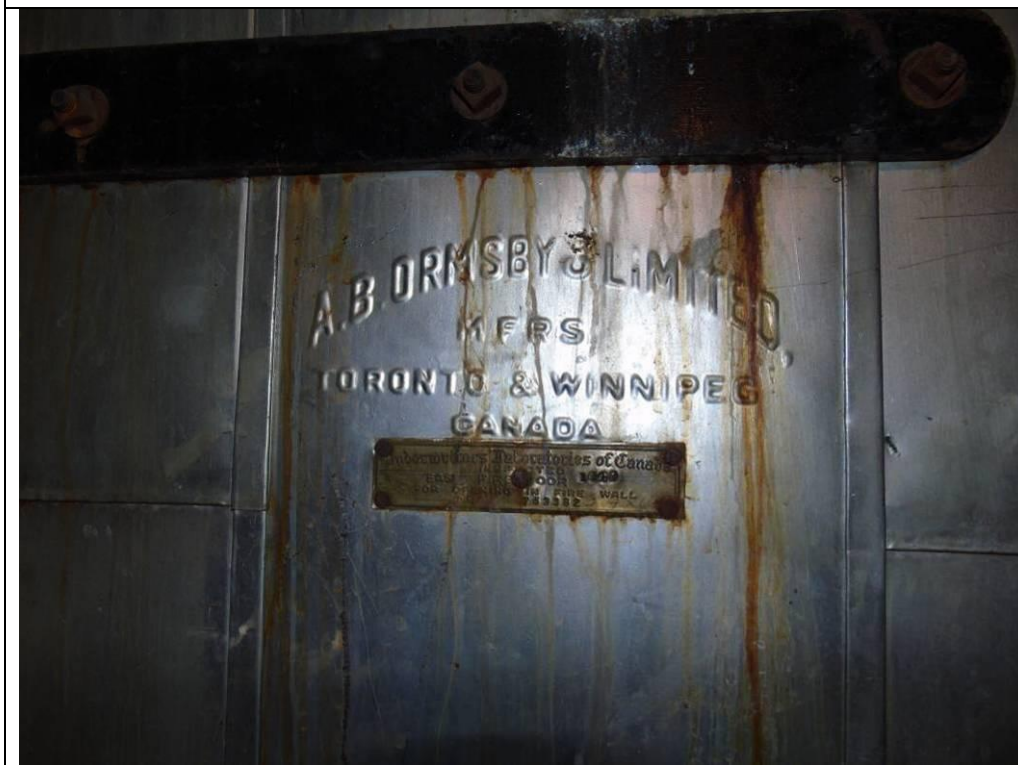
Plate 72:
Basement of 71-
77 and 79 Main
Street South,
showing heavy
metal boiler
room door.

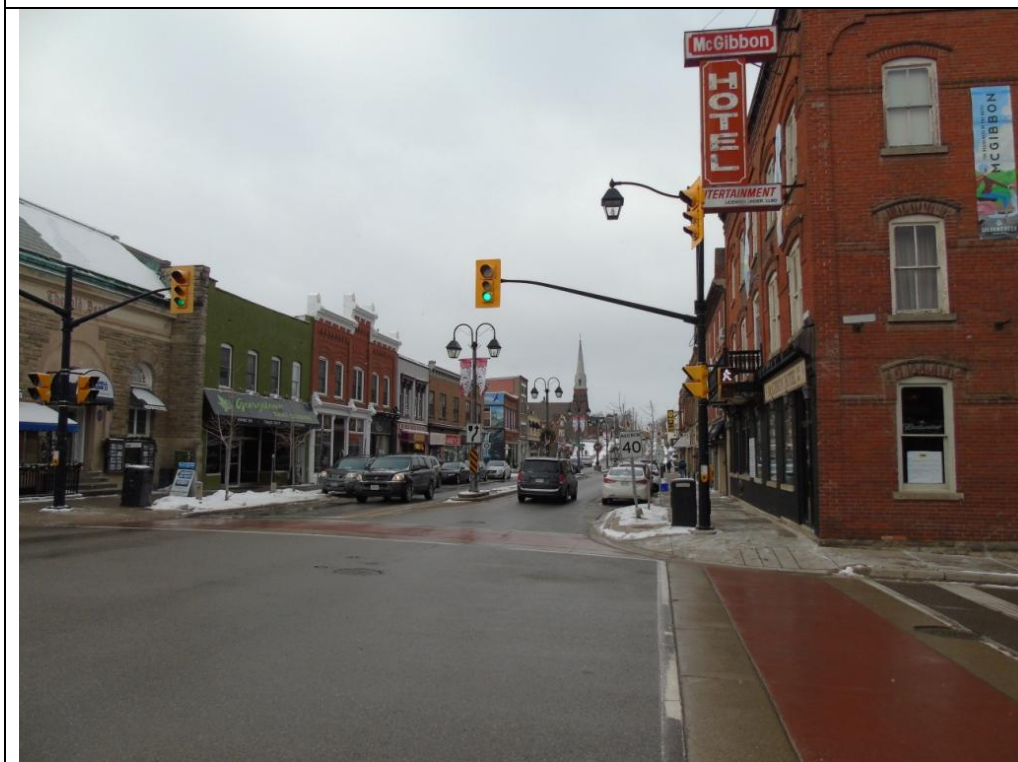
Plate 74: View
from the
intersection of
Main Street
South and Mill
Street, looking
north on Main
Street.

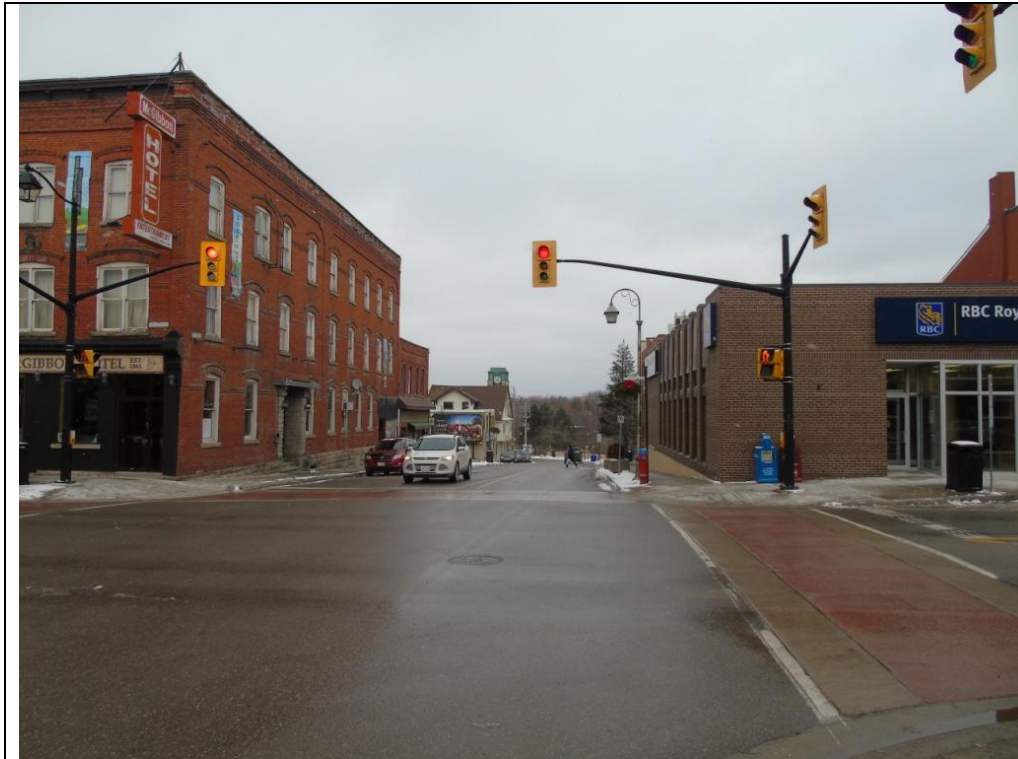
Plate 75: View from the intersection of Main Street South and Mill Street, looking east on Mill Street.

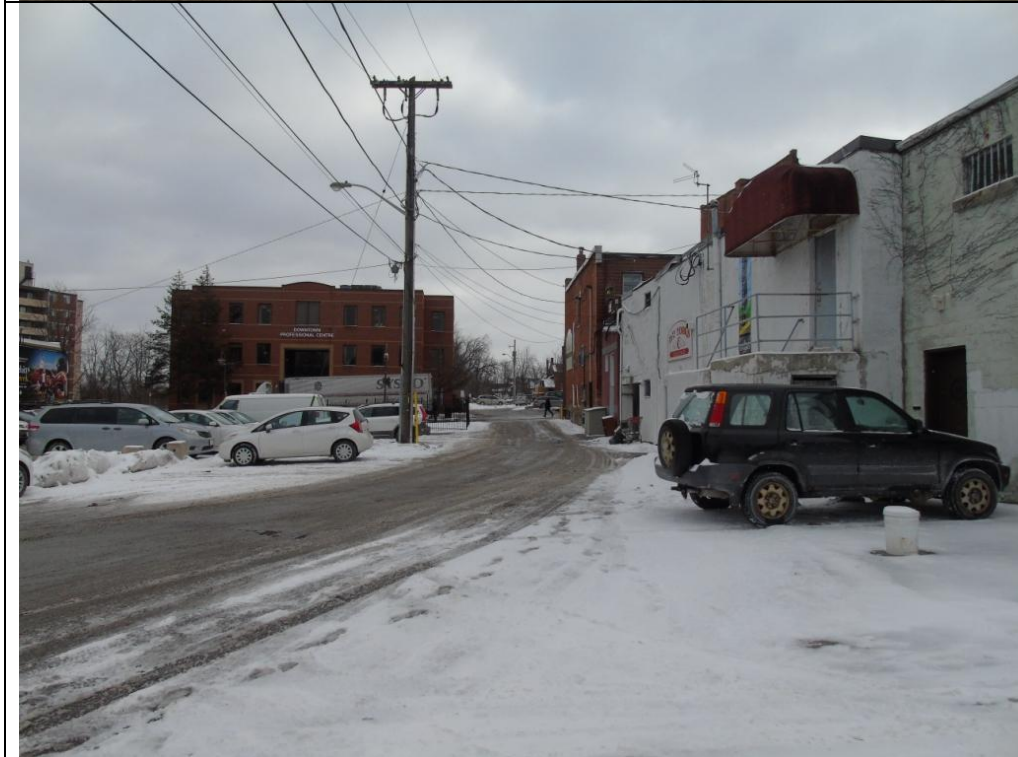
Plate 76: View of parking lot at the northeast section of the study area, looking south to Mill Street.

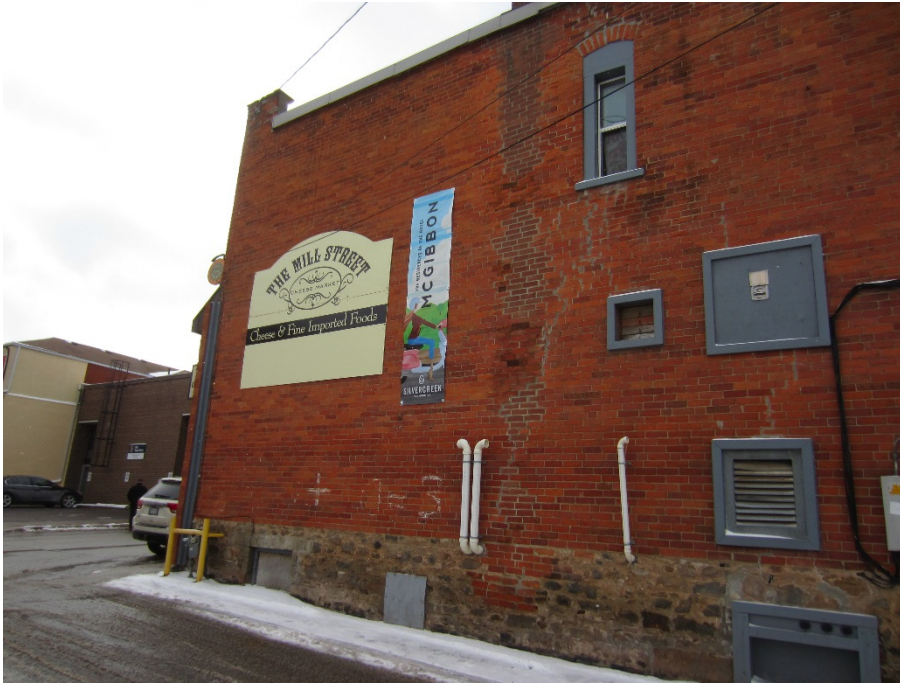
Photo #3: Back of the building

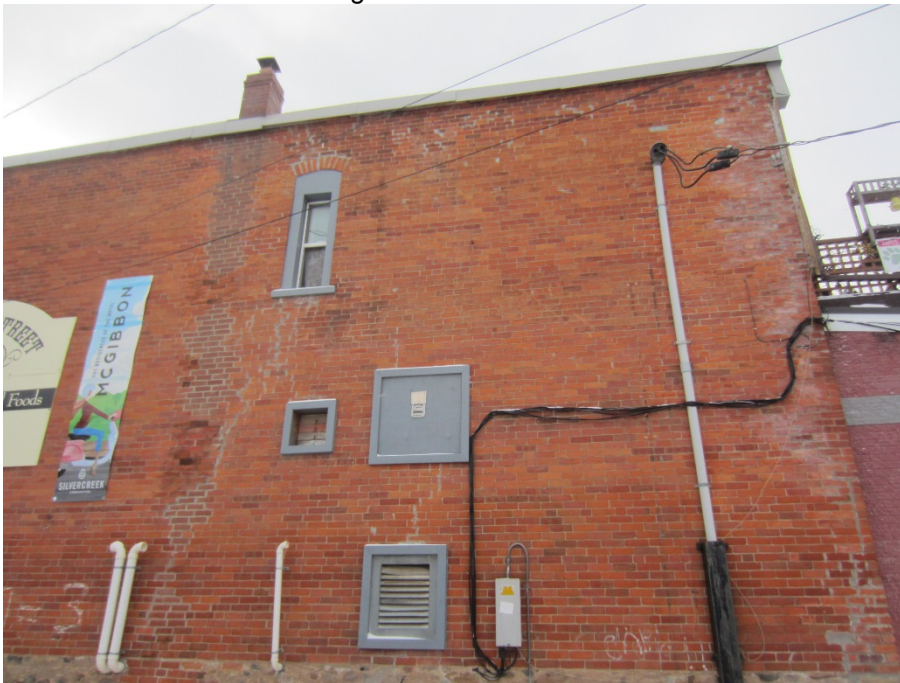
Photo #4: Back of the building

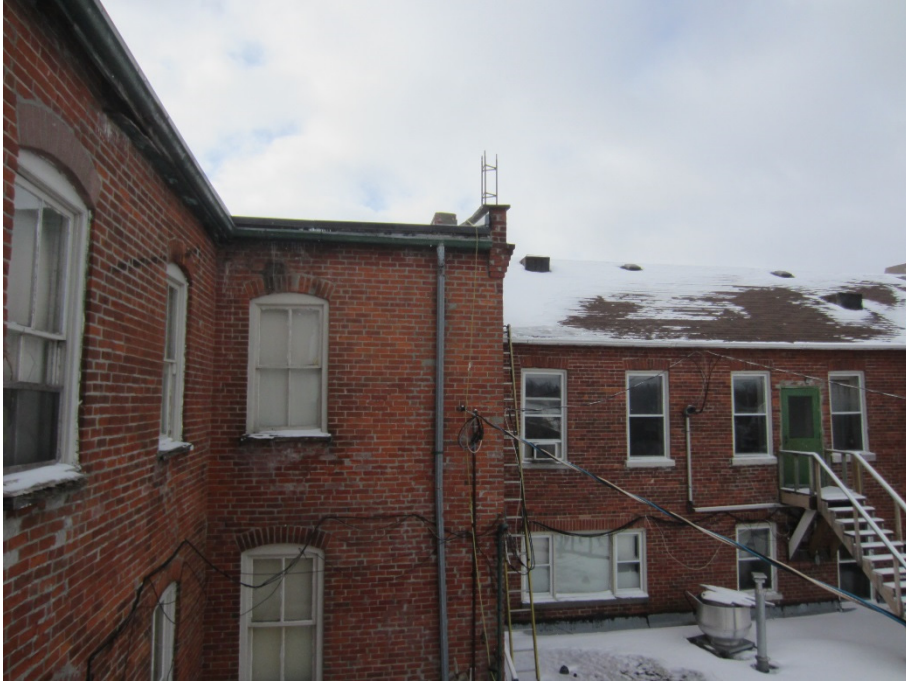
Photo #5: Side of the building

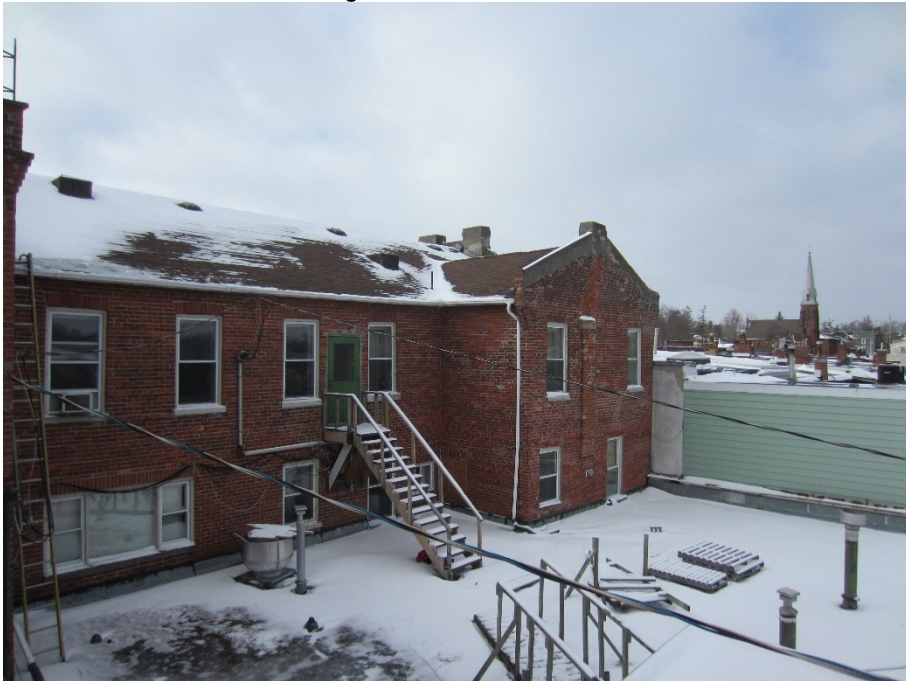
Photo #6: Side of the building

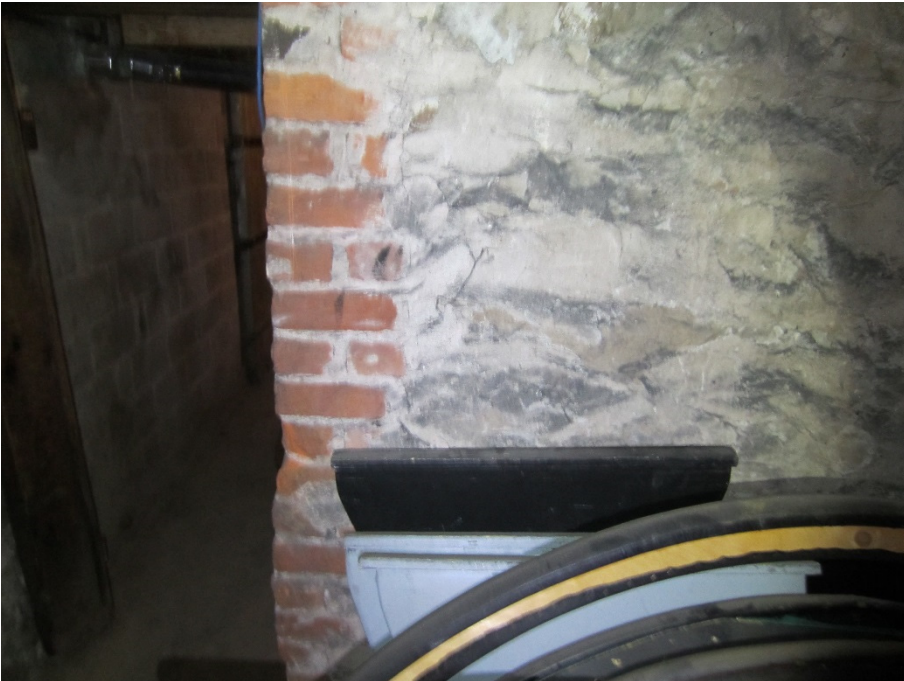
Photo #12: Basement brick foundation
