CULTURAL HERITAGE IMPACT ASSESSMENT

**PROPOSED MCGIBBON CONDOMINIUM PROJECT
69 MAIN STREET SOUTH, 71-77 MAIN STREET SOUTH, 79 MAIN STREET SOUTH, AND 94-96 MILL STREET,
FORMER ESQUESING TOWNSHIP, HALTON COUNTY
COMMUNITY OF GEORGETOWN, TOWN OF HALTON HILLS, ONTARIO**

ASI File: 15TS-266

February 2016

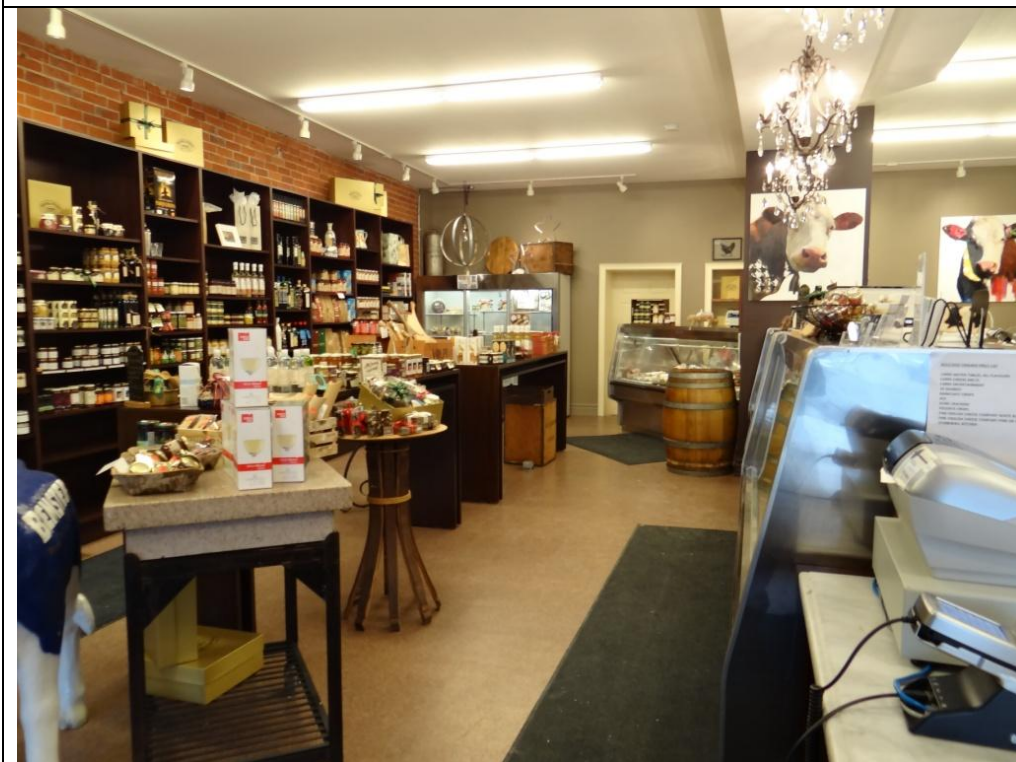
Plate 24: View of the main floor interior of 94-96 Mill Street, looking north.

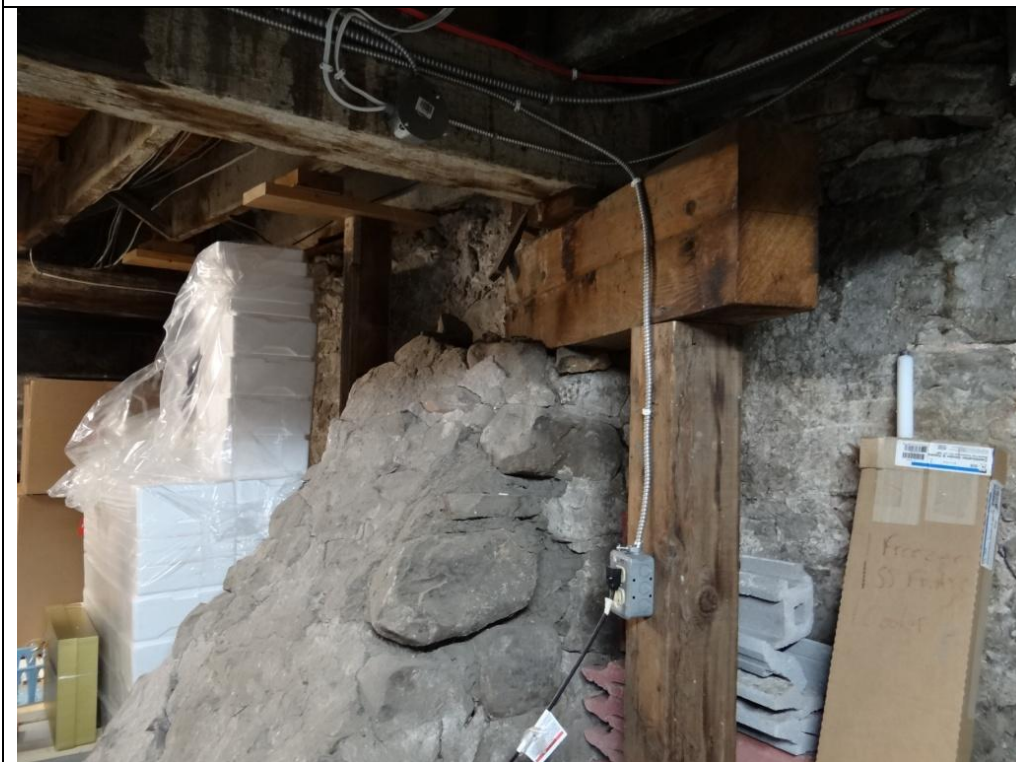
Plate 28: Detail of the stone buttressing and large support beams on the north wall of the basement at 94-96 Mill Street, looking northwest.

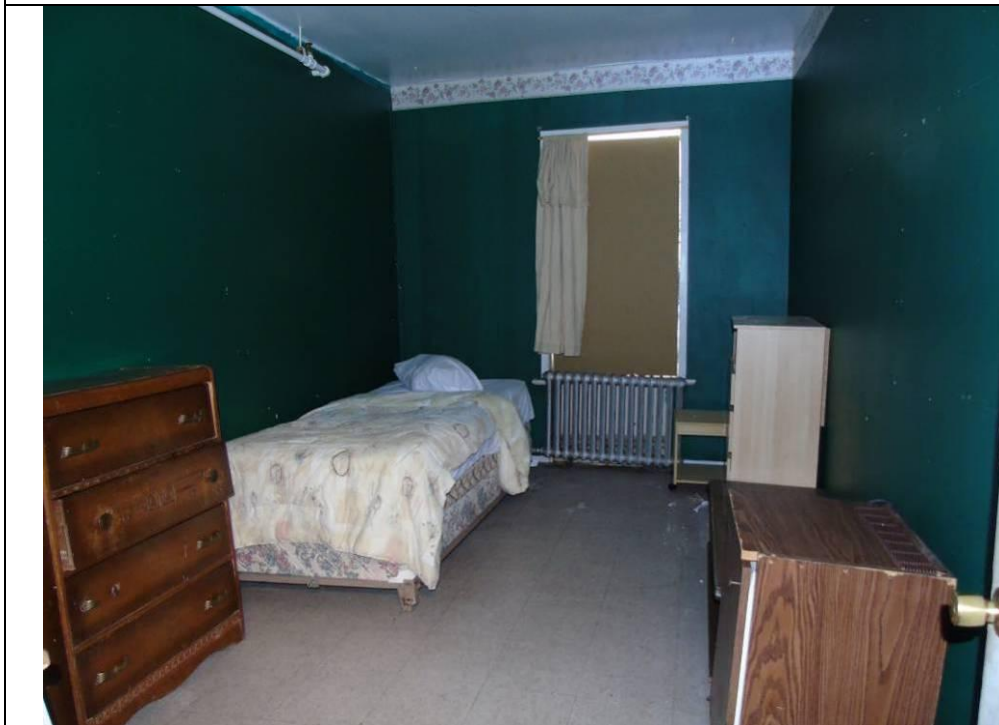
Plate 64: View of a typical room on the third floor.

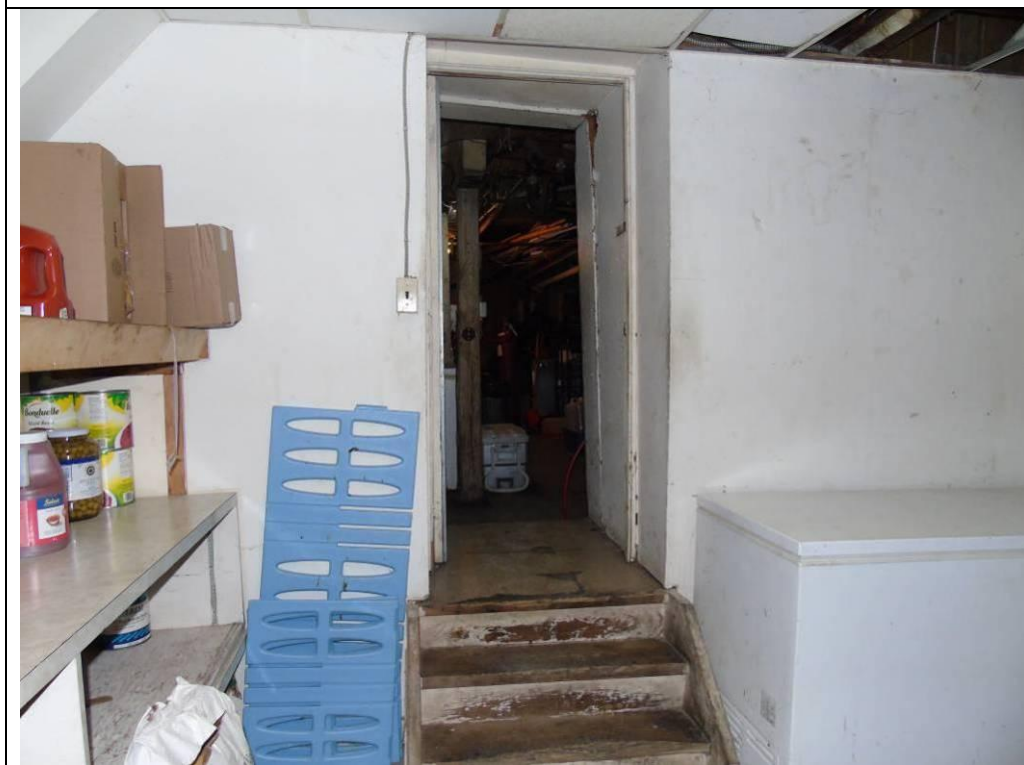
Plate 68:
Basement of 71-
77 and 79 Main
Street South,
showing modern
drywall and
ceiling tiles in a
food storage
area.

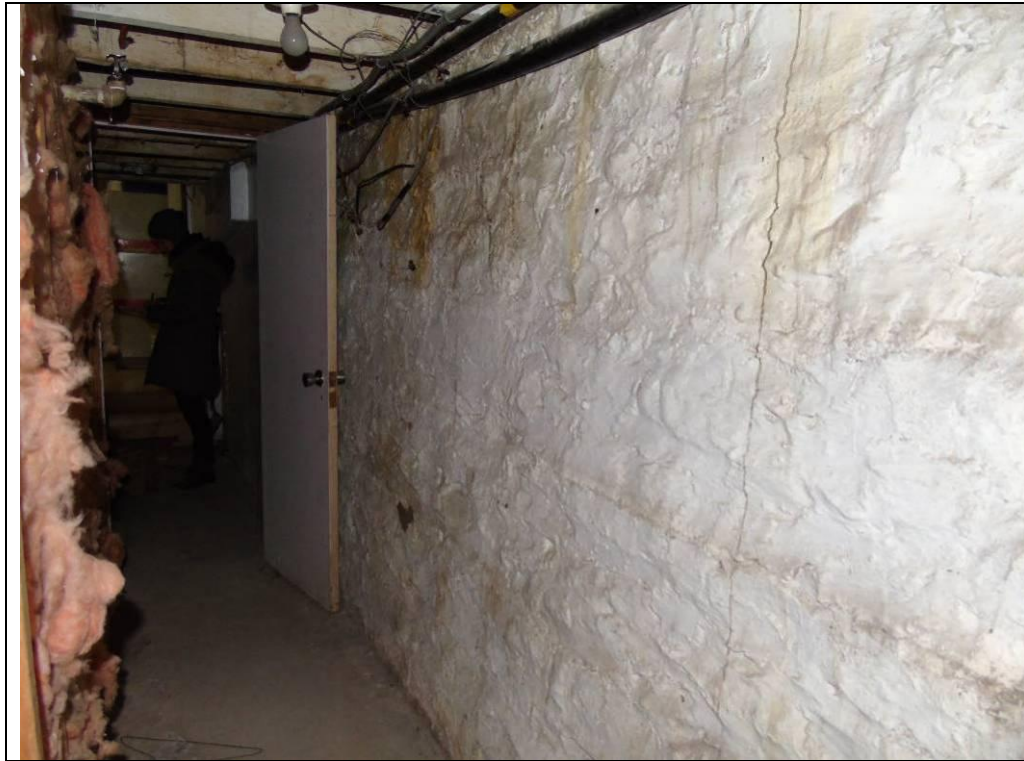
Plate 69:
Basement of 71-
77 and 79 Main
Street South,
showing painted
stone
foundations at
right, and
modern
insulated walls
at left.

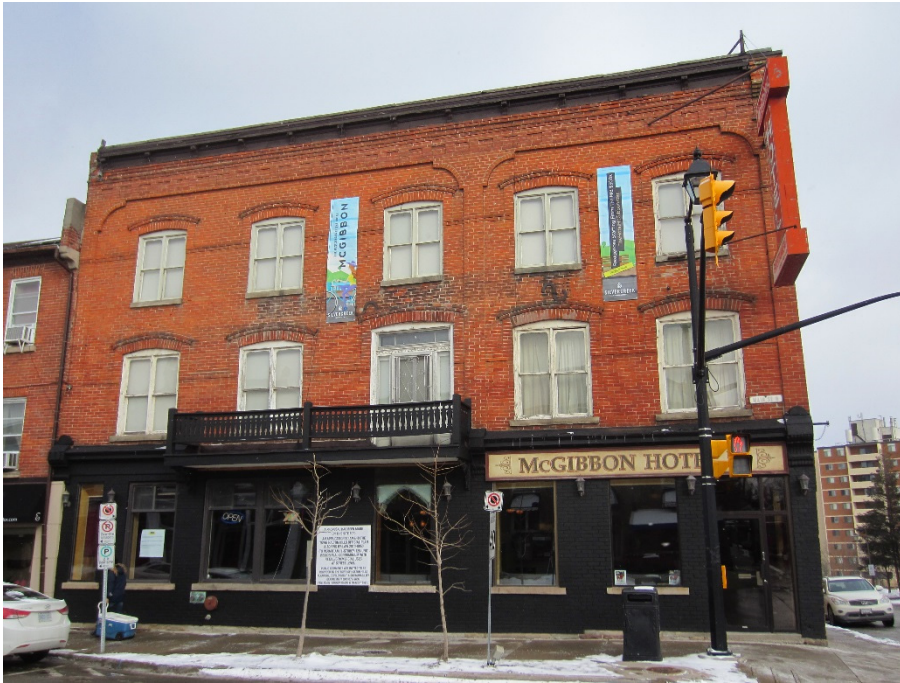
Photo #1: Front of the building (on Main Street South)

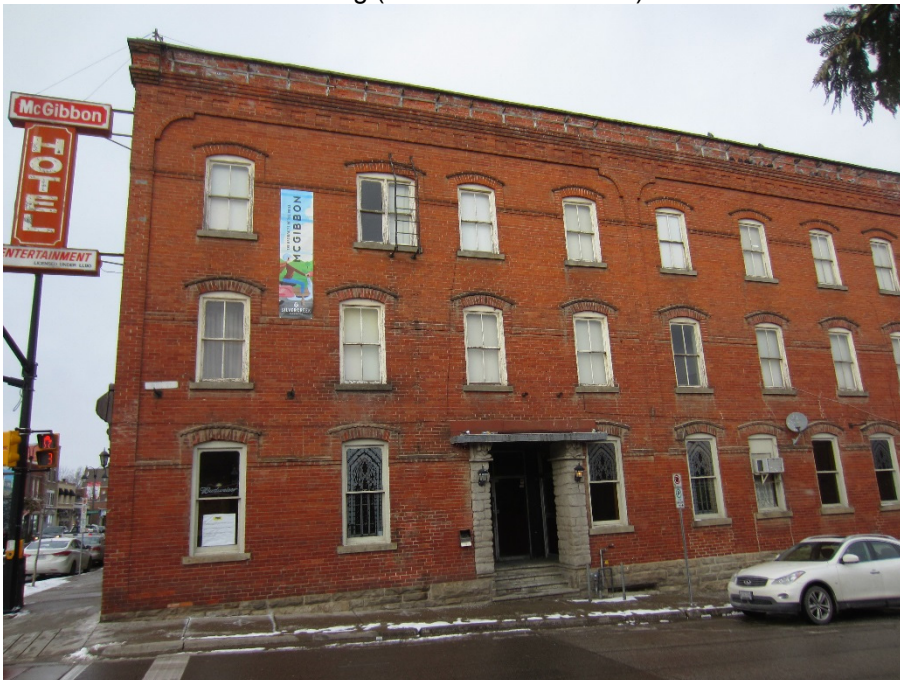
Photo #2: Side of the building (on Mill Street)
